# Deck Engineer on Barge Dies When Struck by Crane Counterweight in Washington State

Investigation: # 10WA040  
Release Date: June 8, 2012  
SHARP Report: # 52-24-2012

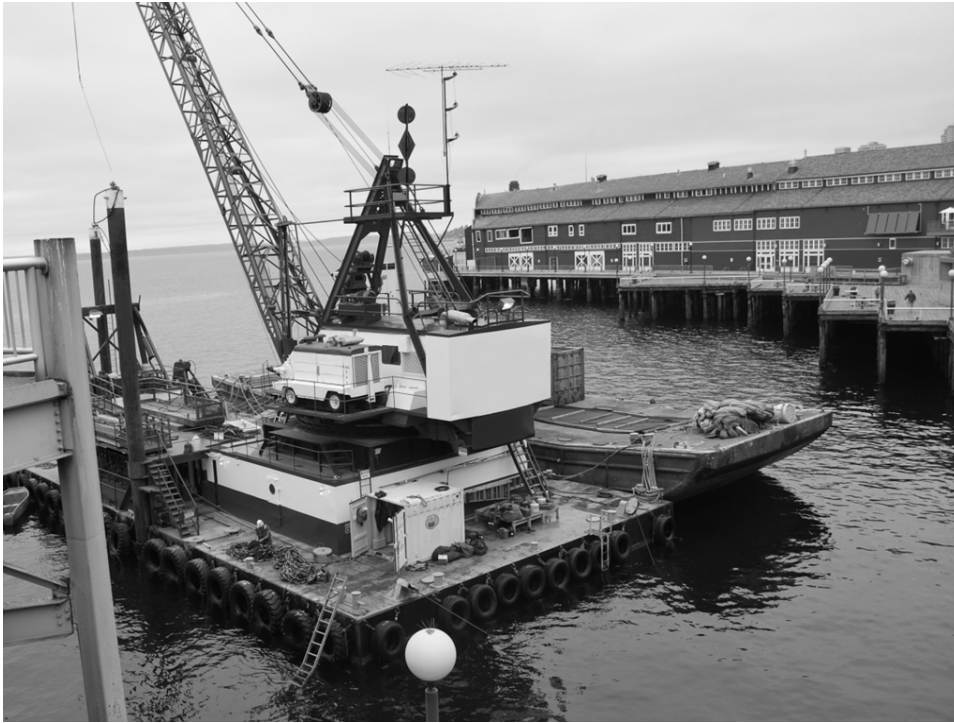
Photo 1: Crane barge at incident site (photo taken over a year later).

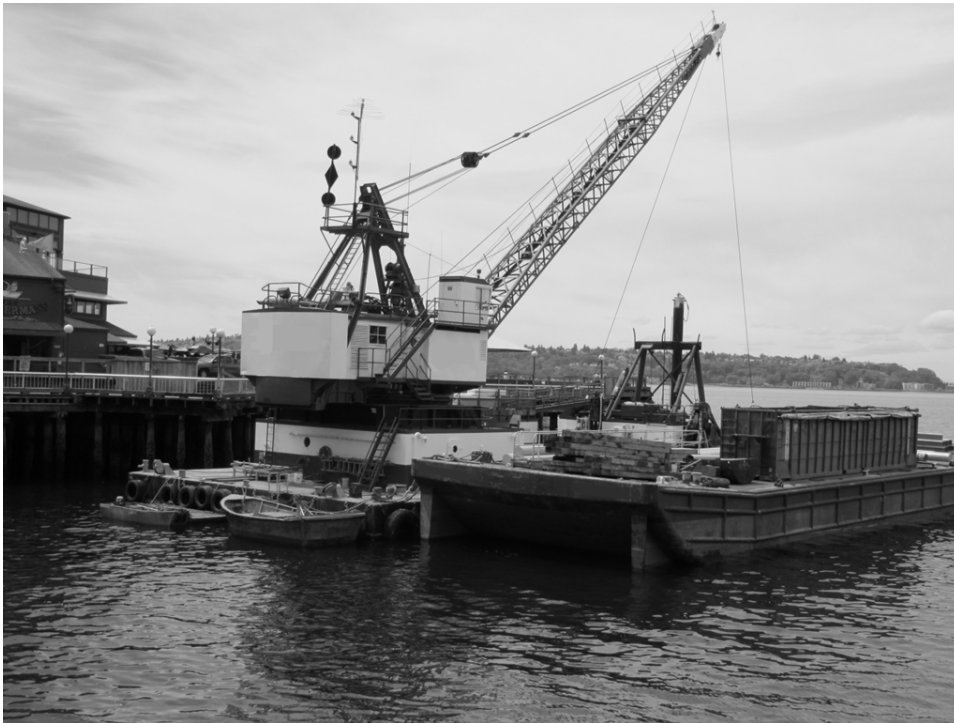
Photo 2: Crane barge and barge used for construction supply storage and waste materials at incident site (photo taken shortly after incident).

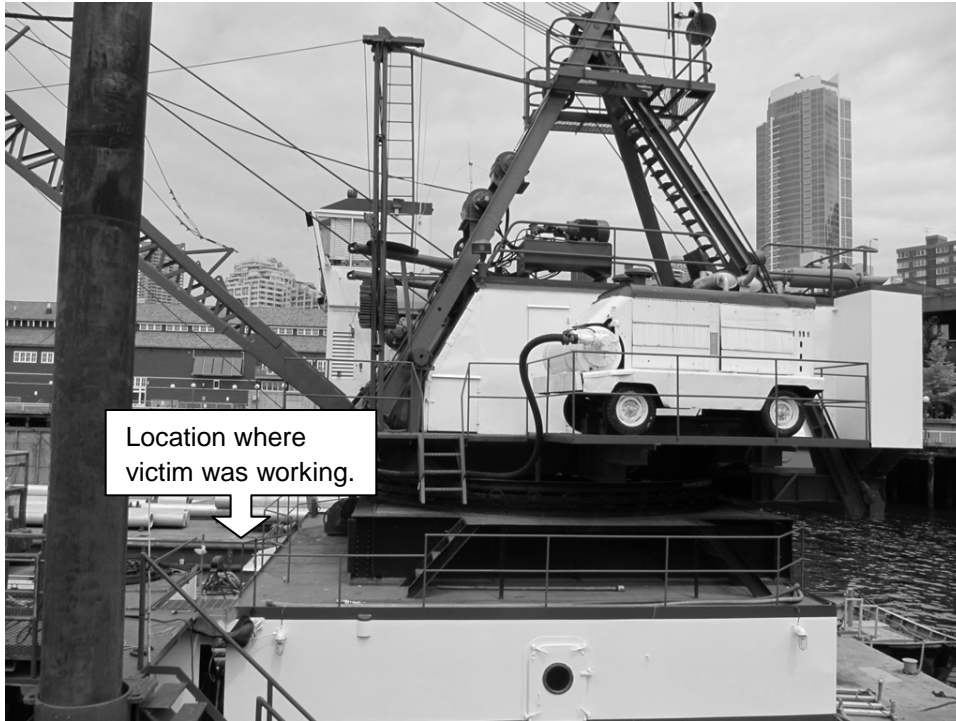
The area on the upper deck in which the victim was intending to weld was within the swing radius of the crane counterweight. At the bottom of the port side stairway between the barge's lower and upper deck ordinarily there was a safety chain with a sign that read "CAUTION: STAND CLEAR OF SWING RADIUS." This safety chain with the warning sign attached was meant to act as a barricade to be put up whenever the crane is operating. This was intended to keep workers from accessing the upper deck where they could be exposed to the area of the swing radius of the crane and struck by hazard of the crane counterweight. On the day of the incident this safety chain was not in place. It is unknown how long the safety chain had been down; it may have been taken down while painting was being done prior to when the victim began her work as a deck engineer on the barge.

Photo 3: Crane and upper deck of barge where the deck engineer (victim) was welding a railing (photo taken shortly after incident).

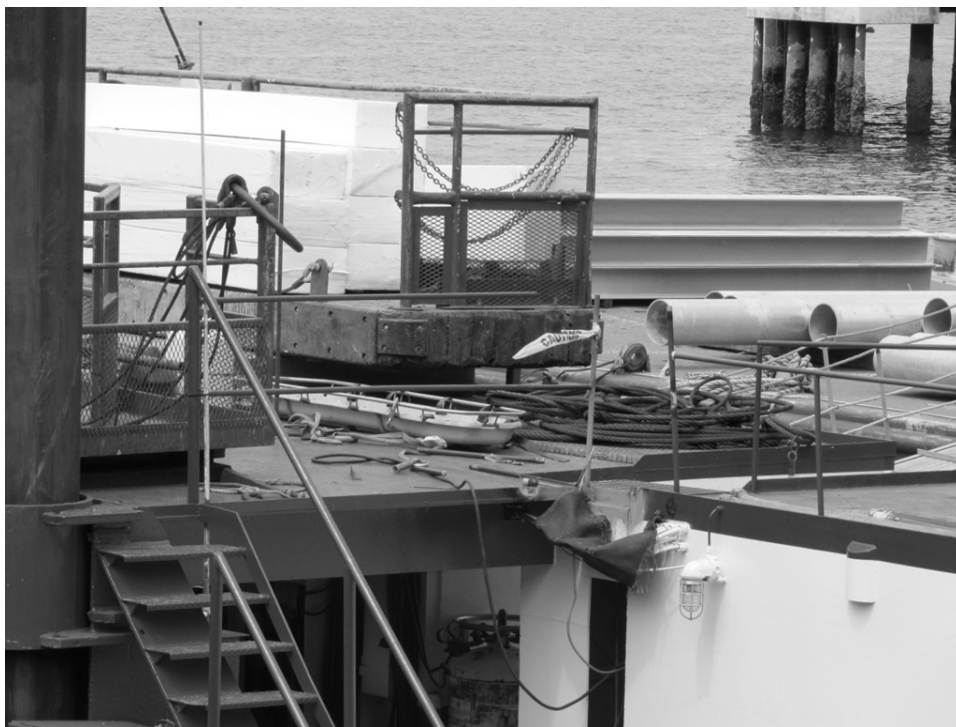
The victim, who reported directly to the crane operator, spoke with the operator about tasks for the day. One of the tasks they agreed on included a welding repair to a portion of a guardrail consisting of a toprail and midrail on the upper deck of the barge. The repair was not considered high priority, but could be done when the victim had time to do it and operations allowed.

Photo 4: Upper deck of barge where victim was welding a broken railing (photo taken shortly after incident).

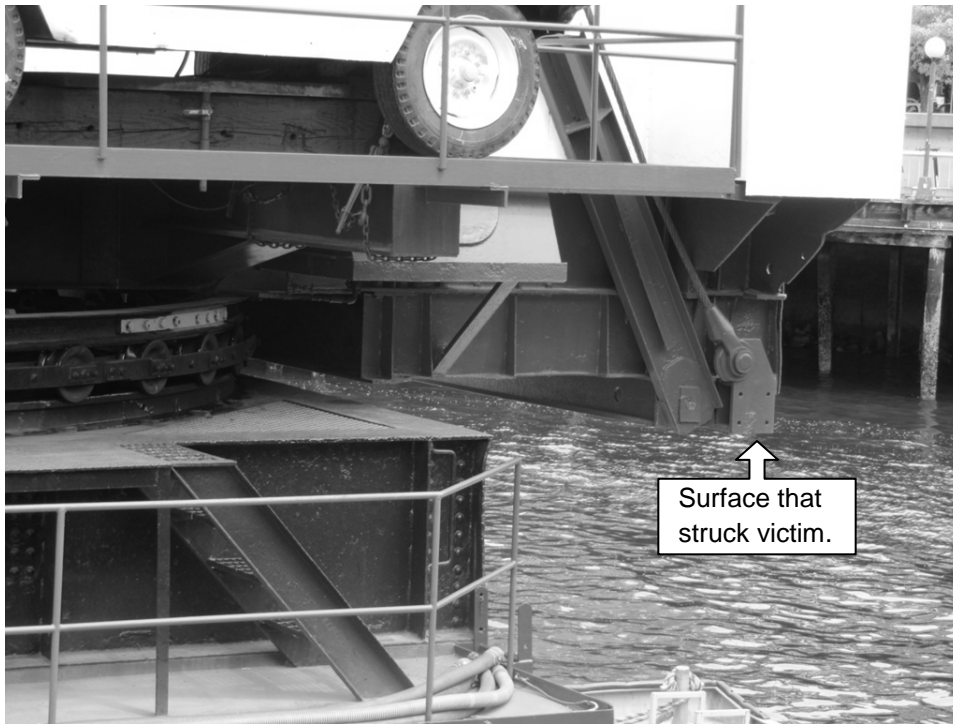
Prior to moving the crane, the crane operator did not establish radio contact with the victim; it was reported that he believed her to be working outside the radius of the crane counterweight swing. She was, in fact, working just inside the rail on the upper deck. The crane operator then picked up the waste piles out of the water and rotated the crane left or counterclockwise. As he did so, the crane's counterweight struck the victim in the head and neck, pinning her against the rail.

Photo 5: Crane counterweight which struck victim (photo taken shortly after incident).

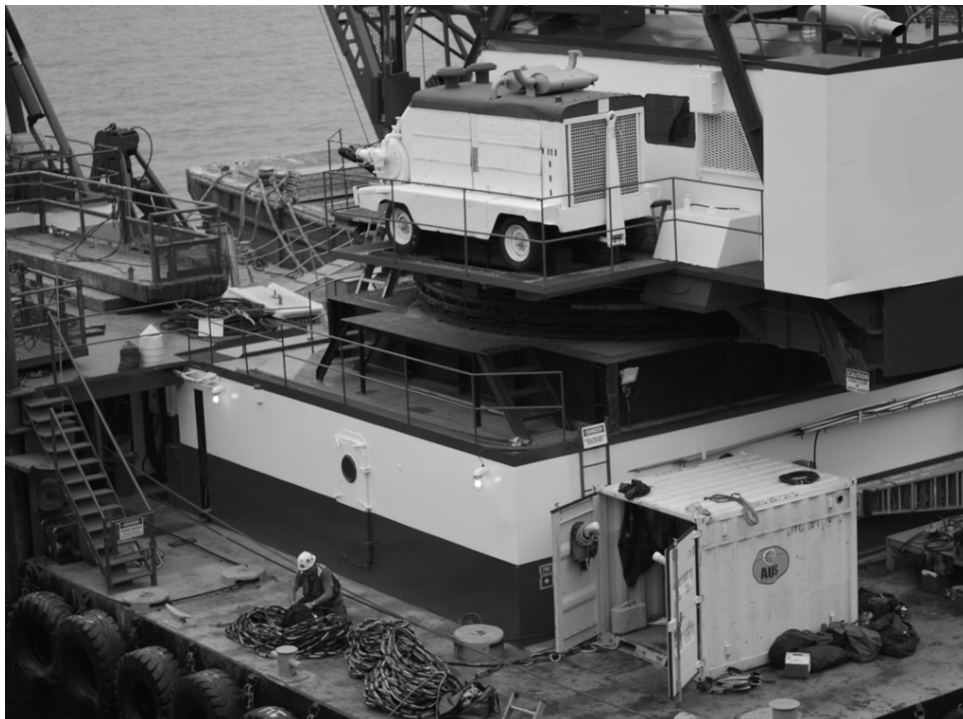
Photo 6: Crane barge at incident site (photo taken over a year later). Note signs warning of crane swing radius and gate and sign placed at foot of stairs which were placed post-incident.

For hazard areas where it is not feasible to erect barriers, post warning signs and create high visibility markings on equipment. Post-incident the employer installed metal swinging, self-closing gates on stairways accessing areas within the crane's swing radius on their barges. Attached to these gates are signs that read "DANGER – SWING RADIUS: No Entry Without Crane Operator Approval." In addition, the area on the upper deck within the swing zone of the crane counterweight is now painted with black and yellow stripes to indicate a hazard zone.

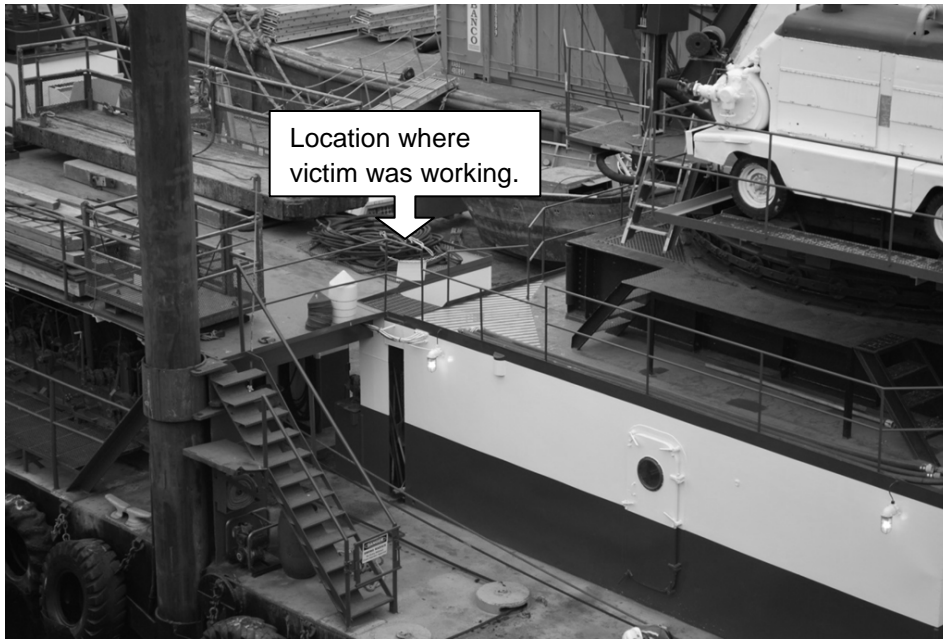
Photo 7: Crane barge showing stairs victim would have used to access upper deck of barge. Note swing gate at bottom of stairs with signage warning of crane swing radius and yellow and black caution stripes on upper deck (area victim was working) warning of area within the radius of the counterweight when the crane swings (photo taken over a year later).

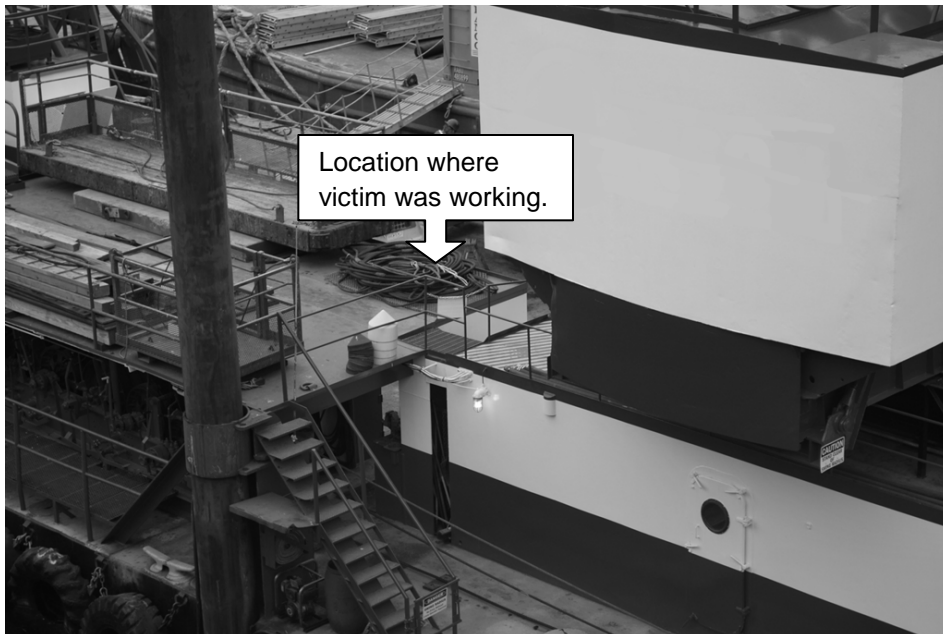
Photo 8: Crane superstructure rotated so that the counterweight is near where it struck the victim who was by the railing in the area of the yellow and black caution stripes painted on upper deck of barge (photo taken over a year later).

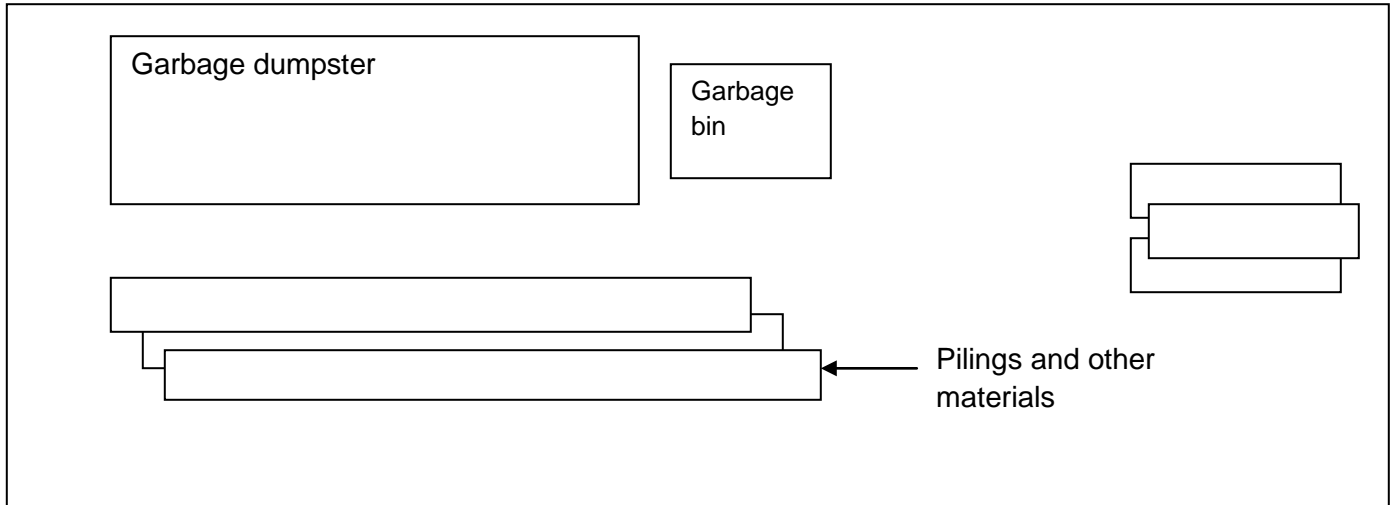
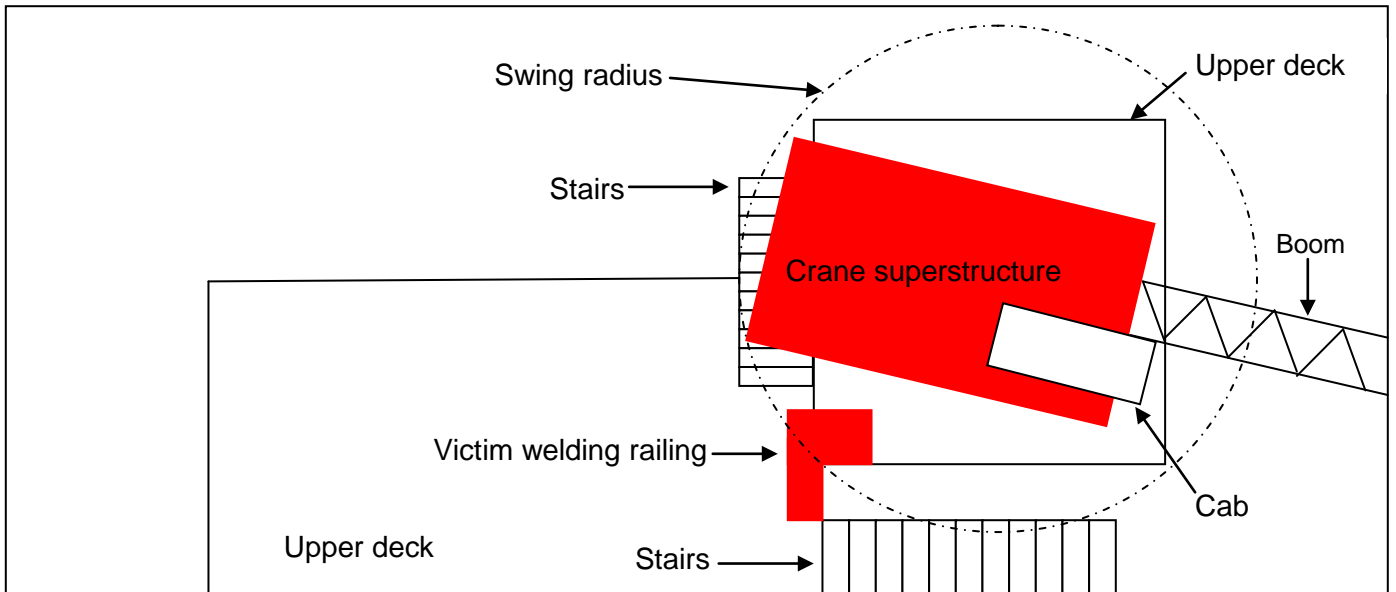
deposited in the garbage dumpster on the second barge. The crane and its boom were facing the shore. The crane operator seated in the crane's cab could not see the victim who was working in his blind spot to the rear right side of the crane as it was positioned.

Figure 1. Approximate position and layout of barges prior to the incident. As the crane made the pick from the water to deposit the waste pilings in the garbage bin on the adjacent barge, the crane superstructure rotated counterclockwise, striking the victim while she was making welding repairs to the railing on the barge's upper deck.
