Orchard Tractor Operator Dies When Run Over by Rotary Mower After Falling From Tractor

Investigation: 13WA01501

Release Date: May 24, 2017

SHARP Report: 52-40-2017

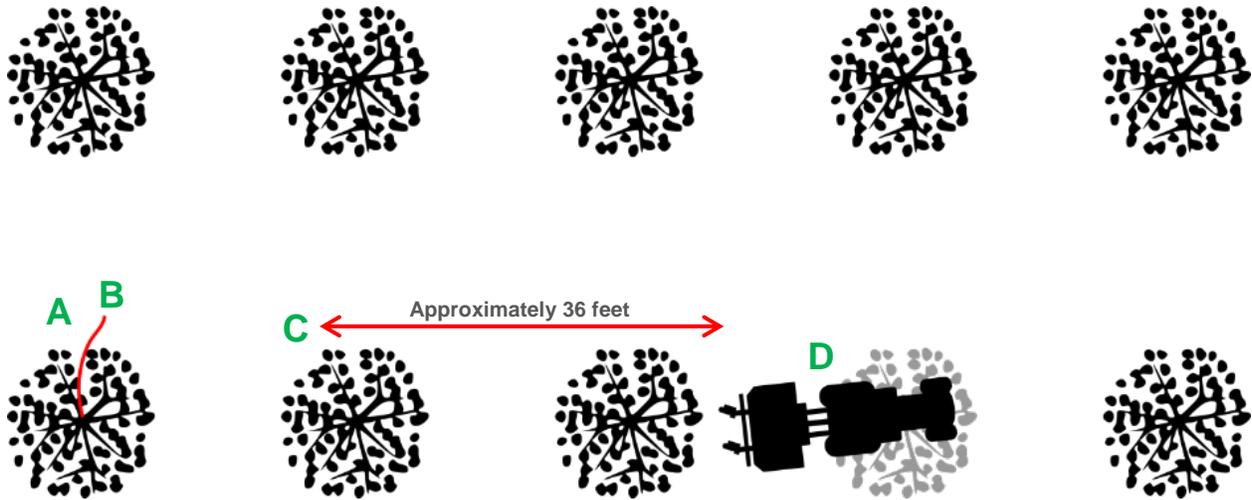
Figure 1. Diagram of incident scene

- A. Location of victim's hat
- B. Location of low hanging branch thought to have struck victim
- C. Location of victim
- D. Location where tractor came to a stop after pushing over and becoming stuck on a pear tree

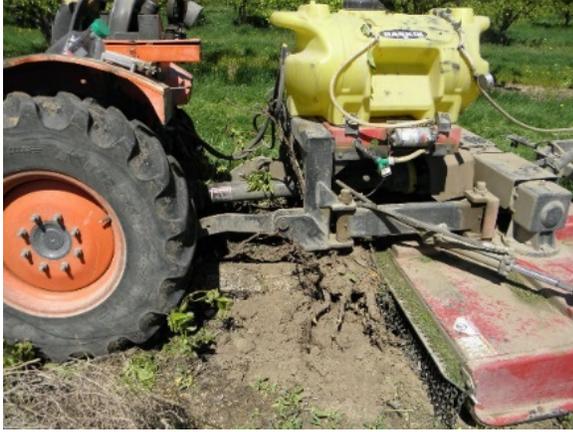
When the tractor manager neared the victim's location, he saw the victim lying on the ground. He was severely injured, with large cuts on the back of his head and arms. It appeared that he had been run over by the mower attachment. The tractor and mower had continued moving until running into a pear tree two trees away from where the victim was lying. The tractor was stuck on the tree, still running in gear with the right

Photo 1: Position of tractor and mower after pushing over and becoming stuck on a pear tree

rear tire still turning (Photos 1 and 2). While the other employee stayed with the victim, the tractor manager went to the tractor and shut it off by pulling the engine stop and removing the key, and then called 911. Emergency responders arrived and began CPR, but the victim was declared dead at the scene.

Recommendation 1: Train operators to always shut down tractors safely before leaving the driver’s seat. Ensure that they follow safety guidelines through frequent retraining and spot checks.

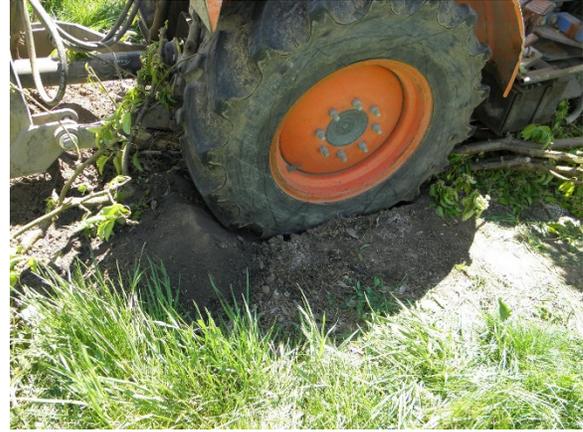
Photo 2: Right rear tire that continued turning after tractor ran over and became stuck on tree

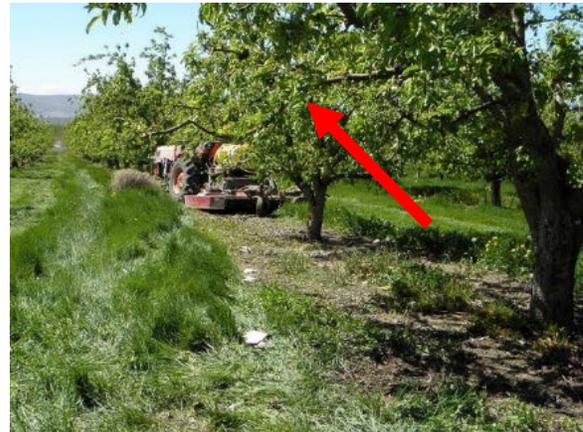
An investigation of the site found the victim's hat on the ground approximately one tree east of his position. Investigators believe that the hat may have been knocked off the victim by a low hanging branch on the tree above where it was found (Photo 3). The grass between the victim and the location of the tractor and mower was uncut, suggesting that the victim had disengaged the mower blades before he fell from the tractor. It was also determined that the mower was not being operated in the offset position designed to allow the operator to maintain more distance between the tractor and the trees while mowing.

Photo 3: View of tractor from position of victim. Arrow indicates low-hanging branch that may have knocked victim's hat to the ground

Discussion: Based on evidence from the scene, investigators believe that as the victim was mowing grass near the trees, he was struck by a low hanging branch which knocked the hat he was wearing off of his head. The fatal incident likely occurred as he attempted to dismount the still running tractor to retrieve the hat. Employers should train operators to identify and remove or avoid obstacles in areas they intend to operate machinery.

Recommendation 3: Keep clear of obstacles, such as low hanging branches, to the extent possible when operating a tractor with or without attachments.

The rotary mower attachment that the victim was using that day was equipped with a hydraulic hitch that enabled the operator to offset the mower up to 14 inches to the side. This function was designed to allow the tractor operator to avoid obstructions, such as low hanging tree limbs, over the area being mowed. If the victim had been using this safety feature on the day of the incident to mow the grass edge closest to the pear trees, he would have been able to keep the tractor nearer to the center of the row and may not have been hit by the protruding branch. Employers should train operators and enforce proper tractor operation.

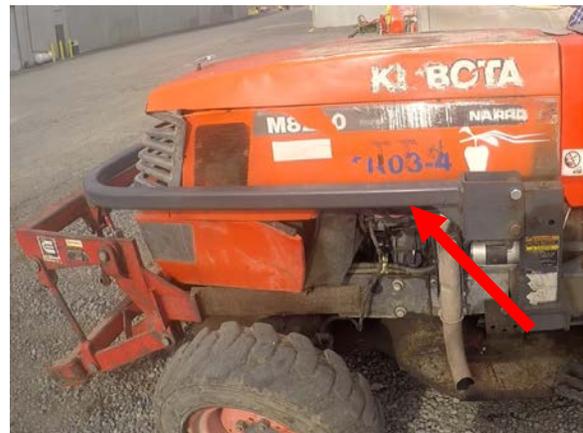
At the time of the incident, the tractor's foldable rollover protective structure (ROPS) was in the down position (Photo 4). In Washington State, the orchard work being performed was exempt from ROPS requirements.

Photo 4: ROPS in folded down position

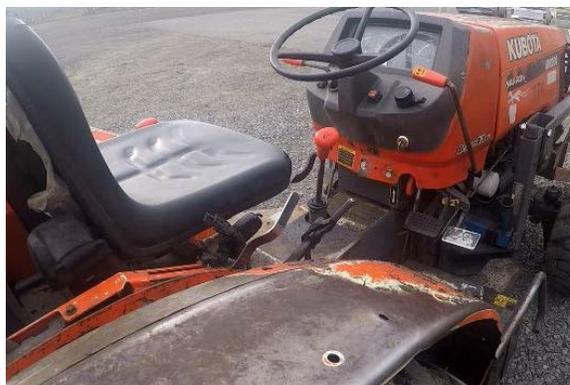
Another possibility is that he left the shuttle in the “forward” position and put the gear selector in the center of the operator’s compartment (Photo 5) in the neutral position, then contacted the lever with his leg as he attempted to dismount, shifting the tractor into gear causing it to move forward.

Photo 5: Gear selector placement in center of operator’s compartment.

An investigation of the tractor found that the gear selector moved easily between gears with little force. In either scenario, the sudden motion may have caused the victim to fall toward the rear of the tractor and down to the ground between the tractor’s right rear wheel and the mower. The tractor continued moving forward, causing the mower to run over the victim’s head and upper body.

Recommendation 4: Consider using tractors equipped with operator presence sensing (OPS) technology or other interlocks that will lock out the powertrain and PTO if the operator leaves the driver's seat.

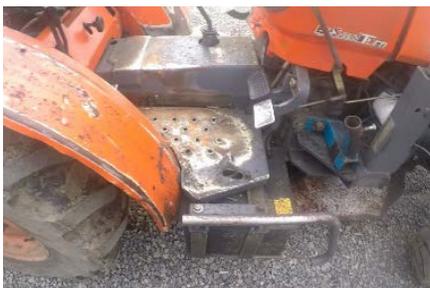
Discussion: The victim was run over by the right side of the mower, indicating that he likely attempted to dismount the tractor from the right side, which was not equipped with built-in steps.

Photo 6: Right side of tractor without steps

In addition, the foot throttle pedal blocked the way for easy access or egress from this side of the tractor (Photos 6 and 7). It would not have been possible to safely dismount the tractor

from this side, which may have contributed to his fall.

Recommendation 2: Train operators to always mount and dismount tractors in a safe manner by using all steps and handholds available, and maintaining three points of contact.

Operators should be trained to mount and dismount tractors safely. To avoid injury, getting on or off a tractor should only be done using the steps provided. Operators should not jump down from the tractor. Steps provide traction to reduce slips and their placement is designed to allow the operator to avoid inadvertently contacting controls. Three points of contact, either two hands and one foot or two feet and one hand, should always be maintained when mounting and dismounting to avoid slips or falls.

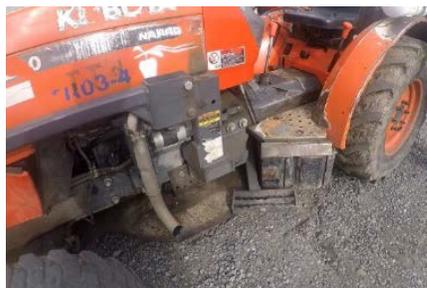
Photo 7: Left side of tractor showing step designed for mounting and dismounting
