CONSTRUCTION FATALITY NARRATIVE

Father and Son Painters Electrocuted when Ladder **Contacts Power Line**

REPORT #: 71-210-2021s

REPORT DATE: September 17, 2021

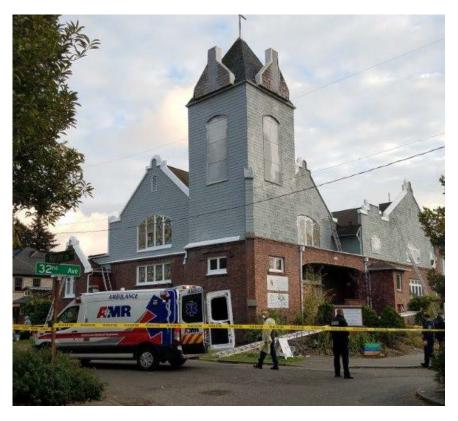
Photo 1. Incident scene showing the church that the contractor and crew were painting.

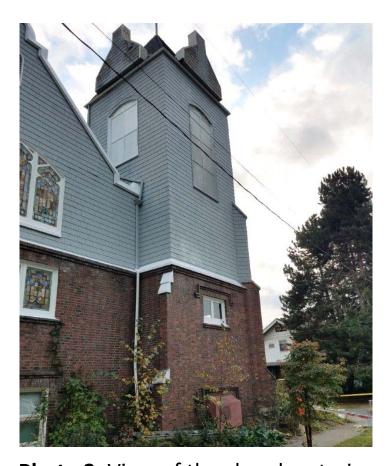
The contractor and his son were moving the aluminum extension ladder that was at its full extension of 48 feet. The contractor and his son held the ladder in the vertical position as his son attempted to retract the ladder's extension. A gust of wind blew the ladder onto a 14,460-volt overhead power line.

Photo 2. View of the church exterior where the extension ladder contacted the overhead power line.

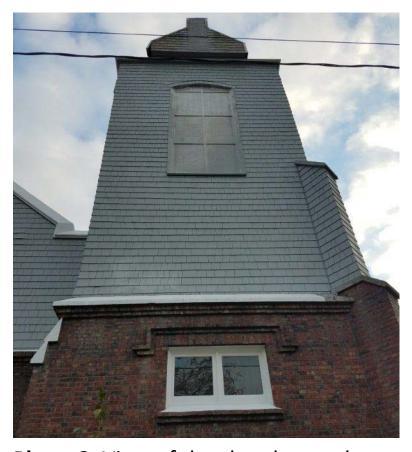
- 1) Measures were not in place to protect against the ladder contacting the energized power line.
- 2) No account was taken of windy conditions when handling the ladder.
- 3) The distance from the power line to the face of the building was 10 feet 8 inches.

Photo 3. View of the church steeple and proximity of the overhead power line.

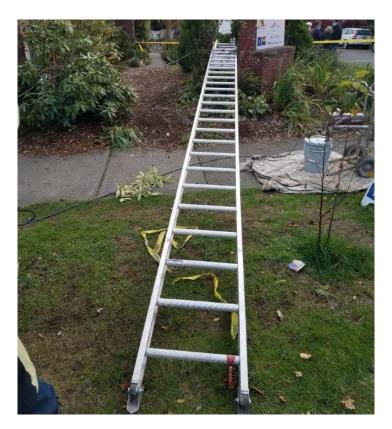
Electrical current traveled from the power line through the conductive aluminum ladder. Both were electrocuted. The contractor died at the scene and his son died nearly a month later.

Photo 4. The 48-foot aluminum extension ladder that contacted the overhead power line.

Employers must use ladders with nonconductive side rails where the ladder could contact uninsulated, energized electric lines or equipment.

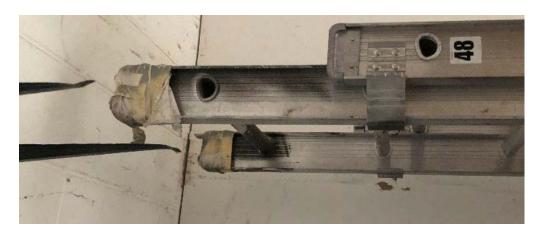
Photo 5. Top of the extension ladder showing burn marks where the ladder contacted the power line.

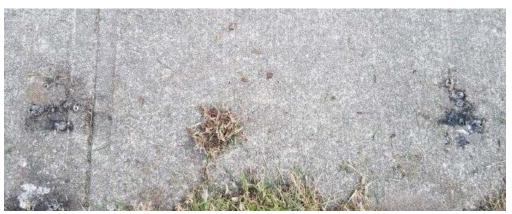
Photo 6. The sidewalk with burn marks where the ladder had been placed.
