## Framer Falls 25 Feet from House Roof

**REPORT #:** 71-224-2022s

**REPORT DATE:** July 18, 2022

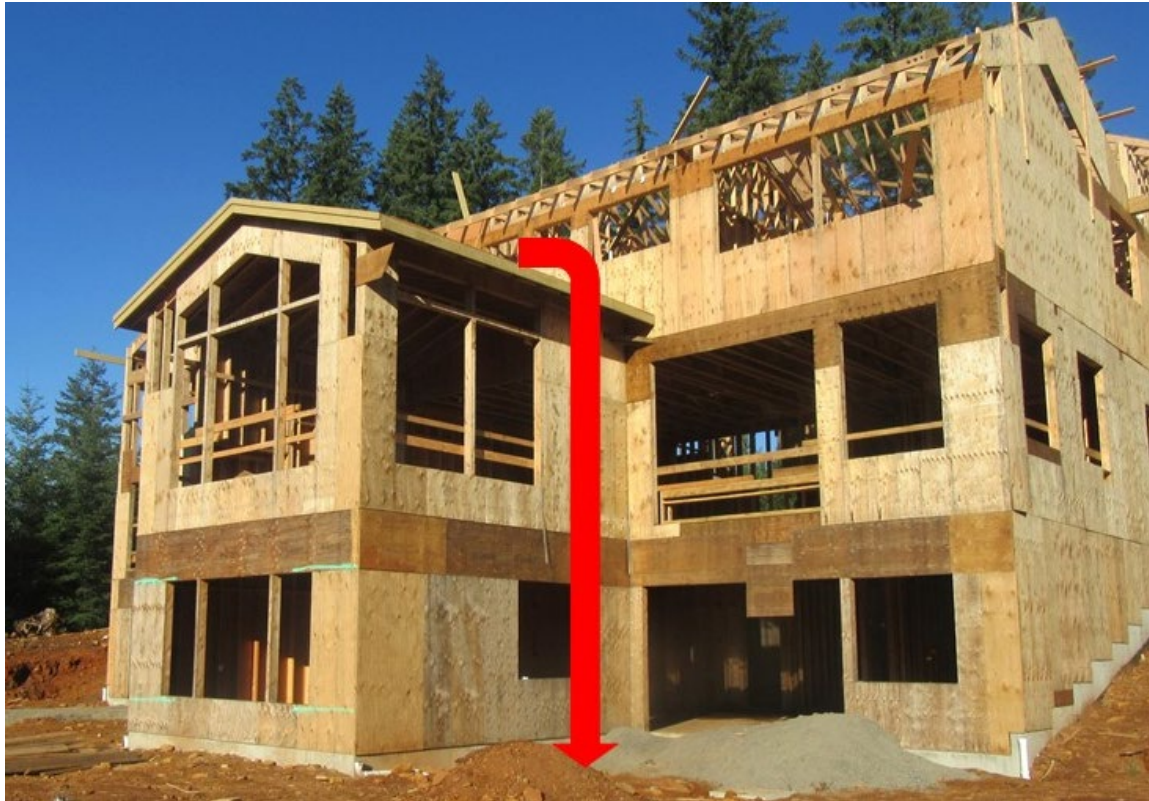
Around 8 a.m., for an unknown reason, he went onto the already sheathed 4/12 pitch roof on the backside of the house. He was not wearing his personal fall protection harness; he had left it in his vehicle. The sheathed roof was wet with dew. While on the roof, he fell 25 feet to the ground below.

**Photo 1.** House where framer fell 25 feet from the lower back sheathed roof. He was not using fall protection

- Conduct pre-shift safety meetings to determine if workers will be doing tasks that put them at risk of falls and reinforce the need for fall protection.
- Perform unannounced fall protection spot checks to ensure workers maintain 100% tie-off.
- Effectively enforce their written safety program.

Workers should use employer provided fall protection.

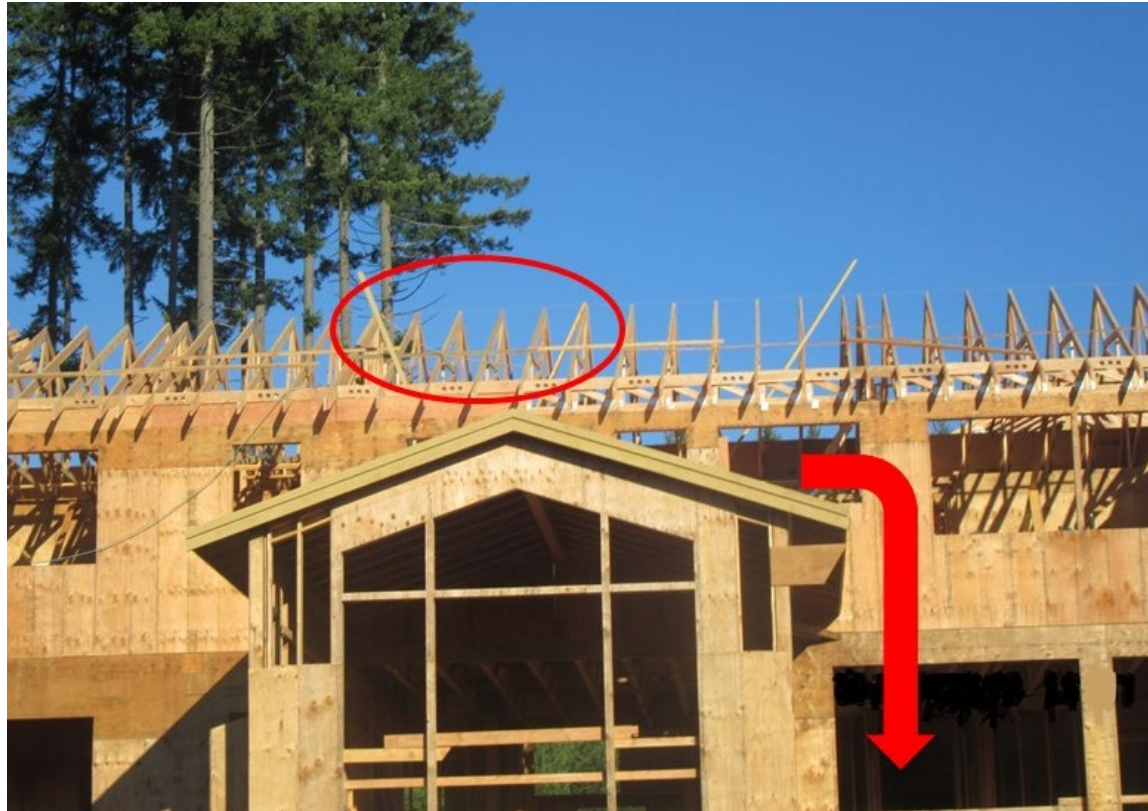
**Photo 2.** A lifeline had been installed on a truss (circled) and was available just below the upper roof edge in front of a window where the framer could have used it before going onto the roof. Arrow shows where the framer fell.

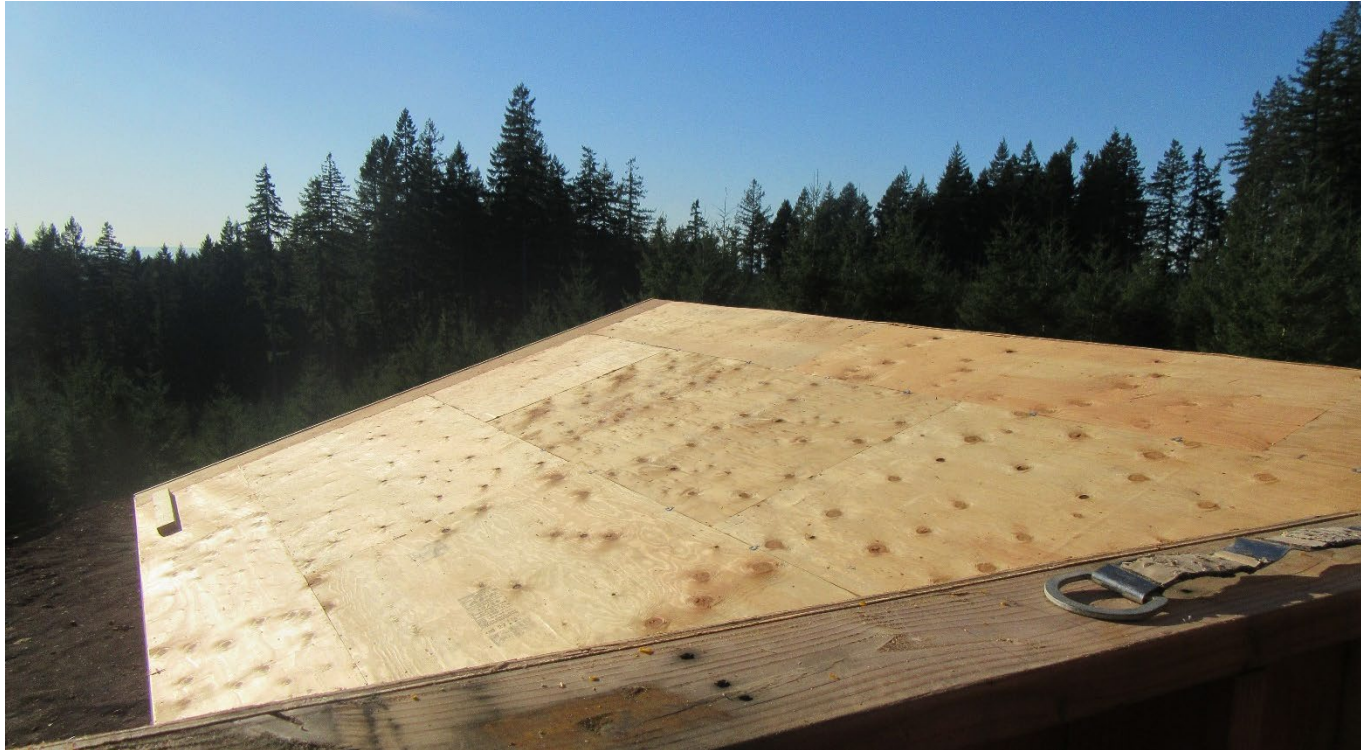
**Photo 3.** View from above the sheathed lower backside roof. The framer fell from approximately halfway along the left side edge. An anchor point on the window sill is visible in the lower right.

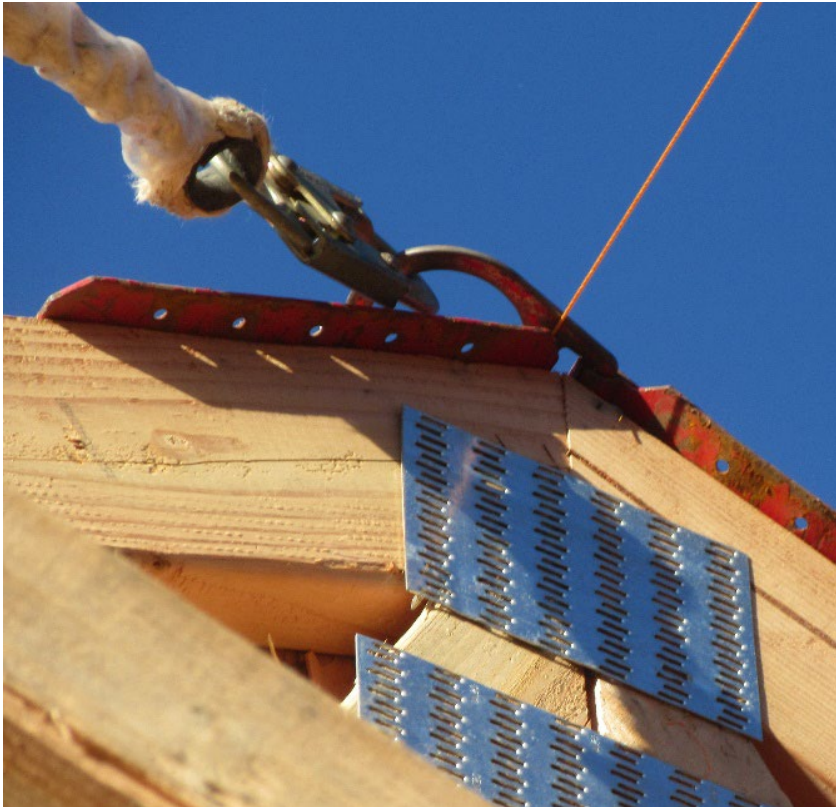
**Photo 4.** Anchor point and lifeline.

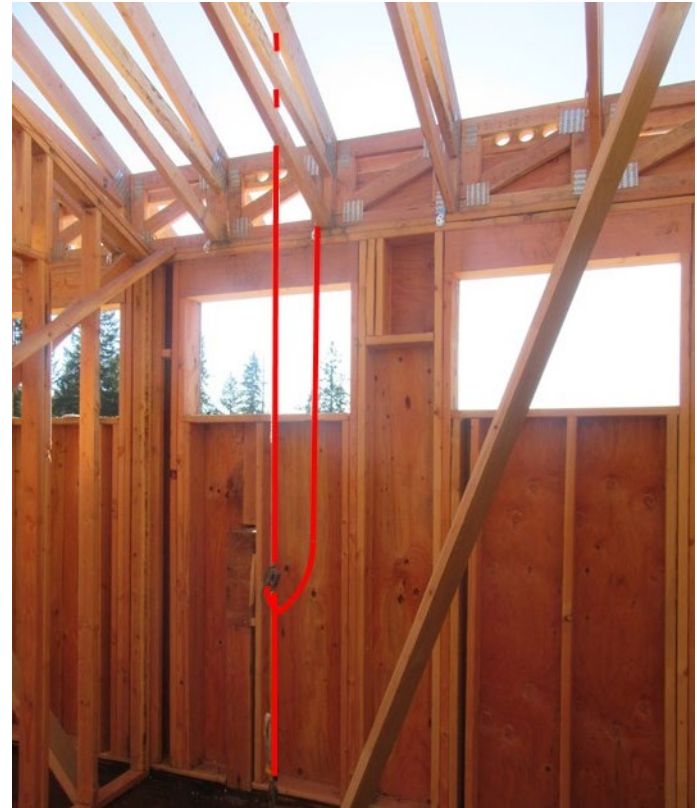
**Photo 5.** Lifeline that could have been used. The roof the framer went onto is on the other side of the wall.
