Site Superintendent Run Over by Backing Dump Truck

INCIDENT FACTS

REPORT #: 71-231-2022s

REPORT DATE: December 5, 2022

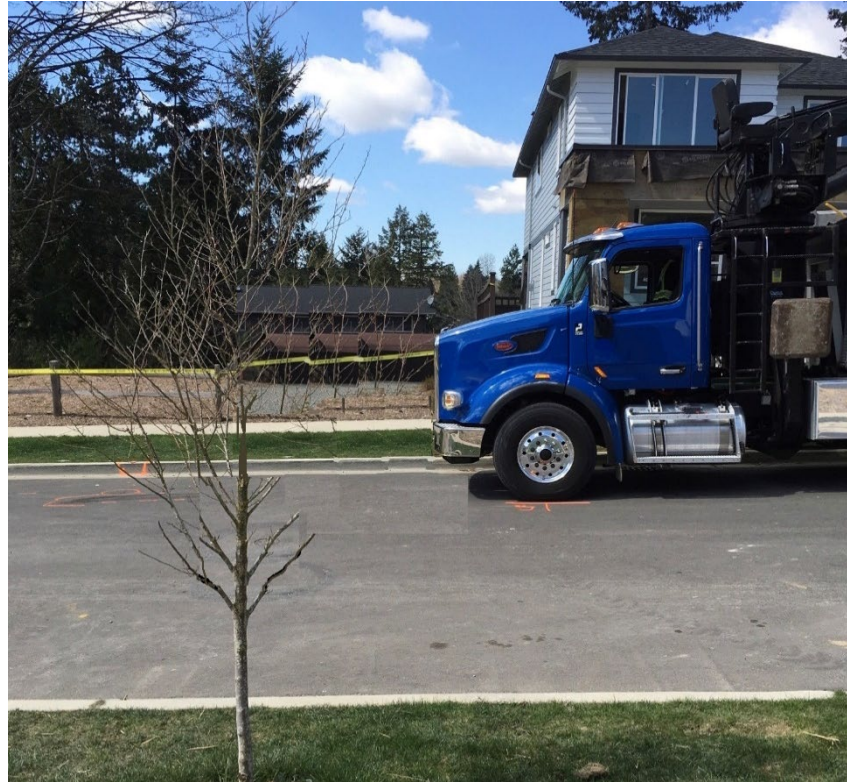
- The truck did not have a backup camera, nor was an observer signaling that it was safe to back up.
- The truck's backup alarm was working as it backed up.
- The truck drivers were not trained on procedures for backing up at construction sites.

Photo 1. Incident scene showing the dump truck after it backed up and ran over the superintendent. The superintendent was found on the street in front of the truck.

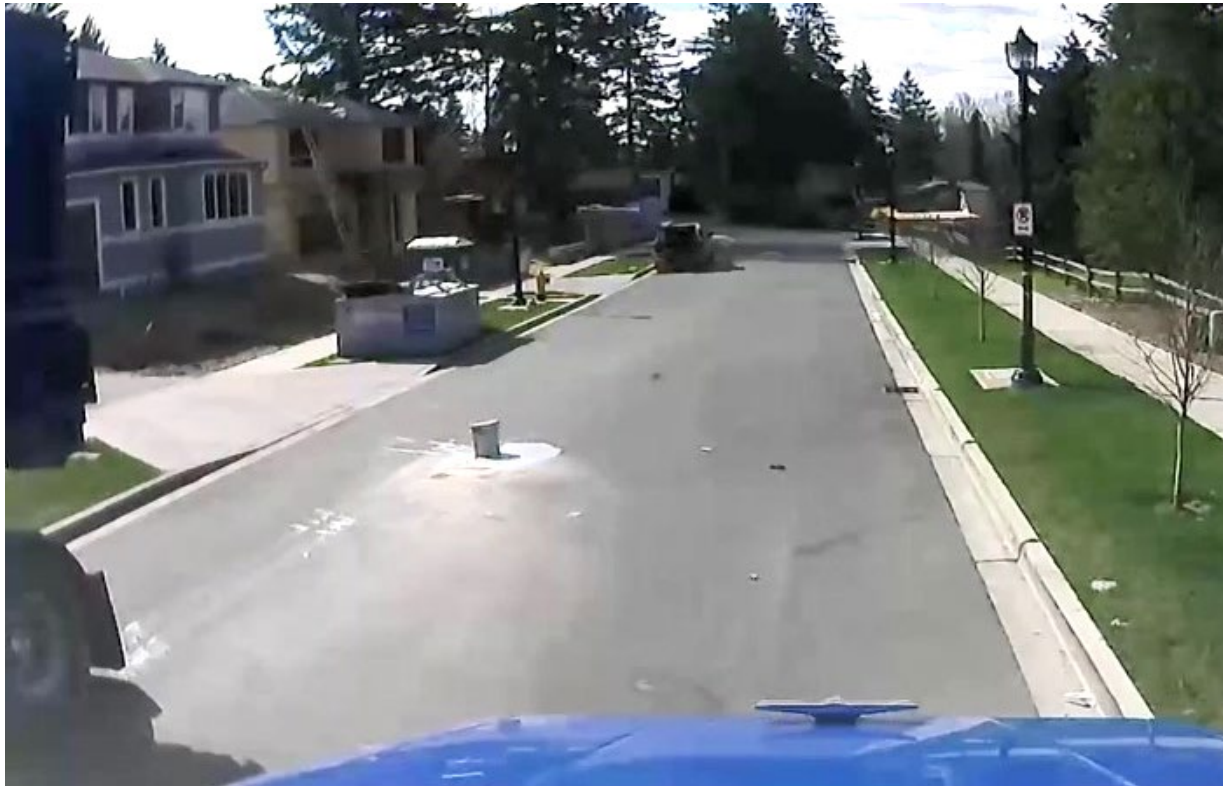
Photo 2. View of the incident scene as captured by the in-cab camera of truck #2 after the superintendent had been struck and run over. Part of the rear of dump truck #1, which the driver was lining up next to, is visible on the left.

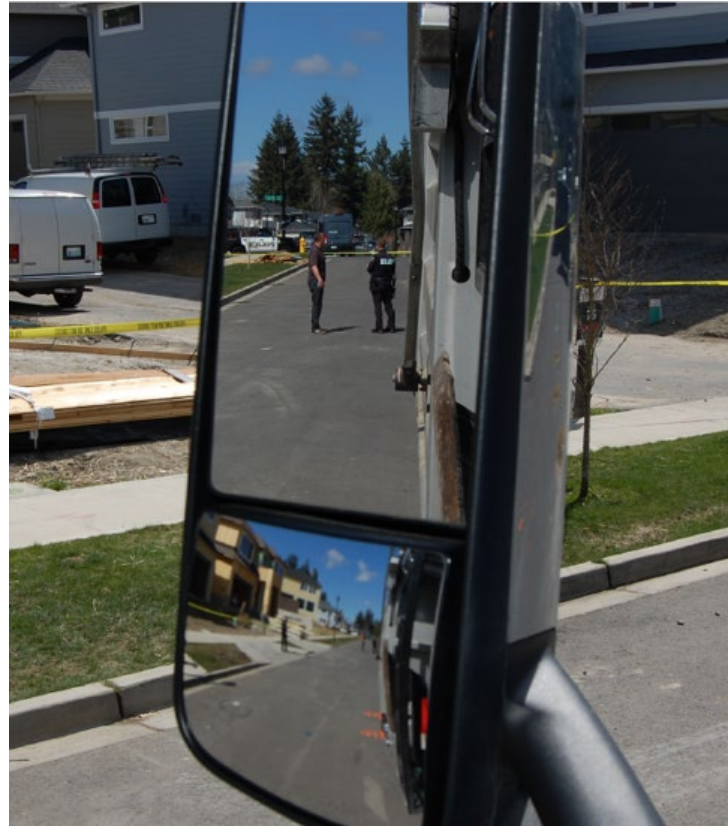
Photo 3. View of incident scene in dump truck's side view mirror shows workers are difficult to see if not wearing high-visibility vests.

- Continuously assess the hazards of vehicles to workers on foot and ensure hazards are corrected.
- Require workers to wear ANSI Class 2 high-visibility garments, such as vests, when exposed to vehicular traffic.

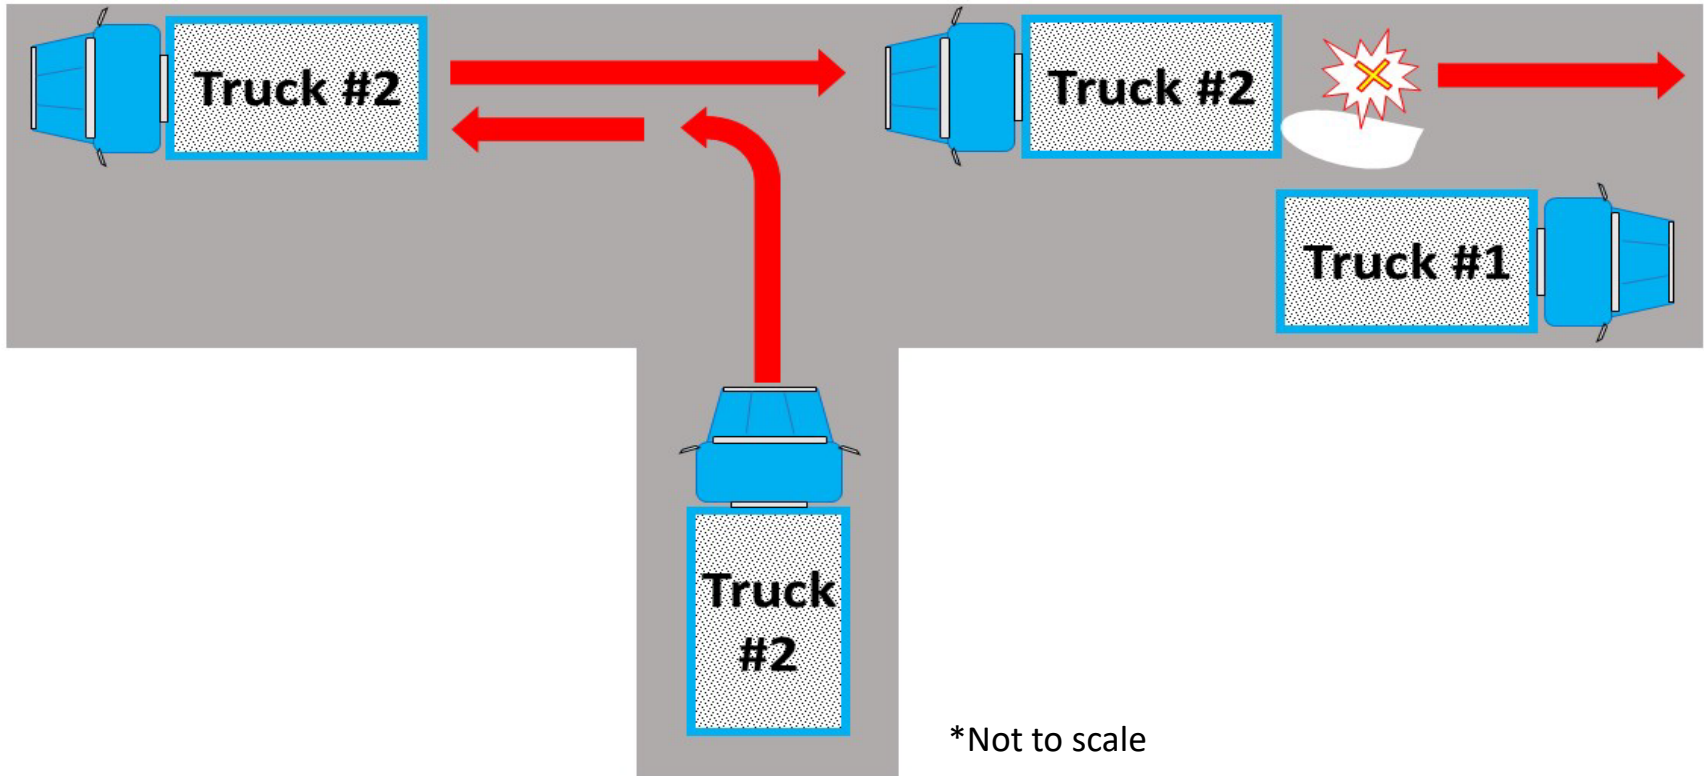
The driver of truck #1 drove out of the alley, turned right, and parked on the side of the street near the superintendent. The driver of truck #2 then turned left onto the street, drove forward, and stopped. He checked his mirrors and got a hand signal from the superintendent to begin backing up. As he was backing up, he lost sight of the superintendent and ran him over. The incident was unwitnessed. It is unknown why the superintendent was in the backing zone, or why the driver could not see him.

Diagram 1. Diagram of the incident scene. Dump truck #1 parked in the street near the paint spill, shown by the white blotch. Dump truck #2 exited an alley and turned left. The driver then checked his rearview mirrors and backed up. The “x” shows the location where the superintendent was struck and run over.

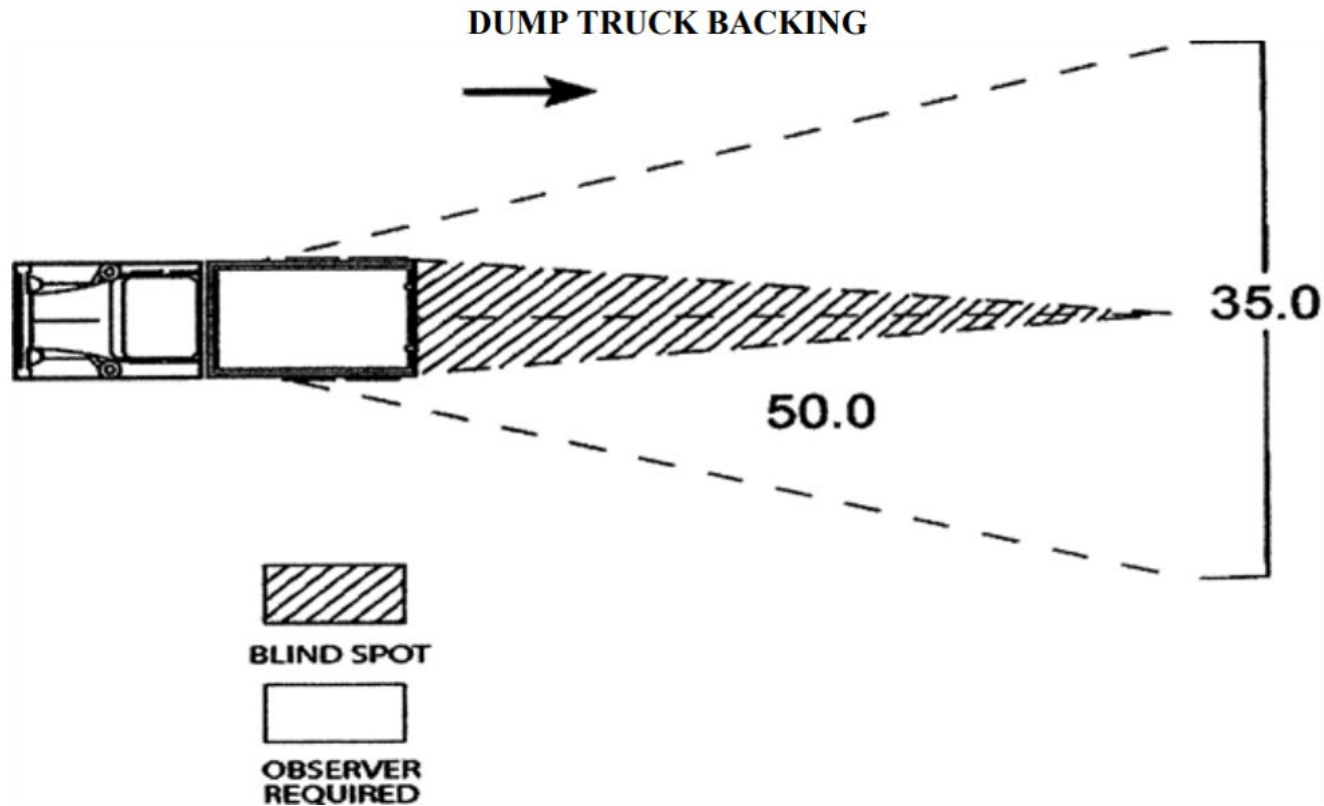
Diagram 2. Diagram of the dump truck backing zone. Distances are indicated in feet.

Before backing a dump truck, the driver must determine that no one is currently in the backing zone and it is reasonable to expect that no employee(s) will enter the backing zone while operating a dump truck in reverse. If employees are in the backing zone, you must make sure the truck is backed only when: An observer signals that it is safe to back or an operable mechanical device that provides the driver a full view behind the dump truck is used, such as a video camera. See [WAC 296-155-610\(2\)\(f\)\(ii\)](#)

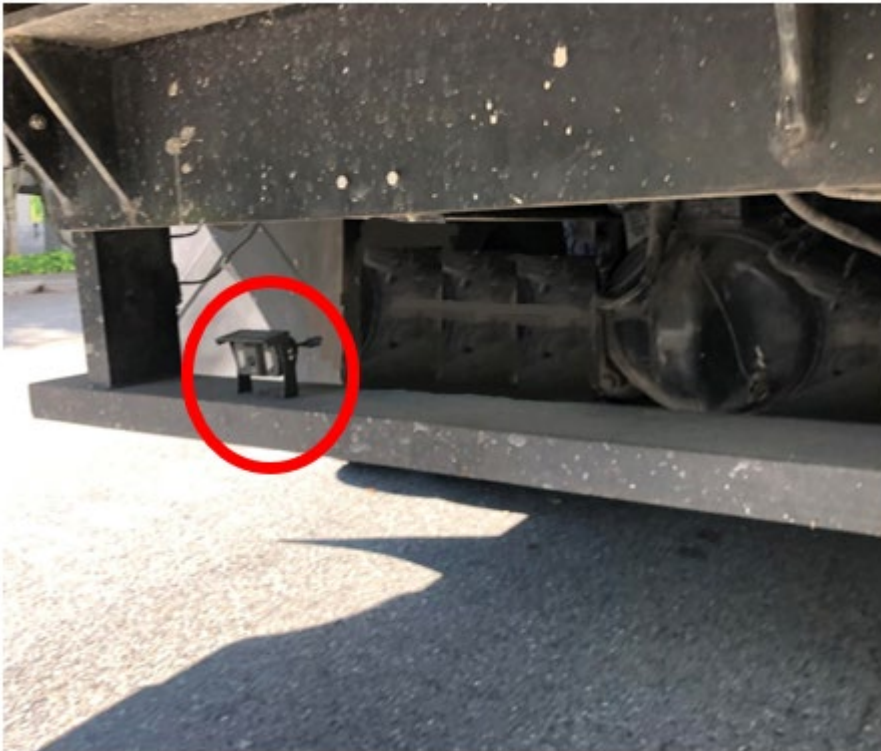
Photo 4. Backup camera mounted on dump truck after the incident.

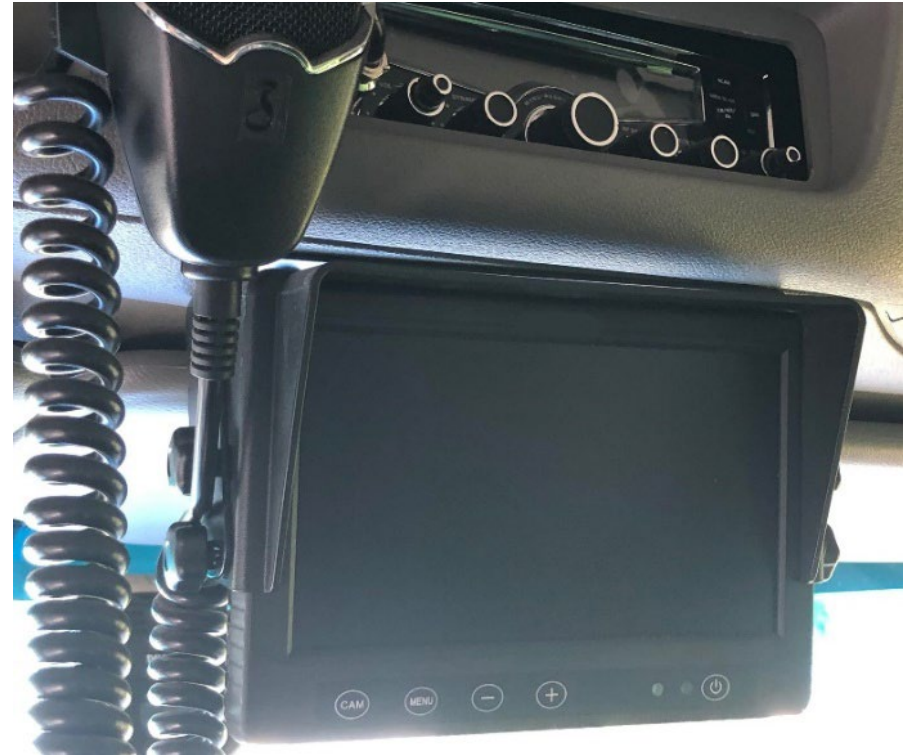
Photo 5. Backup camera monitor in truck cab installed after the incident.
