71-179-2019

March 26, 2019

Ironworker Falls 80 Feet through Bent Plate Gap

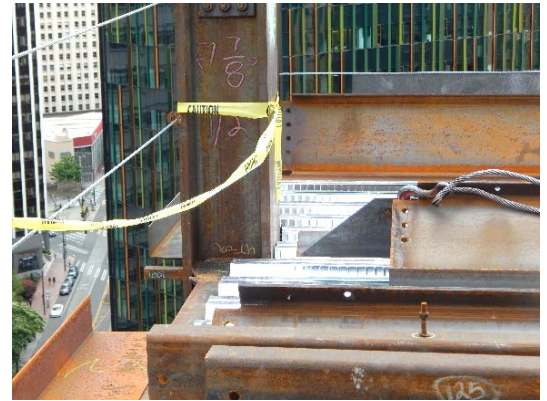
State investigators found that all the guardrail systems at the site were placed outside the edge of deck/floor in the locations where the bent plates had not been placed, allowing for a space employees could fall through. Company procedure was to place bent plates over these gaps later in the construction process after the beam/column weld connections were made and the welds inspected.

The bent plate gap the ironworker fell through. The opening was 36 inches long by 4 inches wide. Caution tape was placed after the incident.

Following the incident, the employer began corrective measures including: installing the bent plates as soon as structurally possible; decreasing the gap from 3 feet to 18 inches; moving the rail posts a few inches inward when possible; and wrapping cable rails around columns.

- Configure guardrail systems to prevent workers from reaching the unprotected floor edge.
- Place temporary covers over bent plate gaps.
- Decrease the size of bent plate gaps.
- Have a steel fabricator install bent plates prior to the erection of columns.
