Grade Checker Severely Injured When Backed Over by Grader

**Industry: Excavation and Grading
Contractors**

**Task: Attempting to replace feathers
on a hub**

**Type of Incident: Run over by
equipment**

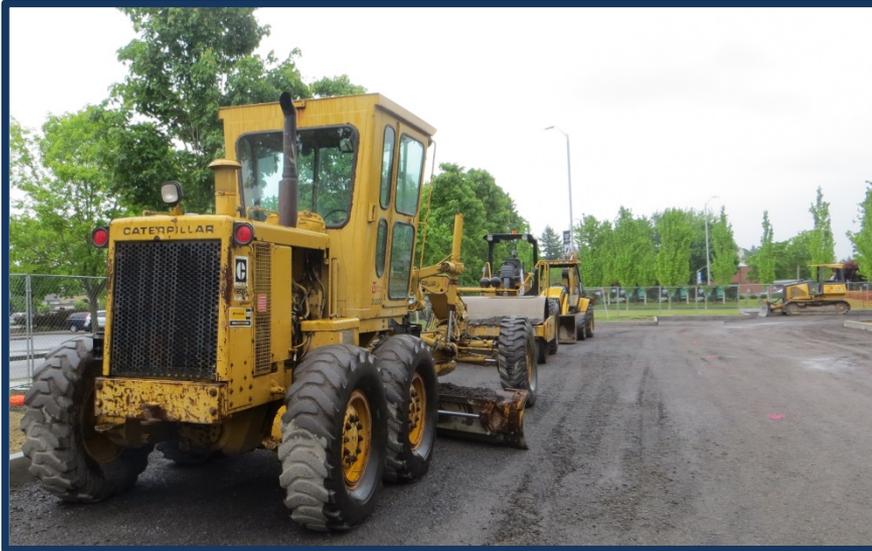
Photo 1: incident scene

Photo 1: Incident scene showing the grader in the parking lot under construction. The grader was moved after the incident.

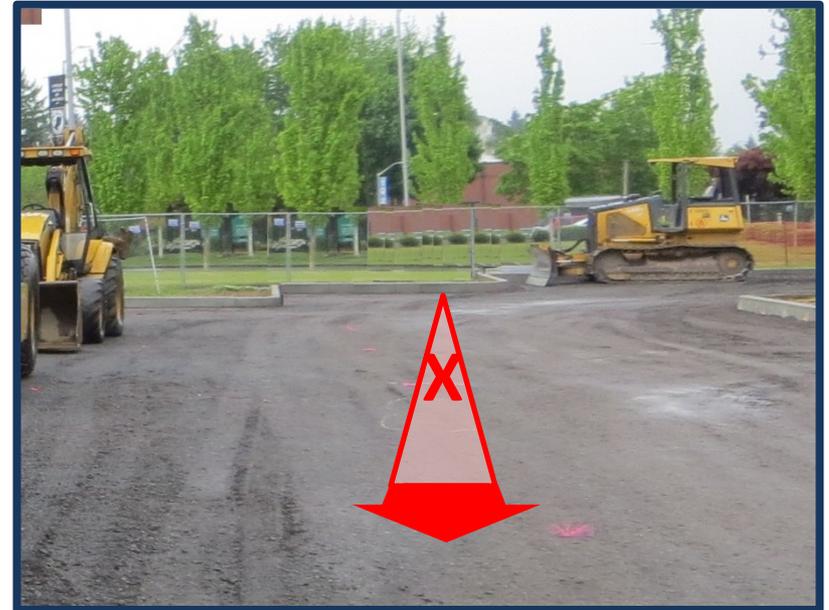
Photo 2: incident scene closer view

As the grader and grade checker moved towards each other, the grade checker stopped at the hub and kneeled down. When he kneeled down, he was in a blind spot of the grader's mirrors; the operator was unable to see him. The grade checker was so focused on his task that he did not notice the grader. The grader's two left tires then ran over the left side of his body. He suffered multiple serious injuries.

Photo 2: Incident scene showing location of grader and grade checker at the time of incident. The red arrow indicates the direction in which the grader was backing up. The "X" shows the location of the grade checker, who was kneeling down, when he was backed over.

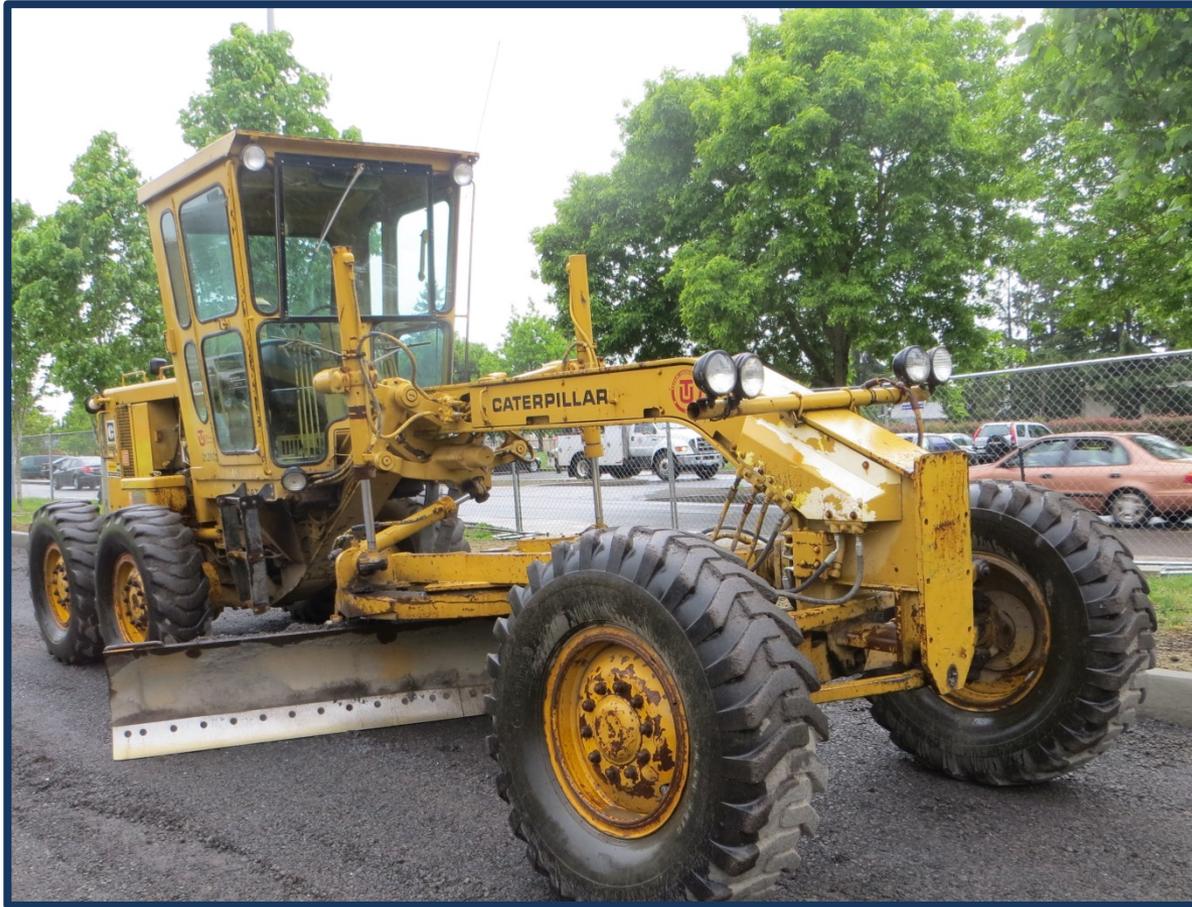
Incident grader.

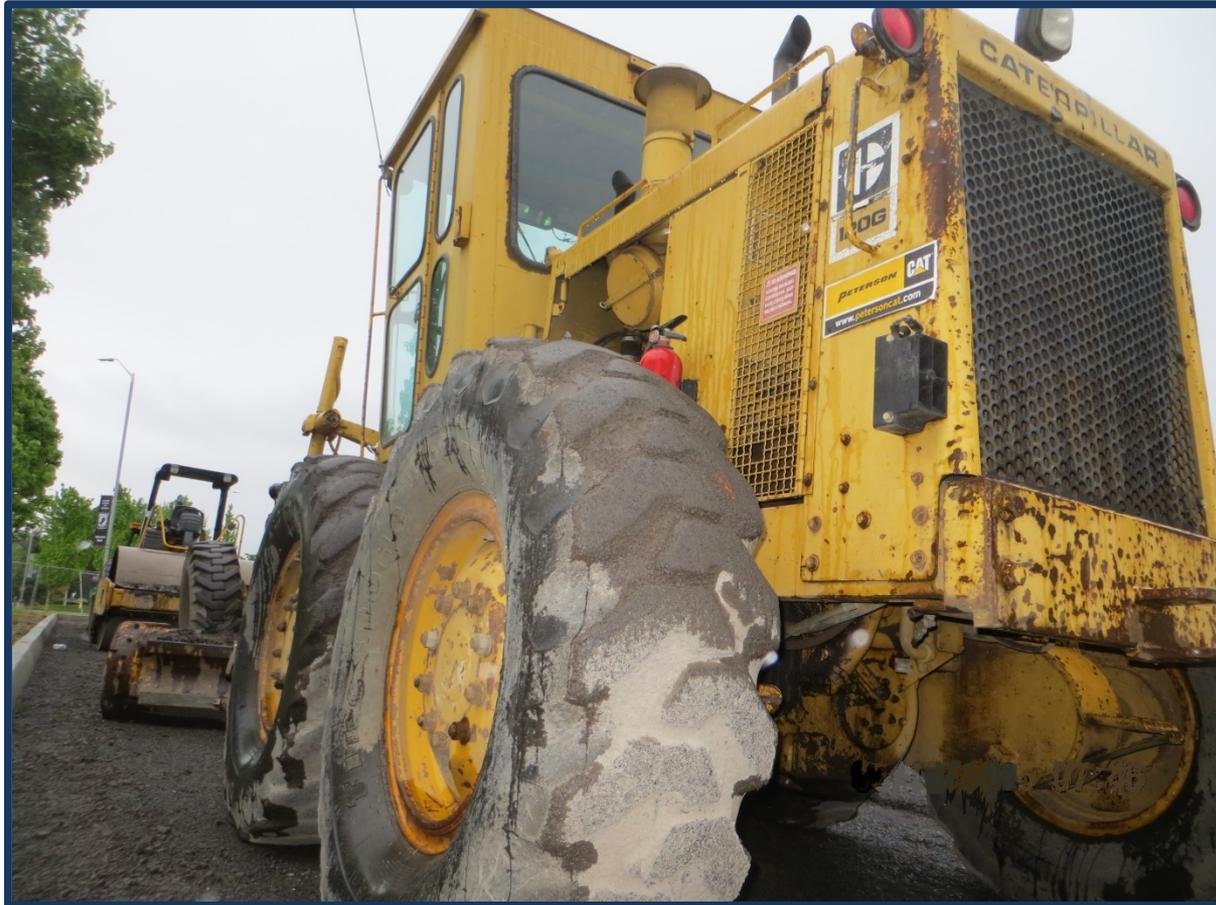
Incident grader showing the two left rear tires that backed over the grade checker.

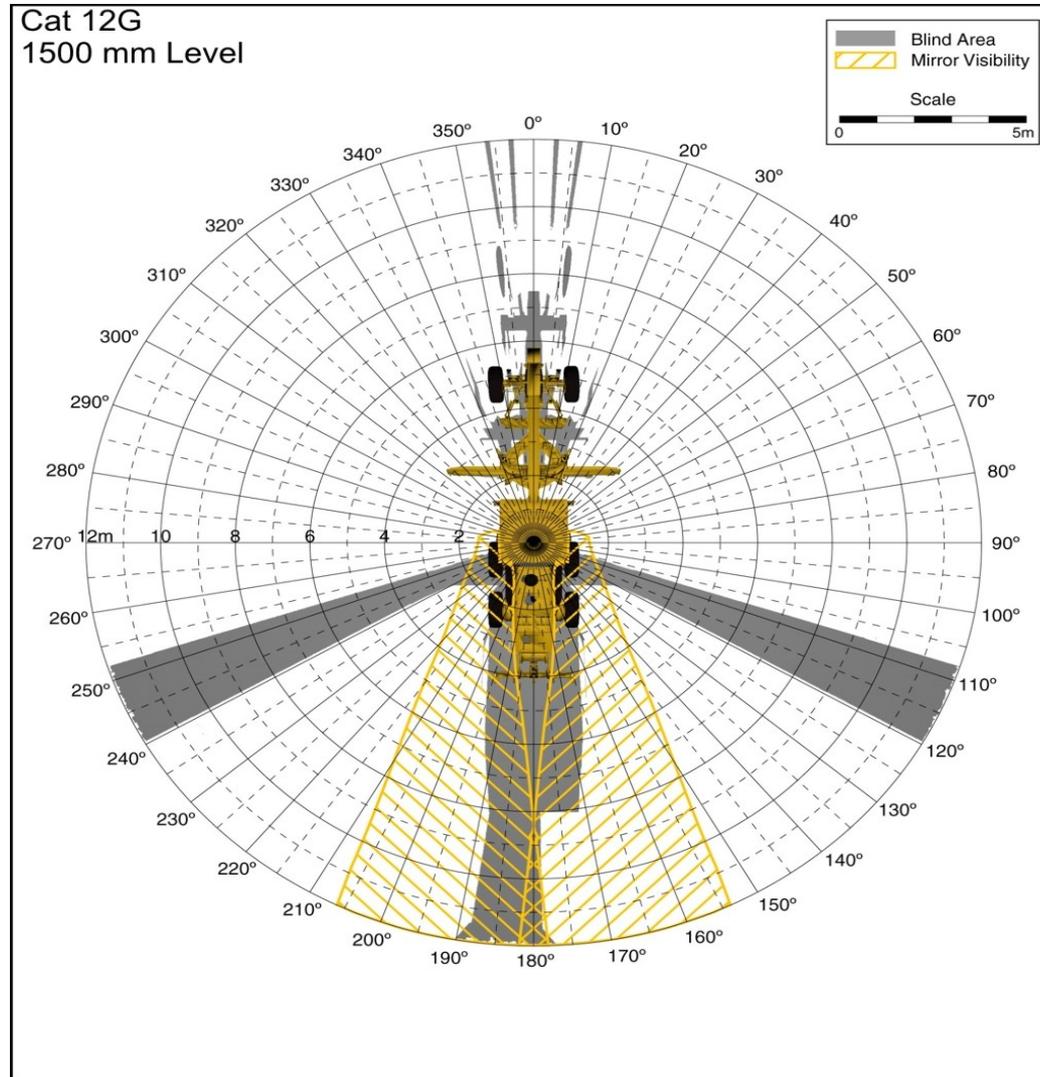
An investigation found that the grader's back-up alarm was working. Before backing up, the operator had checked the grader's mirrors, but the grader does have operator blind spots to the rear. The employer was not cited for any safety violations.

Diagram shows the operator's visibility while seated at the controls of a Cat 12G grader. The gray shaded areas indicate operator blind spots on a level plane at the height of 1500 mm (4 foot 11 inch). The yellow diagonal lines represent the area the operator can see to the rear using the mirrors.

- Consider installation of collision avoidance or proximity warning systems (radar and sonar devices, or tag based systems that use personal electronic tags to detect a marker field generated by a transmitter on the vehicle) or monitoring technologies (video cameras and additional mirrors) on construction vehicles and equipment to increase the likelihood that equipment operators will detect workers on foot around their equipment.
