FATALITY NARRATIVE

Orchard Tractor Operator Run Over by Trailer-Mounted Water Tank

Incident Date: October 14, 2008
Release Date: March 4, 2014
SHARP Report No.: 71-128-2014
Case No.: 08WA05301

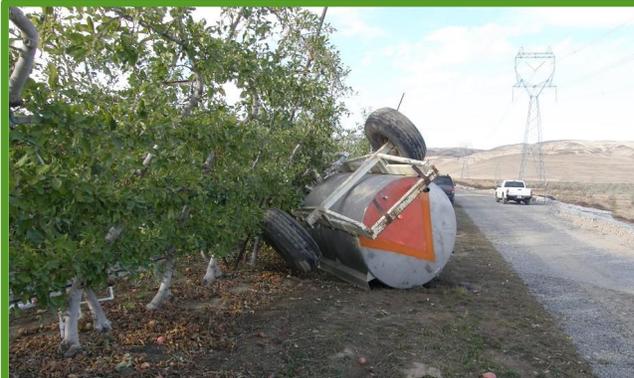
Incident scene at orchard with overturned water tank trailer. The tractor, which separated from the trailer, is located behind the row of apple trees.

the operator's seat. After landing on the ground he was run over by the trailer wheels. He died at the scene. Investigators found the water tank trailer separated from the tractor. A piece of broken wire was found in place of the required safety bolt on the trailer's coupler. This wire broke either just before or after the victim came off the tractor, allowing the separation of the trailer from the tractor's hitch. Also, the tractor did not have a rollover protective structure (ROPS) or a seat belt. It is possible that the victim could have survived if the tractor had a ROPS and he was wearing a seat belt.

- Train employees how to safely operate tractors that they will be required to use. See WAC 296-307-08018.
- Maintain in a safe condition towing connections between tractors and all equipment and remove from service if in need of repair. See WAC 296-307-07001.
- Ensure that tractors are equipped with a rollover protective structure (ROPS) and a seat belt and ensure that employees use the seatbelt. See WAC 296-307-08009, and 296-307-08012.

- Train tractor operators to understand and recognize the hazards associated with operating tractors while traveling downhill towing trailers, implements, and equipment such as water tanks and sprayers. This training should include how to safely operate the tractor and emphasize the importance of reducing speed and downshifting to the appropriate gear for the slope and terrain.
