# Fatality Narrative

## Aerial Work Platform Operator Pinned Between Basket and Overhead Beam \*

**Case No.:** 08WA00601.

**SHARP Report No.:** 71-84-2009.

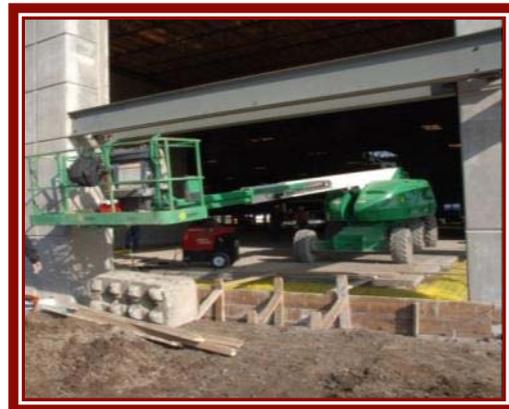
On February 21, 2008, the operator of a hydraulic extending boom platform was crushed between the lift's basket and a beam. The 39-year-old carpenter and welder was employed by a company that supplies and erects panelized roof, steel and wood roof and floor structures. He was helping to build a warehouse. The victim, who had considerable experience doing this kind of work, was welding vertical stanchions to a horizontal beam above a doorway from the basket of a hydraulic extending boom lift. He had partially completed the welding and started to reposition the basket when he either extended or elevated the basket, causing him to be pinned between the basket's frame and the overhead beam.

Photo of incident scene.

- Conduct a job hazard analysis before starting a job involving an aerial lift.
- Employers should provide training on aerial lift safety that would include the hazards of overhead obstructions and steps to take to prevent injury from becoming entangled in these obstructions.
- Require the presence of a ground person to assist the lift operator if hazardous conditions are encountered.
- Tether the key that operates the aerial lift from the ground controls to the ground control panel.
- Manufacturers and distributors are encouraged to follow the International Organization for Standardization (ISO) Standard for articulated boom-supported aerial work platforms regarding providing pressure sensor/relief valves on their equipment.
