Fatality Narrative

Carpenter Falls From Balcony*

Industry: Residential remodeling
Occupation: Carpenter
Task: Installing soffit in ceiling of apartment balcony
Type of Incident: Fall

Release Date: May 30, 2006
Case No.: 05WA06501
SHARP Report No.: 71-47-2006

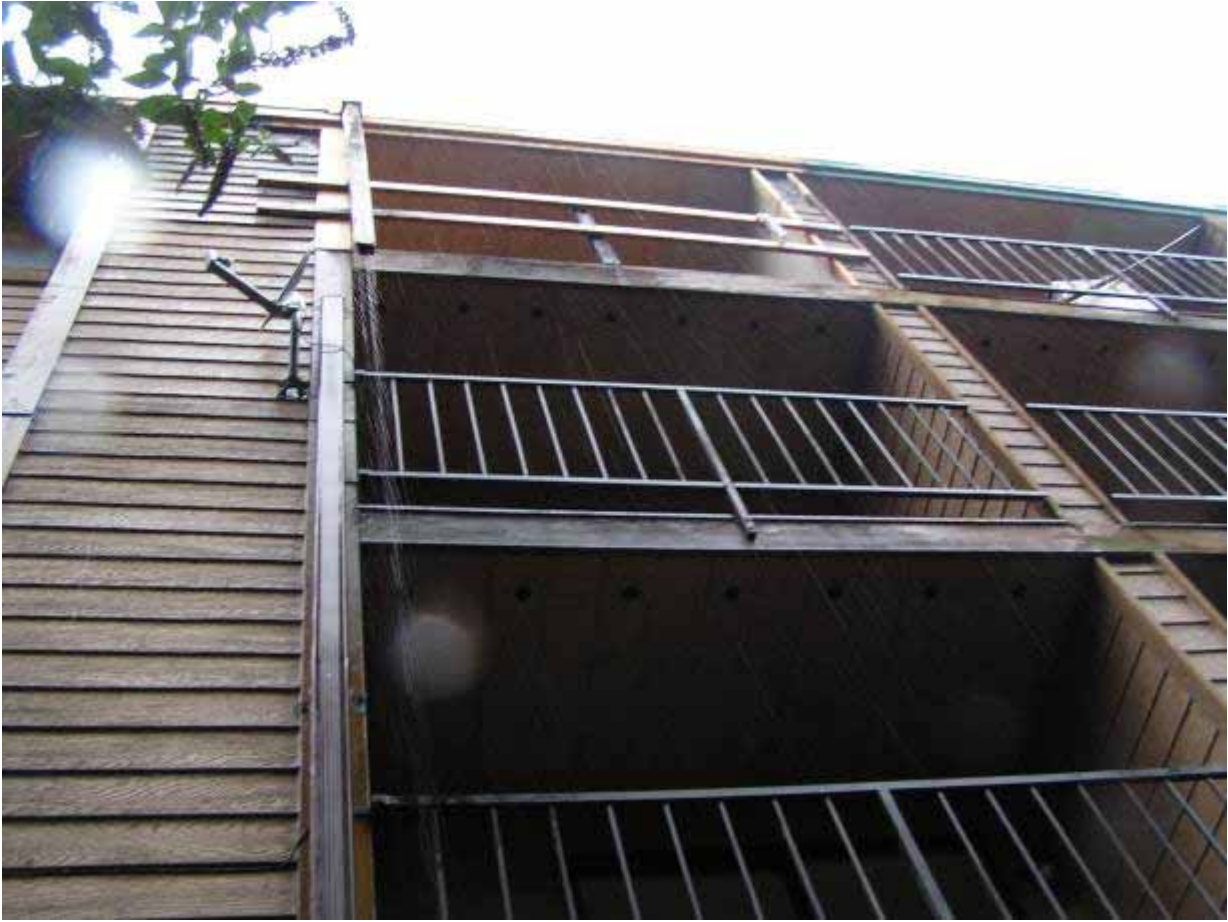
On November 1, 2005, a carpenter was killed when he fell from an apartment building balcony. The victim, a 40-year-old journeyman level carpenter, had been employed for one week with a company that does residential remodeling work. He and another employee were working from the fourth floor balcony of an apartment, installing the soffit in the balcony's ceiling. The victim reached overhead to tap the soffit boards into place, holding a small piece of scrap wood in one hand and a hammer in the other. The victim leaned his back on the balcony's temporary 2x4 standard railing in order to swing his hammer, and the railing gave way. He fell 26 feet 9 inches to the ground below and was taken to a hospital where he died of his injuries.

Figure. The apartment balcony with a temporary guardrail re-constructed after the incident.

- ! Ensure that temporary standard railings are built securely enough to bear the weight of a worker leaning against them.
- ! Regulations require that the railing be able to withstand "a force of at least 200 pounds applied within 2 inches of the top edge, in any outward or downward direction." This may require the installation of some intermediate bracing.

- Temporary railings should be only constructed by competent people who are knowledgeable in the proper design and construction of temporary railings.
- Inspect temporary railings on a daily basis to ensure structural integrity and to make sure railings haven't been damaged during the construction process.

- ! Where guardrails may receive heavier stresses, the employer must increase the strength accordingly by use of heavier material or additional bracing.
