INCIDENT FACTS

71-176-2018

Carpenter Severely Injured in 11-Foot Fall from Scaffold

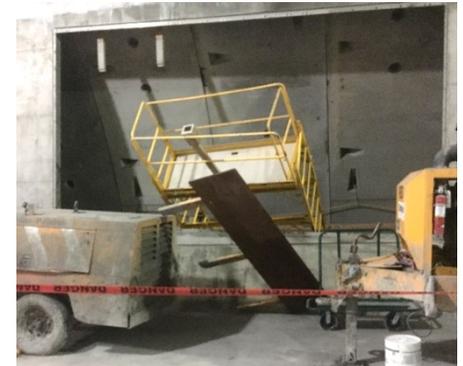
Incident scene showing the Baker scaffold tipped to the side.

Working from the 8-foot-high scaffold deck, the victim stripped a form from overhead. His coworker was standing below inside the knockout ready to grab the 8'x2' form. As the victim leaned over the handrail to lower the form, the scaffold began to tip over. The coworker was able to move out of the way. The scaffold hit the lower wall of the knockout and he was thrown off, landing headfirst 11 feet below on the concrete. He suffered severe head, neck, and spinal injuries resulting in impaired mobility.

Investigators found that the employer did not follow procedures to ensure that new workers were prepared to work, and that they did not receive proper direction, instruction, and supervision. The Baker scaffold was not appropriate for the assigned task, and it had not been assembled correctly according to the manufacturer's specifications, which require outriggers to be used when a 39" deck extension is added.

- Employers should ensure that workers, especially new workers, receive proper direction, instruction, and supervision to safely perform the work they are assigned.
- Scaffolds should be properly assembled and used according to the manufacturer's specifications. In this instance, outriggers should have been used to prevent the scaffold from tipping.
