71-169-2018

April 23, 2018

Ironworker Falls 30 Feet through Skylight Roof Opening

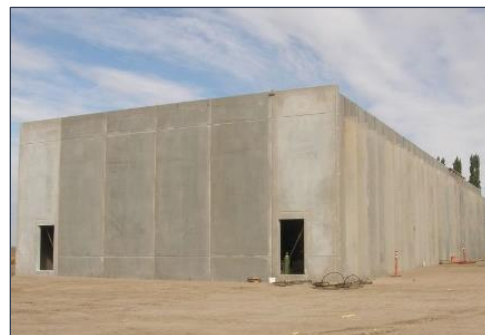
State workplace safety investigators found that the victim was not using his fall protection system, though there were adequate fall protection anchors and lanyards available. The previous day a coworker had seen the victim not using fall protection on two occasions and told him that he needed to tie-off. Typically, the employer covered skylight openings before workers started work on a roof. In this incident, 3 out of 4 skylight openings were covered, but they did not have enough material on site to cover the opening which the victim fell through.

The precast concrete building where the victim fell through a skylight roof opening.

Cover or guard unprotected skylight openings, or use a personal fall arrest system as an equivalent means of fall protection. See [WAC 296-155-24609 \(4\) \(d\)](#)

- Workers must use fall protection when required and use it 100% of the time.
- Ensure that employees use fall protection when required and encourage employees to report incidents of employees not using appropriate fall protection systems.
- Perform a daily job site hazard assessment to identify and correct hazards, such as a roof opening.
