# FATALITY NARRATIVE

## Mechanic Crushed by Bin Destacker

**Industry:** Postharvest Crop Activities  
**Task:** Replacing bin destacker cylinder  
**Occupation:** Mechanic  
**Type of Incident:** Crushed by machinery

**Incident Date:** Dec. 29, 2014  
**Release Date:** Dec. 14, 2017  
**SHARP Report No.:** 71-165-2017

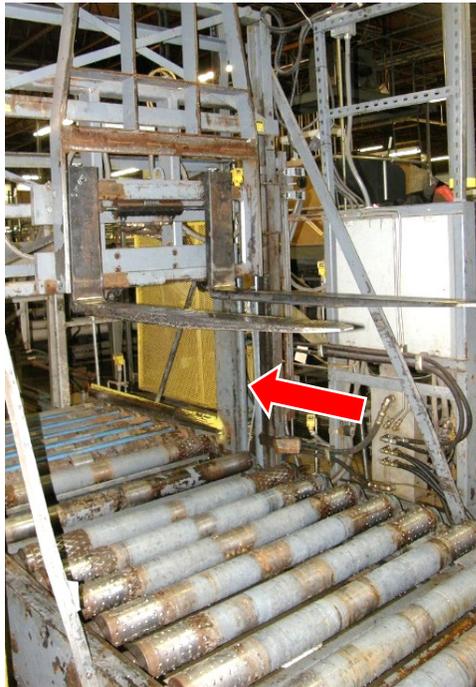
In December 2014, a 34-year-old mechanic doing maintenance on a bin destacker at a fruit packing plant died when part of the machinery came down, crushing him. He had worked for his employer, a grower and packer of tree fruits, for nearly a year. On the day of the incident, he was working alone changing a hydraulic cylinder on a fully automated bin destacker. The hydraulic cylinder raised and lowered the machine's forklift assembly. It was located on the right side of the forklift assembly where the control panel was located. He was not supposed to be changing this cylinder by himself. He had never changed this cylinder before; he had only observed another employee doing it. He turned the machine off before starting work, but there was residual energy in the hydraulic line to the forklift assembly. For an unknown reason, he raised the forks and climbed onto the rollers to access the pressure fitting on the hydraulic line to the forklift assembly. It was not necessary for him to be on the rollers under the forklift assembly. The fitting was located under the rollers and behind the cylinder he intended to replace. Both could be accessed from the outside of the destacker on its right side. He did not use any method of restraining the forks. The employer required that a chain be wrapped around the assembly to anchor it to the destacker frame for work under the forklift assembly. As he kneeled on the rollers underneath the forklift assembly, he used a wrench to release a pressure fitting that then disconnected the hydraulic line. Without the hydraulic pressure, the forklift assembly, weighing between 600 and 700 pounds,

**Bin destacker with forks raised. The arrow points to the cylinder the mechanic was attempting to replace.**

came down and crushed his neck and shoulders. The coroner reported that the victim died of "traumatic asphyxia due to mechanical compression of torso." Investigators found that: there were no written procedures for mechanics at the plant on how to perform lockout/tagout for specific equipment; not all mechanics were provided with energy control procedures training; and the victim did not make sure that there was no stored energy on the forklift assembly when he loosened the fittings on the hydraulic hose.

- Conduct a job hazard analysis of machinery and equipment, processes, and tasks to identify potential hazards employees might be exposed to.
- Develop written standard operating procedures (SOPs) of machinery and equipment to ensure safety of employees. The SOP should include maintenance and repair work.
- Develop and enforce written lockout and tagout procedures that are specific for each machine or piece of equipment.
- Ensure that employees perform appropriate lockout/tagout procedures to control hazardous energy before conducting maintenance on machinery.
