Mechanic Crushed by Bin Destacker

Industry: Postharvest Crop Activities

Task: Replacing a bin destacker cylinder

Type of Incident: Crushed by machinery

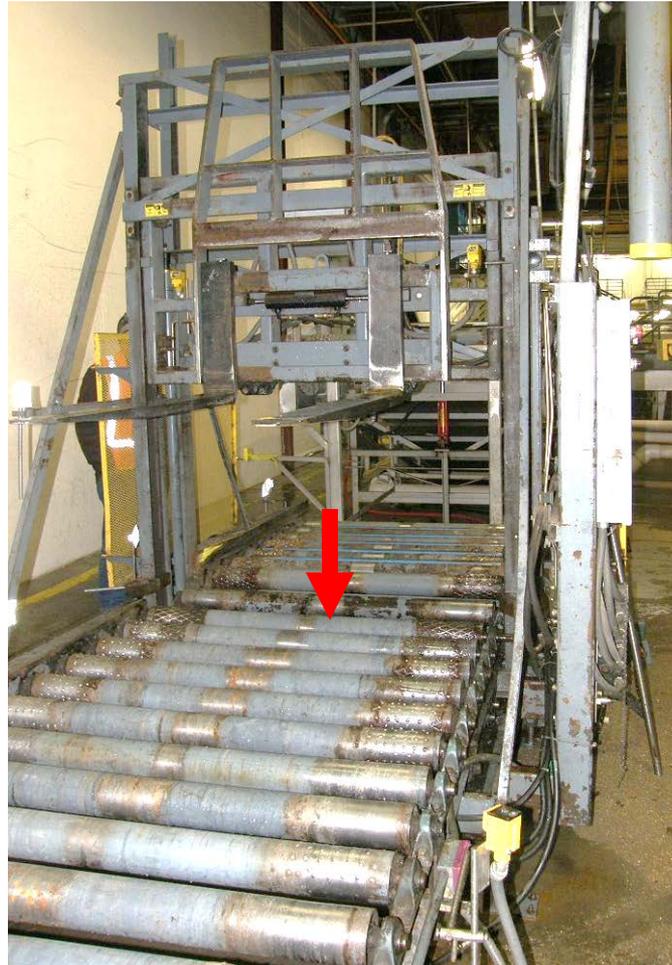
The mechanic was kneeling on the rollers underneath the destacker forklift assembly when he disconnected a hydraulic line that caused the assembly to fall and crush him.

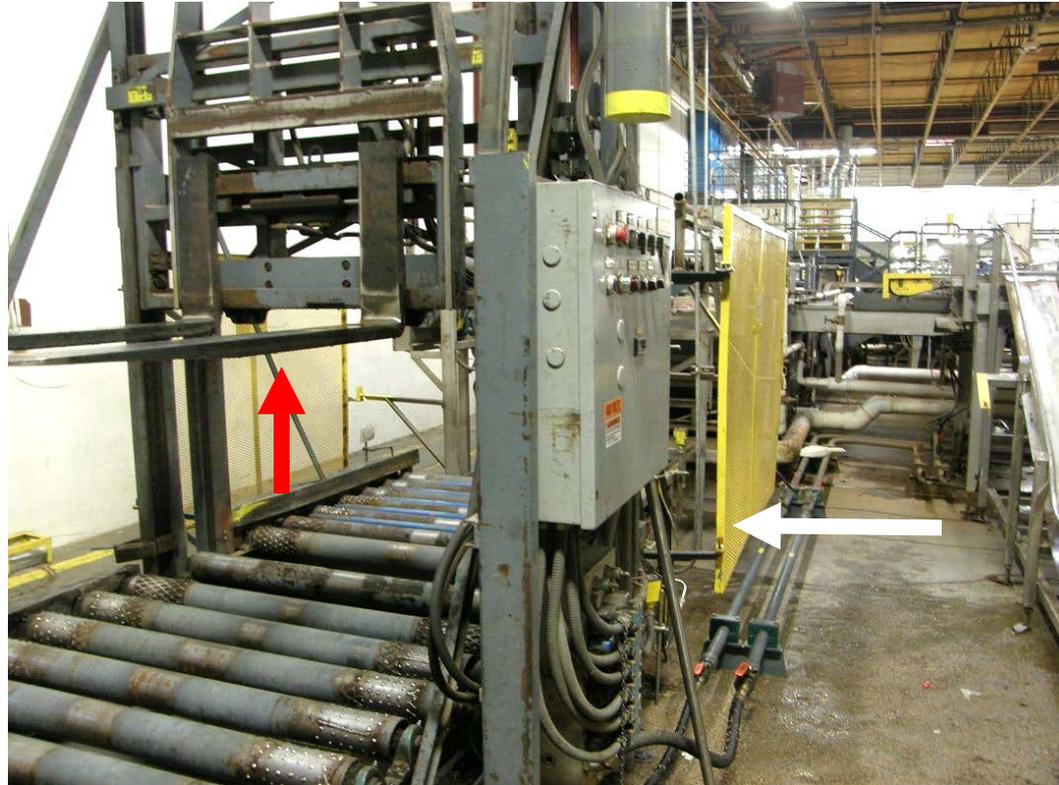
The bin destacker in the fruit packing plant. The red arrow points to the forklift assembly that crushed the mechanic. The white arrow indicates the area behind the yellow guard gate where the mechanic should have accessed the hydraulic hose and cylinder.

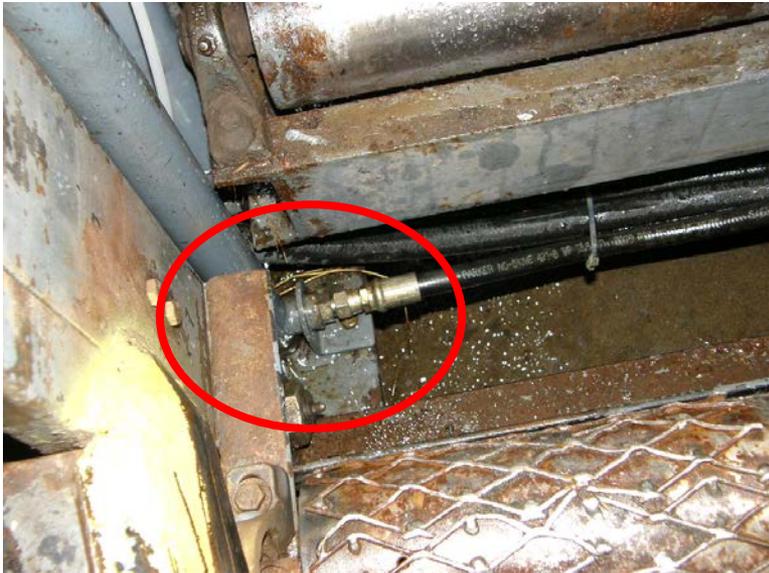
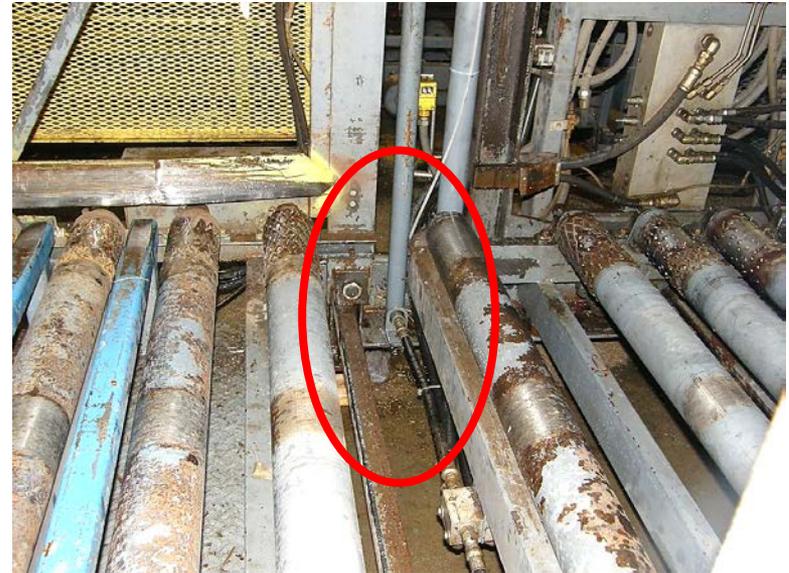
Hydraulic hose fitting located under the rollers that the mechanic disconnected, which released the hydraulic pressure and caused the bin destacker forklift assembly to fall on him.

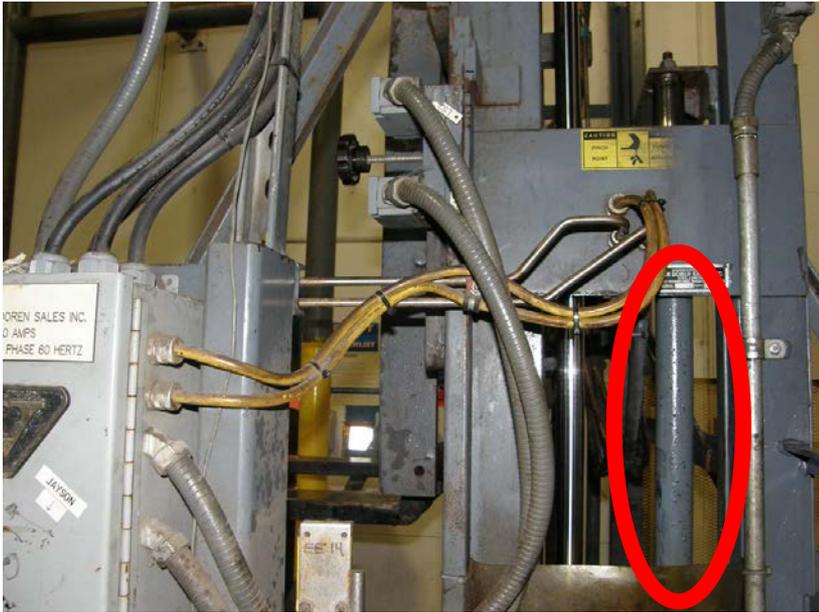
Photo 1

Photo 1. Bin destacker hydraulic cylinder (circled) which controlled the machine's forklift assembly that the mechanic was attempting to replace.

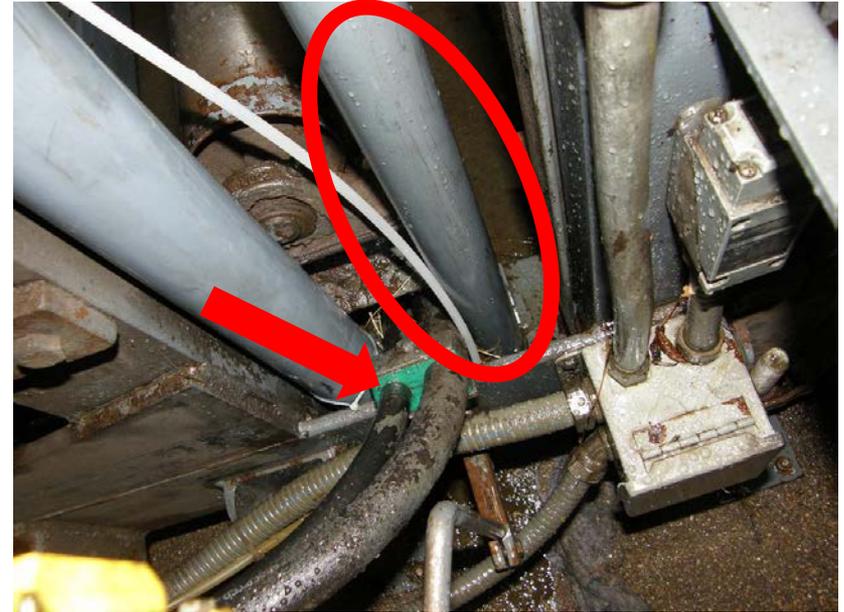
Photo 2

Photo 2. View from under the rollers looking toward the floor of the hydraulic cylinder (circled) and the hydraulic hose (arrow).
