FATALITY NARRATIVE

Rofer Crushed Between Beam and Boom-Supported Elevating Work Platform

Task: Installing metal siding panels on building

Type of Incident: Crushed between/Machine-related

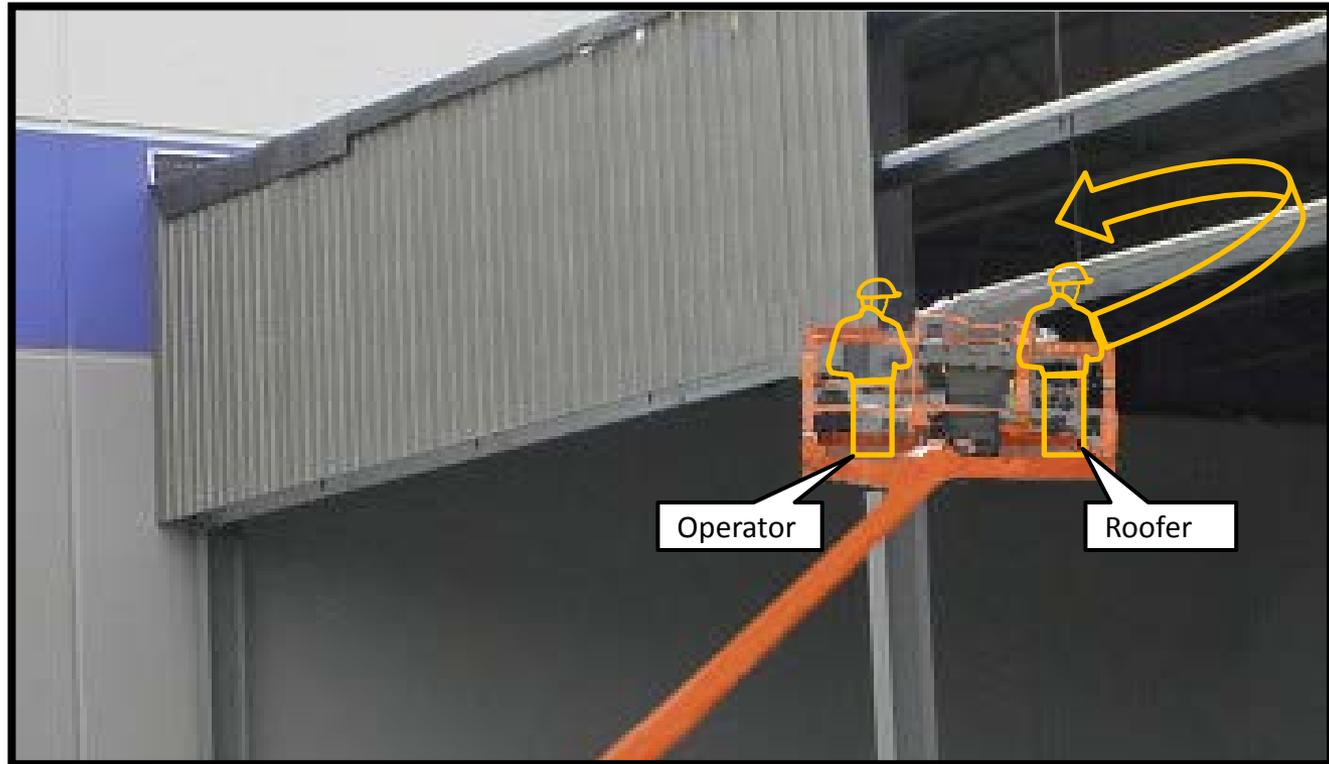
The operator, unable to access the panel, called for assistance from workers on the ground who were able to operate the lift's ground controls. An investigation found that the victim likely inadvertently activated the platform's rotation switch, which can be done by slight pressure, thereby causing the platform to rotate.

Recreation of the incident scene showing the elevated work platform. The operator was standing on the left side of the raised platform and the victim (roofer) on the right side. The victim inadvertently activated the platform's rotation control which caused the platform to rotate 90 degrees counter clockwise, crushing the victim between the overhead beam and the platform control panel.

- Perform a job/task hazard assessment to identify overhead obstructions and plan how to avoid them.
- Consider purchasing or retrofitting aerial lifts with an operator protective structure (OPS) to protect workers from being crushed against overhead obstructions. (Employers must have written permission from the manufacturer before modifying an elevating work platform. See WAC 296-869-30020)
- Equipment manufacturers should design aerial platform controls so that they are protected against inadvertent activation by workers on the work platform.

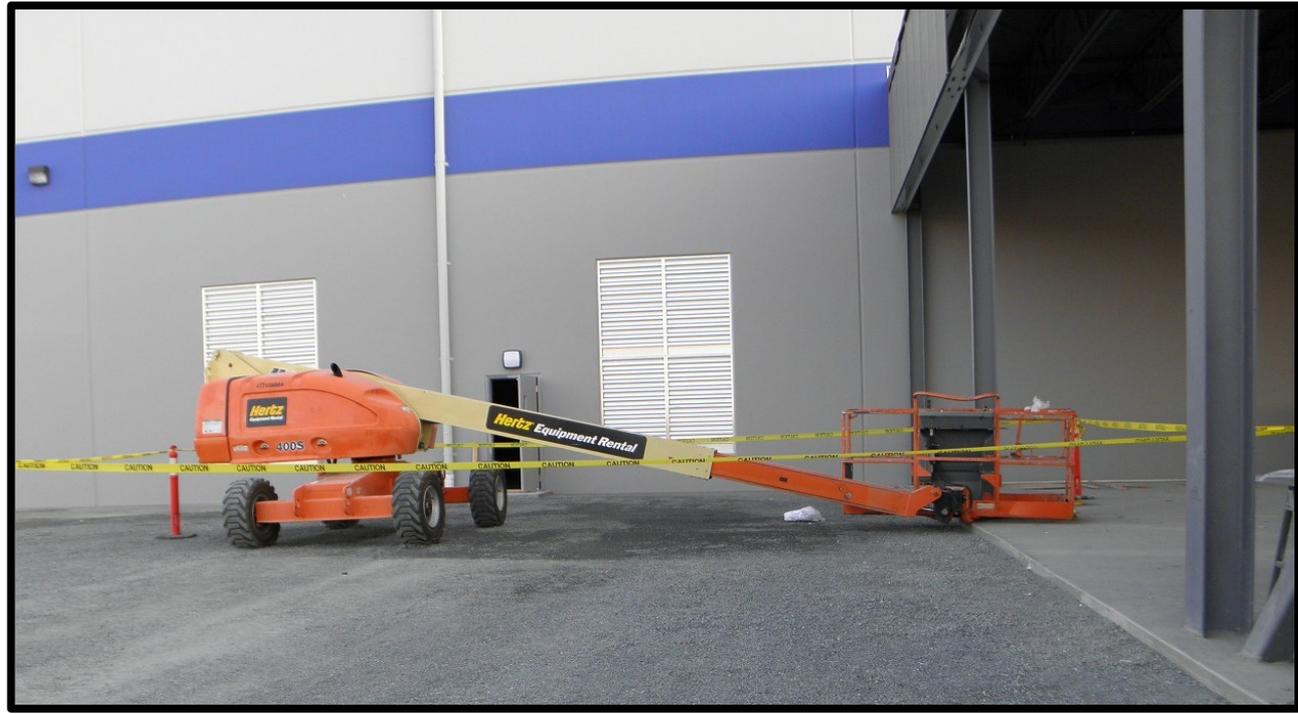
Post-incident scene showing the position of the lowered work platform.

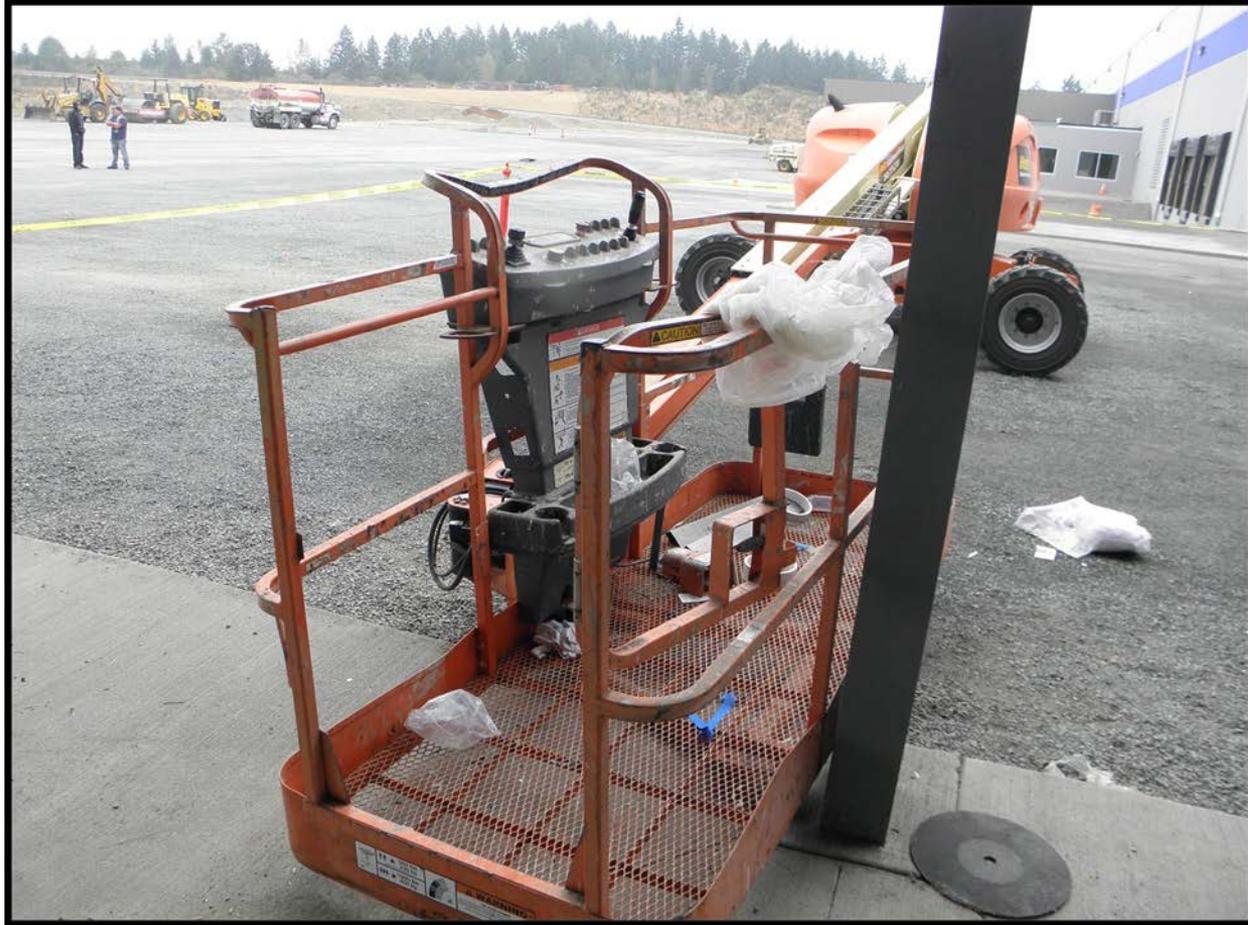
Work platform at incident scene. Victim was standing to the left of the operator.

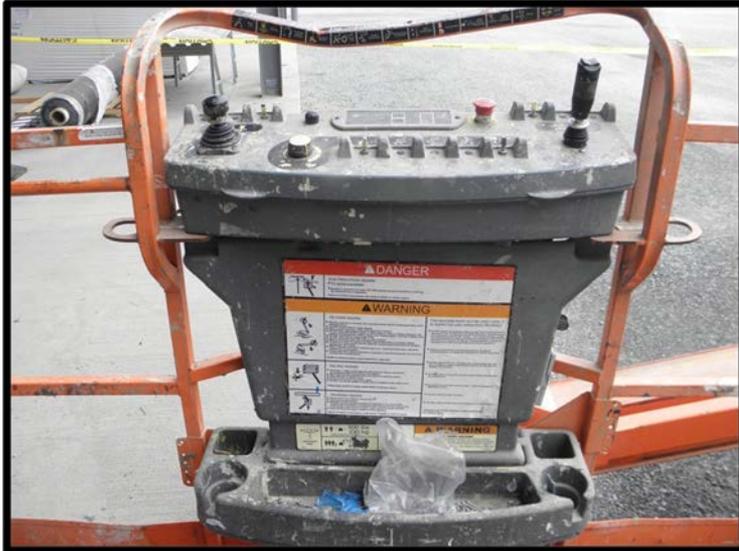
Work platform controls.

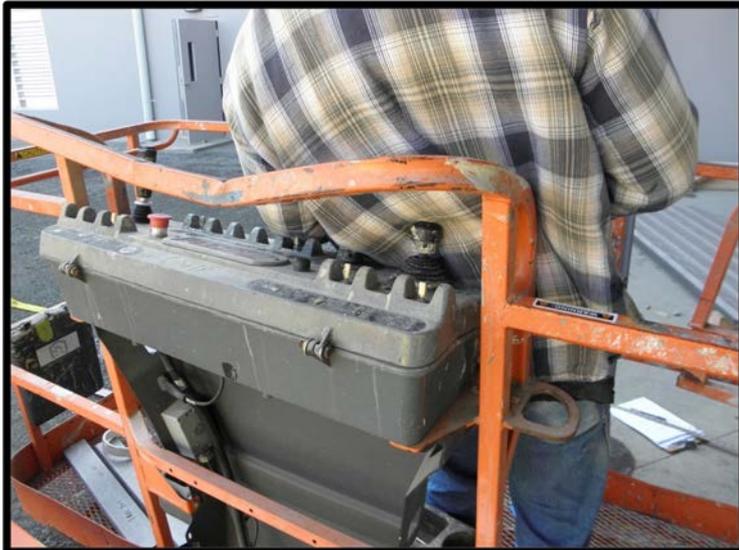
A reenactment showing how the victim's elbow might have made contact with and activated the platform's rotational control.

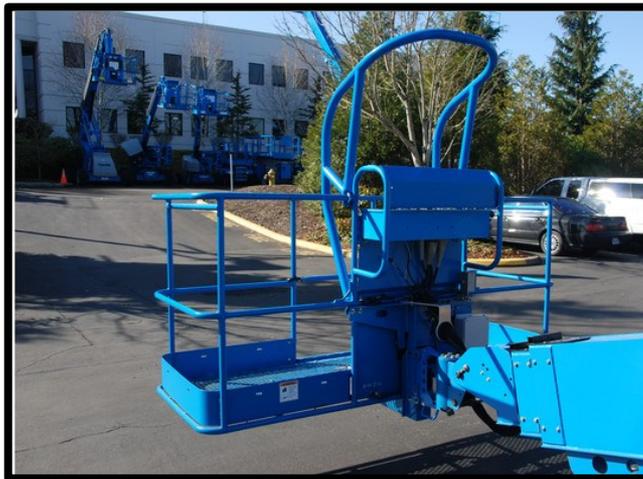
Example of an operator protective structure (OPS) mounted on a work platform.
