Fatality Narrative

Painter Killed When Scissor Lift Tips Over*

Industry: Painting contractors
Occupation: Painter
Task: Preparing to pressure wash building exterior
Type of Incident: Fall/scissor lift tip over

Release Date: June 30, 2008
Case No.: 07WA03001
SHARP Report No.: 71-71-2008

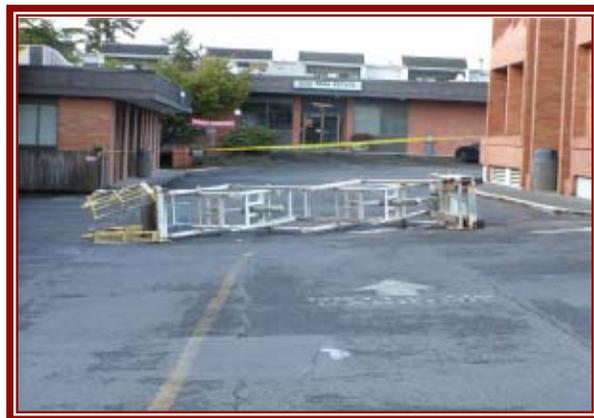
On April 21, 2007, a painter received fatal injuries when an extended scissor lift tipped over. The 51-year-old victim, a painter, had 10 years experience in the painting industry and was employed by a painting contractor. The victim and another worker were assigned by their employer to a job site where they were to pressure wash and clean the brick exterior of a two-story bank building. The two workers arrived at the job site at about 1:00 pm and used pressure washing equipment and a scissor lift elevating work platform to wash the building exterior. About two hours after cleaning the north side of the building, they moved the equipment to the building's east side. The scissor lift was positioned on the surface of an asphalt parking lot adjacent to and sloping away from the building. The victim was working from the platform of the scissor lift which was extended to about 17 feet above the ground. The scissor lift tipped-over, ejecting the victim who suffered fatal injuries after hitting the pavement. As the incident was unobserved, it is unclear what caused the tip-over. What is clear from the incident investigation is the scissor lift operator was not trained in the use of this equipment; the lift was positioned parallel to the building on the sloping parking lot surface; and the lift's damaged outriggers were not being used.

- ! Employers must ensure that all elevating work platform operators, including scissor lift, are properly trained in the safe use of the equipment and are familiar with the manufacturer's operation and maintenance guidelines.
- ! Operators should survey the work area before and during use of an elevating work platform at a work site to ensure there are no tip-over hazards present, such as slopes, holes, drop-offs, bumps, or uneven surfaces in the travel path of the lift.
- ! Ensure that lifts are regularly inspected and maintained and that damaged equipment is repaired so it meets or exceeds the manufacturer's specifications for safe operation.
- ! Before the work platform is elevated, be sure that outriggers or stabilizers are used as required by the manufacturer.
- Do not drive with the work platform elevated, unless the manufacturing states that you can.
