**INCIDENT FACTS**

71-168-2018

Apartment complex under construction

# Siding Contractor Falls 23 Feet from Apartment Balcony

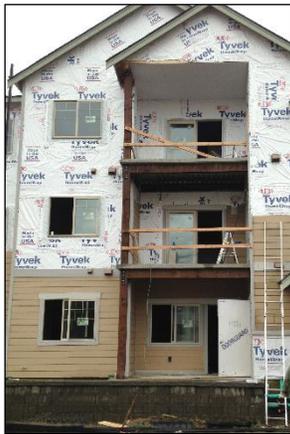
Apartment building where siding contractor fell from the third story balcony.

A 61-year-old siding contractor died when he fell 23 feet from an apartment building balcony. On the day of the incident, he was working as a subcontractor at an apartment complex under construction. He and two other employees were installing trim and soffits on the exterior of the building. He was working alone on a third floor balcony of the building preparing to install a soffit. He climbed a 4-foot stepladder to measure a part of the soffit that extended out beyond the balcony and its temporary wooden guardrails. In order to position himself, he took one foot off the stepladder and placed it on the top guardrail. The guardrail came loose and he fell off the balcony, landing on a concrete sidewalk below. EMS responders took him to a hospital where he died.

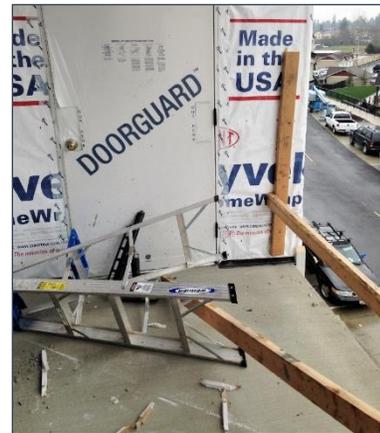
Investigators determined that the temporary guardrails on the balcony, and many others throughout the five building development, were improperly installed by a framing contractor. The original guardrails on the incident balcony had been removed by a siding contractor and his employees so that they could install moisture barriers on the building exterior. When they replaced the guardrails, they also did so improperly. The project general contractor did not ensure that the guardrails were installed and maintained in a safe manner.

Incident scene on a third floor balcony of apartment building under construction.

- General contractors should convey firm expectations for using fall protection to employees and subcontractors before the job starts. During the job they should visit sites to monitor for compliance and take corrective action.
- All contractors should ensure that appropriate fall protection is used by workers.
- Consider using safer alternatives to ladders for working at height, such as a mobile baker scaffold with guardrails or a portable lift platform.
