Fatality Narrative

Site Superintendent Falls Through Skylight Cutout*

Case No.: 06WA01101

SHARP Report No.: 71-51-2006

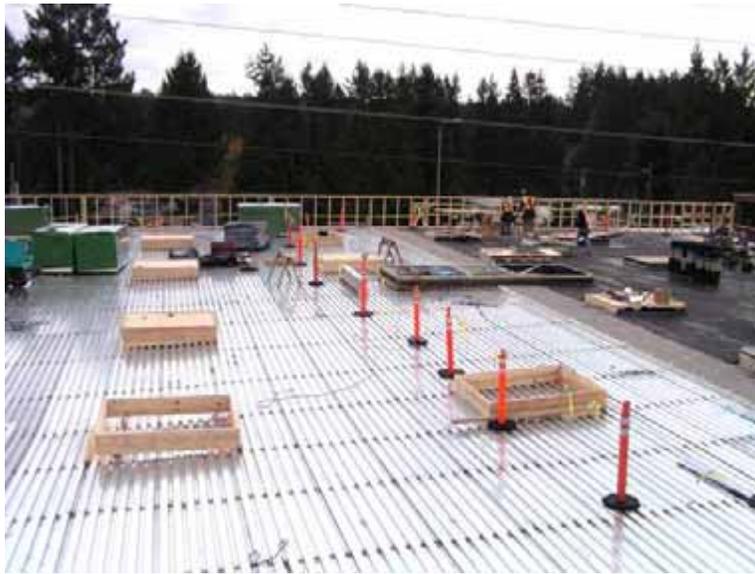
On February 18, 2006, a site superintendent was killed when he fell through a skylight cutout. The 62-year-old victim, with 30 years of experience as a construction manager and supervisor, had worked for his present employer for 7 months. The incident happened at a grocery store under construction, where workers had been cutting 5' by 6' skylight openings in the metal pan decking of a roof. Two workers were in the process of installing curbs and temporary covers in preparation for the installation of the skylights. The victim asked the two workers to help him move scrap metal decking and a piece of equipment so that they could proceed with their work. The workers secured the partially sawn cutout they were working on by screwing an eight-foot 2 x 4 onto it. The victim was walking from one section of the roof to another holding a piece of scrap decking in his hand when he stepped on the cutout decking being held in place by the 2 x 4 and fell through the opening 18 feet to the ground. Neither the victim nor the other two workers were using fall protection.

Photo: The picture above shows the incident site where the supervisor fell through a partially-cut and unprotected skylight opening.

- ! Employers must ensure that employees who are exposed to fall hazards at heights greater than 10 feet use fall protection.
- ! Temporary roof and floor openings must be covered with material capable of supporting the maximum potential load.
- ! Metal decking must remain in place until immediately prior to installation of skylights
- ! If covers or fall protection are not used, standard guardrails must be placed to protect workers from falling through temporary roof and floor openings.
- ! Employers must develop and implement a site-specific fall prevention plan.
- Use alternate work methods that minimize the risk of falling. For example, after this incident the employer began using a scissor lift so that workers could cut skylight holes from underneath the metal decking.
