# ***FATALITY NARRATIVE***

## **Carpenter Falls 60 Feet from Bridge Platform**

**Industry: Highway, Street, and Bridge Construction**

**Task: Dismantling bridge concrete form**

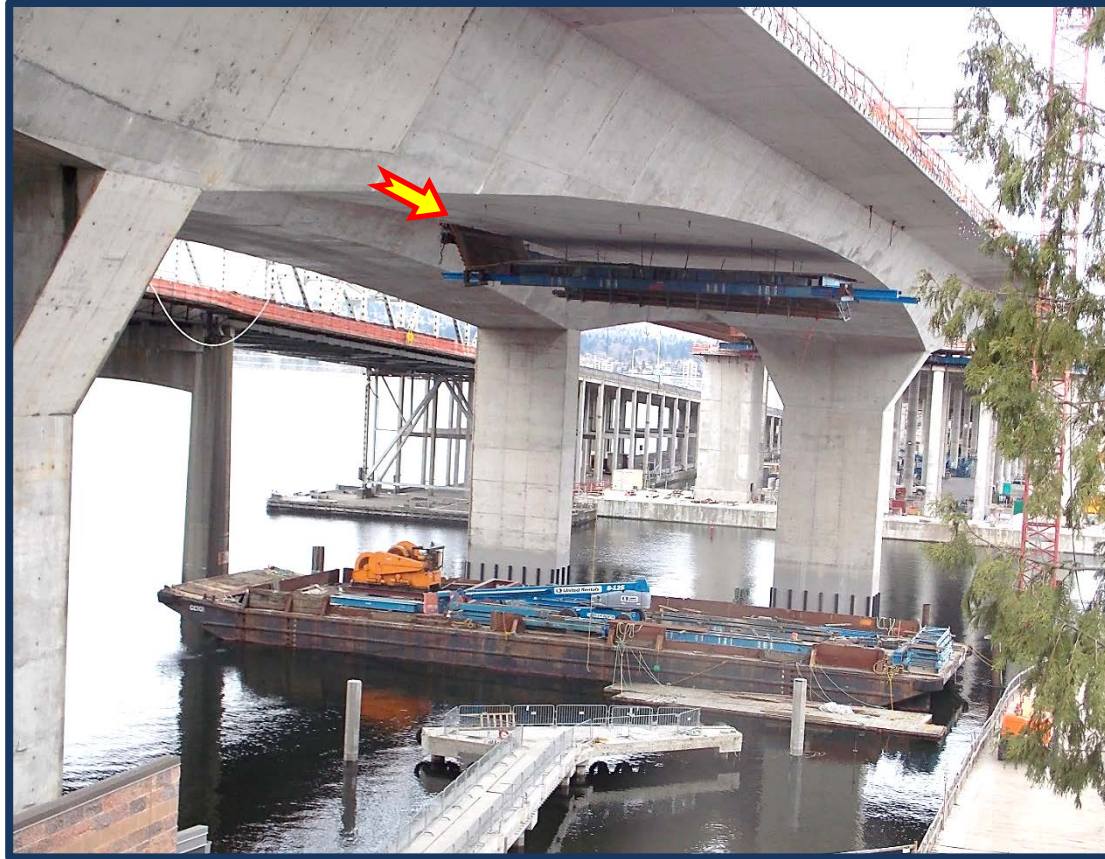
Incident scene showing the concrete form suspended beneath the bridge. The arrow indicates where the victim fell from, landing on the concrete pier below.

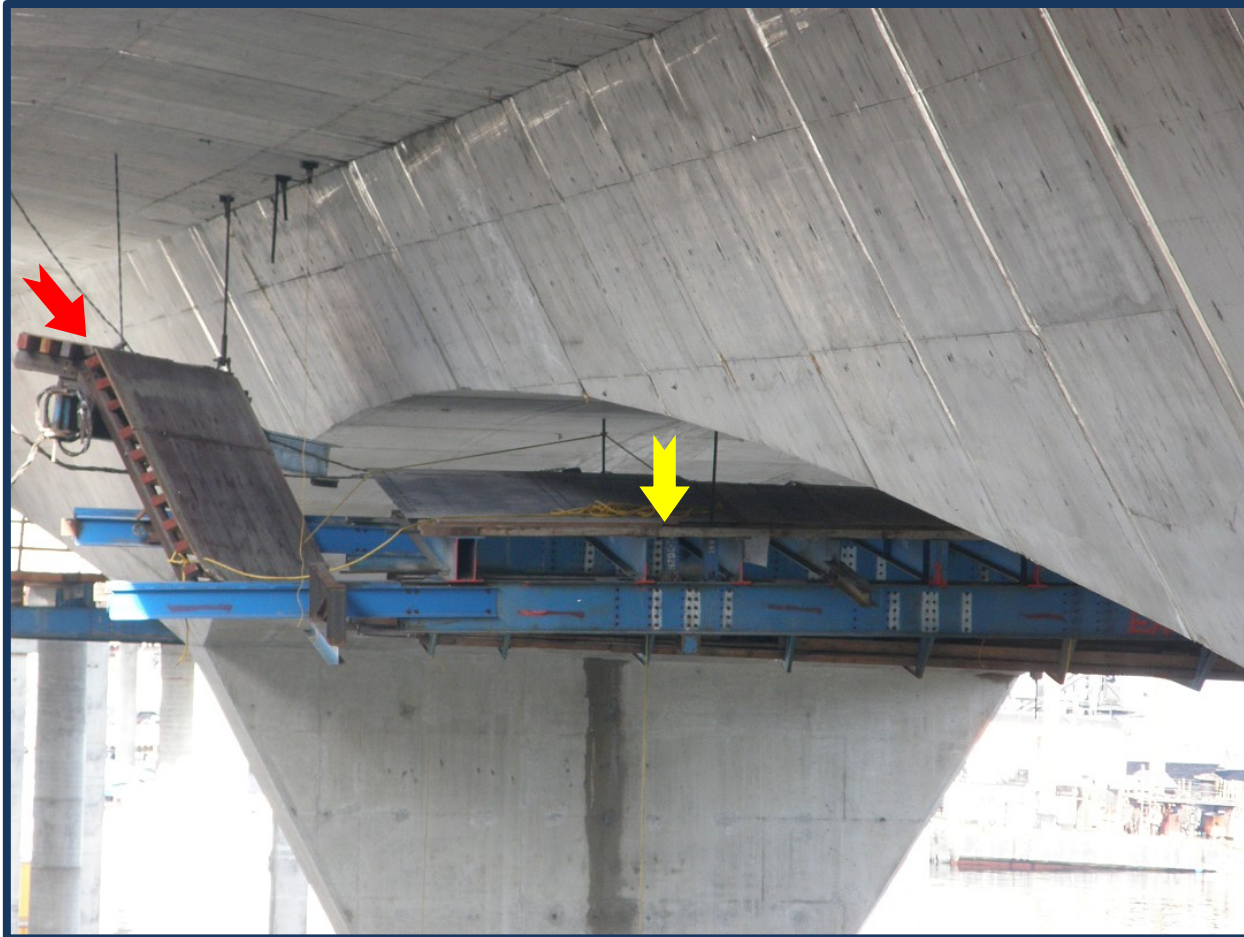
The investigation identified that the victim's fatal fall was due to improper use of the retractable lanyard. The victim was working more than 6 feet above his anchor point and during the fall the cable went over a steel edge of the form, both of which the lanyard manufacturer warns against. Also, there were retractable lanyards located above the victim that could have been used as an anchor point.

Incident scene showing the concrete forms suspended below the bridge. The red arrow indicates where the victim was kneeling on the wing wall form; the yellow arrow indicates the anchor point of his retractable lifeline.

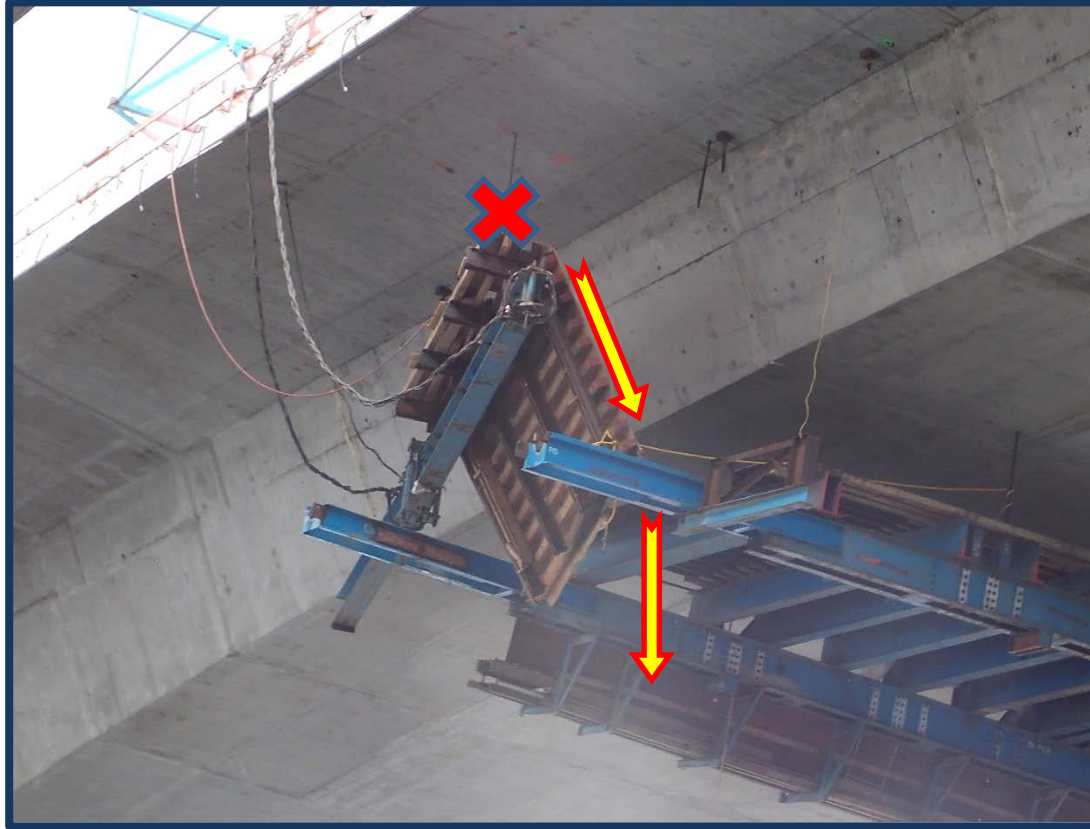
Incident scene showing the location of the victim (indicated by "X") when the wing wall form shifted and he slid down the form and fell between the gap between the wing wall form and the main concrete form.

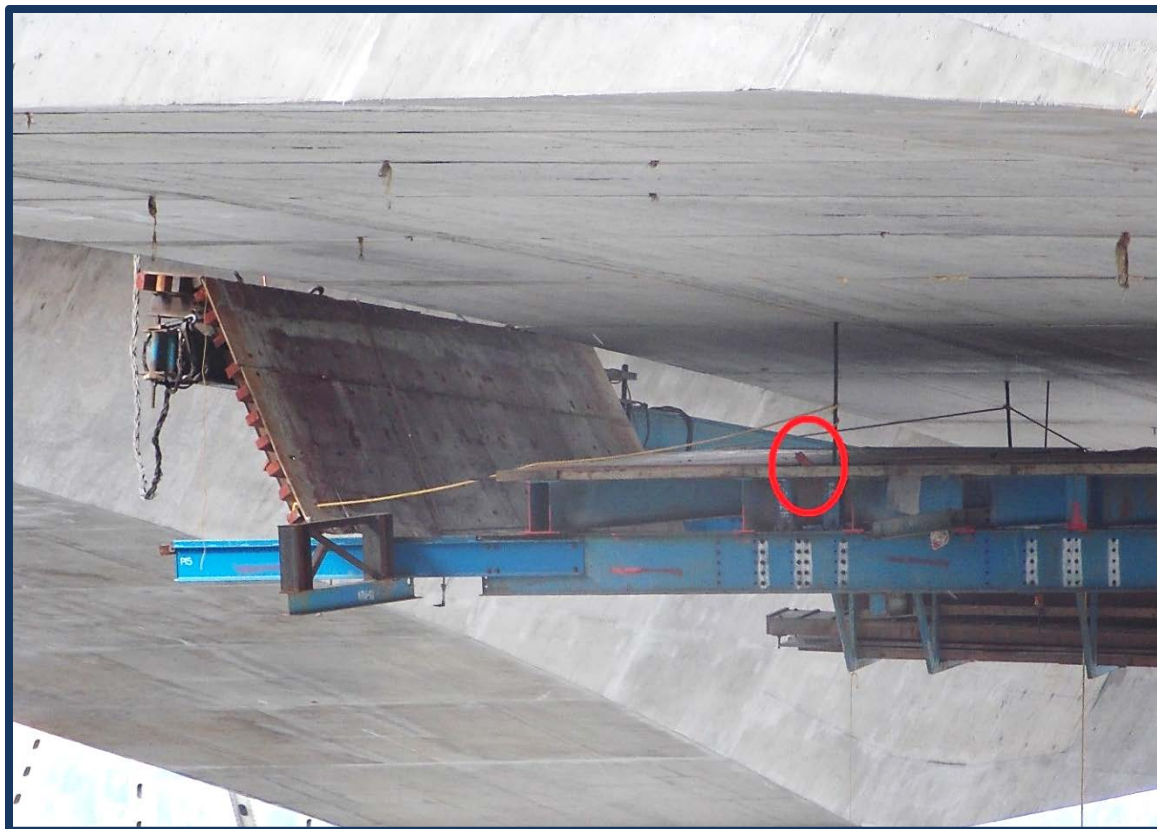
The victim's retractable lanyard at the incident scene.

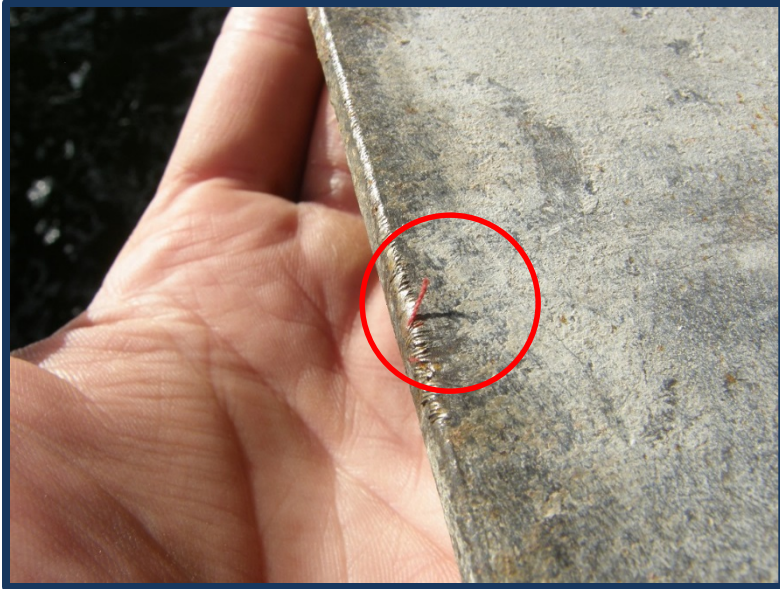
Photo 1 shows the steel platform edge which the victim's retractable steel cable lanyard contacted when he fell, causing it to sever. A red fiber from the cable is shown (red circle).

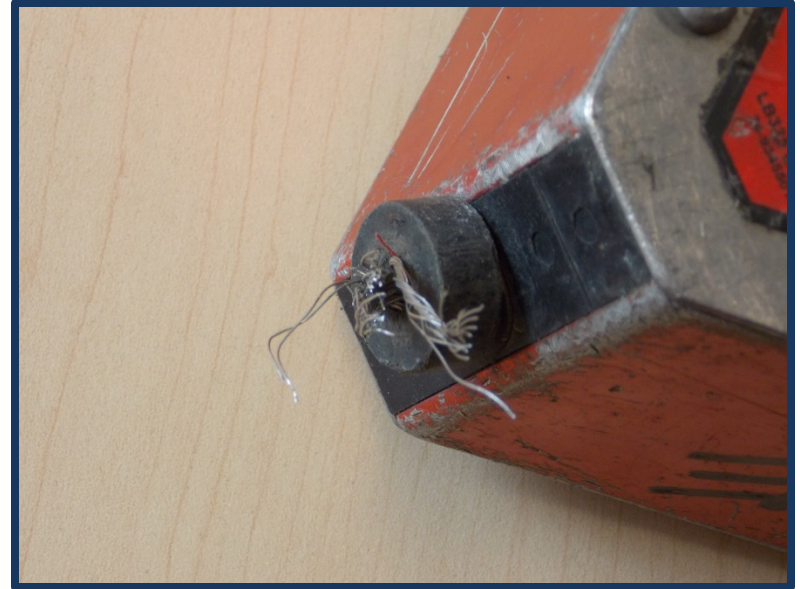
Photo 2 shows the victim's retractable lanyard with strands of the severed steel cable.
