INCIDENT FACTS

71-181-2019

Window Cleaner Falls 50 Feet

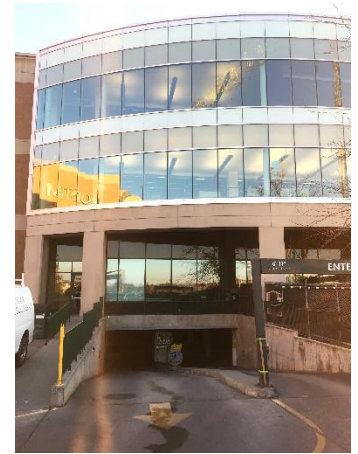
Without the counterweights in place and the roof rig not tied back, the weight of the window cleaner pulled the roof rig off the roof and he and the rig fell 50 feet, landing on asphalt. He died at the scene.

Library building location where the window cleaner fell.

- Make sure that workers suspended from a boatswain's chair or rope decent system use an independent fall arrest system where the fall arrest anchorage is separate from the suspension system anchorage. See [WAC 296-878-15025\(3\)](#)
- Make sure that single-point adjustable Boatswain's chair suspended scaffolds have tiebacks that are equivalent in strength to the scaffold suspension ropes and that the tiebacks are secured to a structurally sound anchorage on the building. See [WAC 296-874-30008](#)
- Make sure that rope descent system is designed, used, and maintained according to: (a) ANSI/IWCA I-14.1-2001 Window Cleaning Safety, (b) the manufacturer's instructions. See [WAC 296-878-20005\(1\)](#)
- You must leave counterweights attached to the outrigger beams until after the scaffold has been disassembled. See [WAC 296-874-30006\(3\)](#)
