Ironworker Falls 80 Feet through Bent Plate Gap

REPORT #: 71-179-2019s

REPORT DATE: March 26, 2019

SCENE: High-rise building under construction

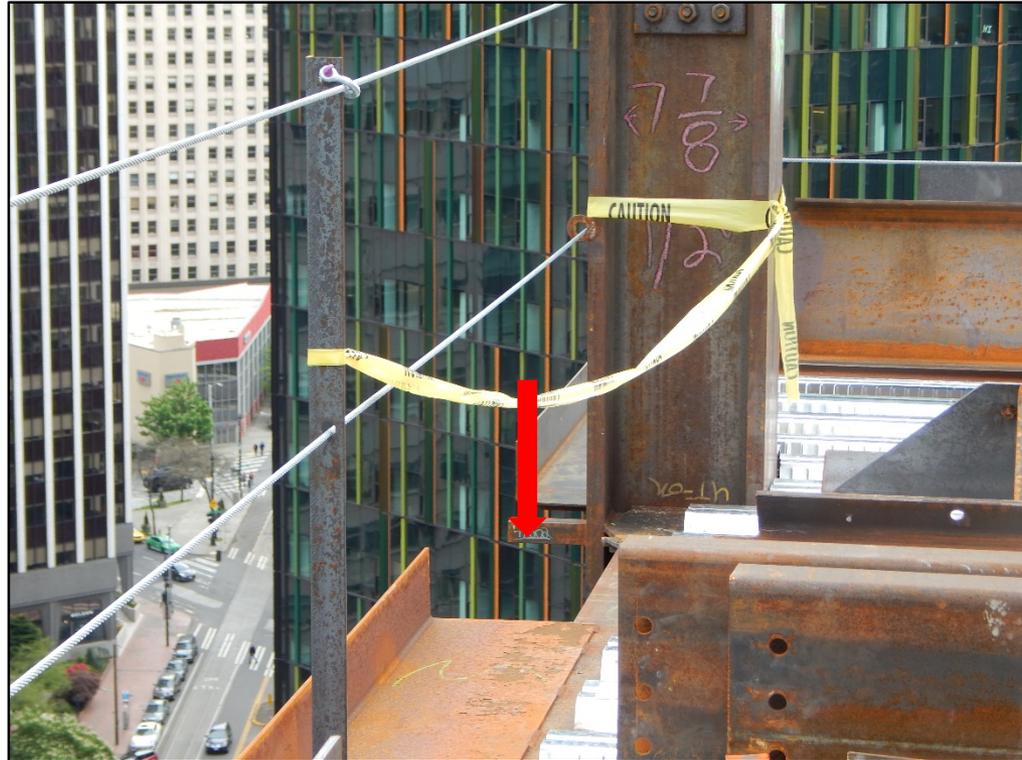
There was not much room for the ironworker to maneuver between the beam and the steel cable guardrails. There was a floor gap 36 inches long by 4 inches wide by the standing column near him.

State investigators found that all the guardrail systems at the site were placed outside the edge of deck/floor in the locations where the bent plates had not been placed, allowing for a space employees could fall through. Company procedure was to place bent plates over these gaps later in the construction process after the beam/column weld connections were made and the welds inspected.

Photo 1. Gap the ironworker fell through when he stepped backward. The opening was 36 inches long by 4 inches wide from where the deck ends and the steel cable railing crosses. Caution tape was placed after the incident.

- Configure guardrail systems to prevent workers from reaching the unprotected floor edge.
- Place temporary covers over bent plate gaps.
- Decrease the size of bent plate gaps.
- Have a steel fabricator install bent plates prior to erection of columns.

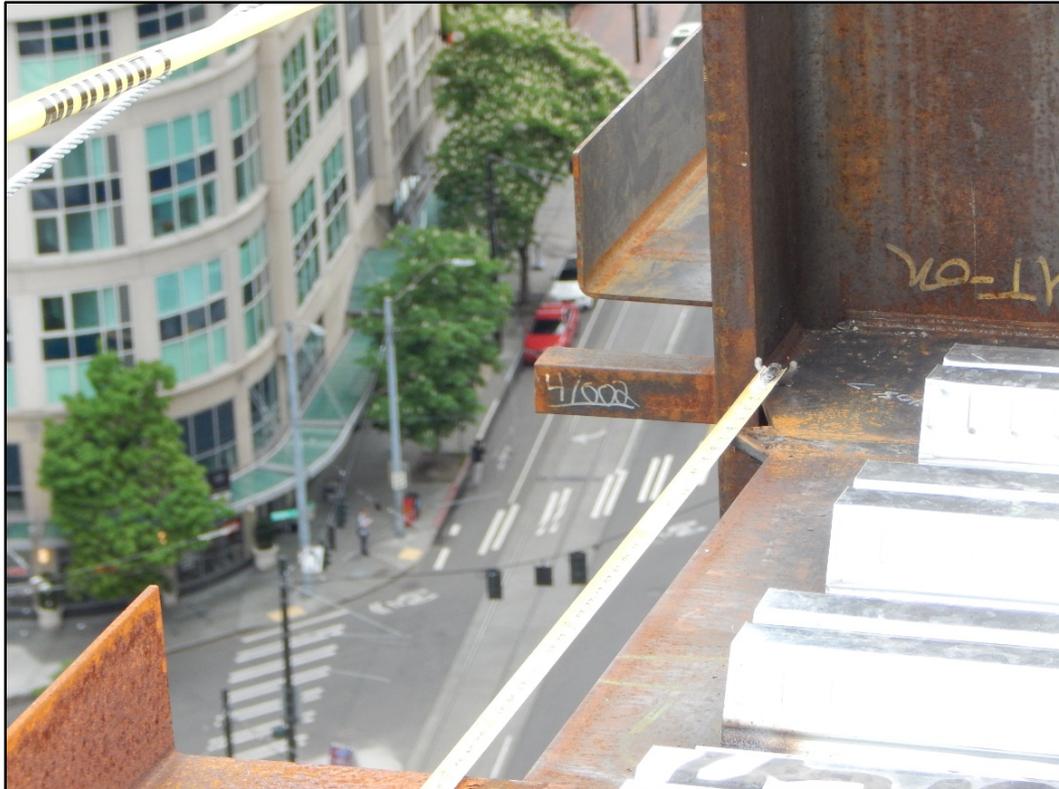
Photo 2. Close-up view of the gap the ironworker fell through.

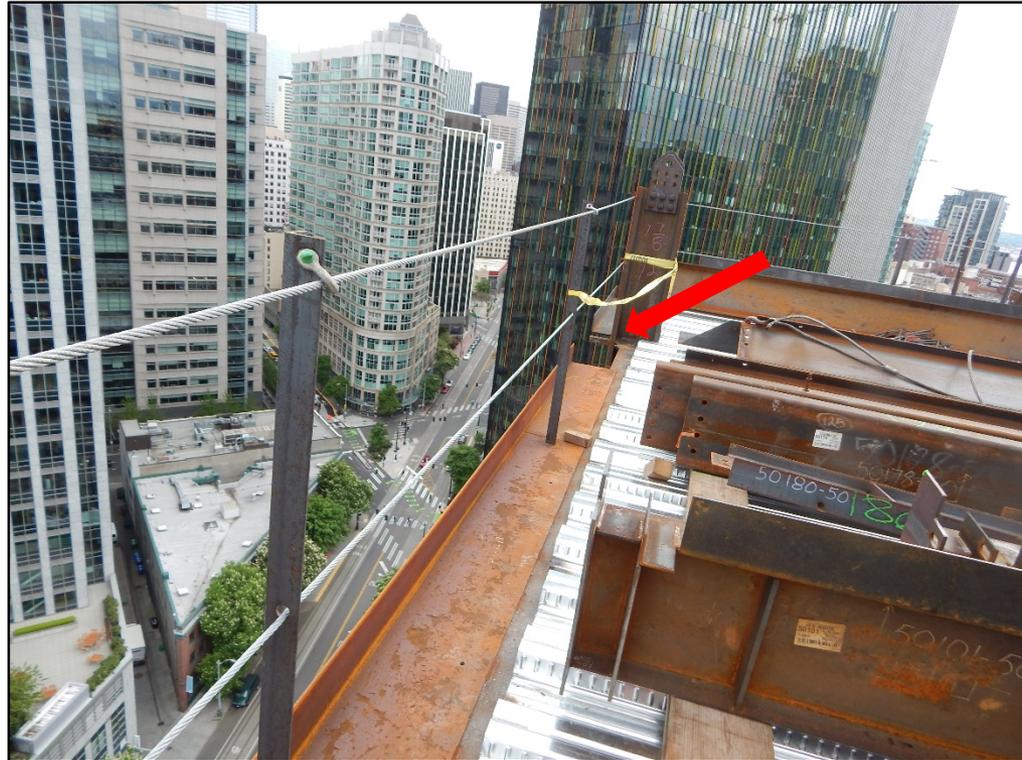
Photo 3. Work area on the building’s 18th floor showing the bent plate gap the ironworker fell through. He was “shaking out” a beam when when he stepped backward into the gap. Caution tape was placed after the incident.

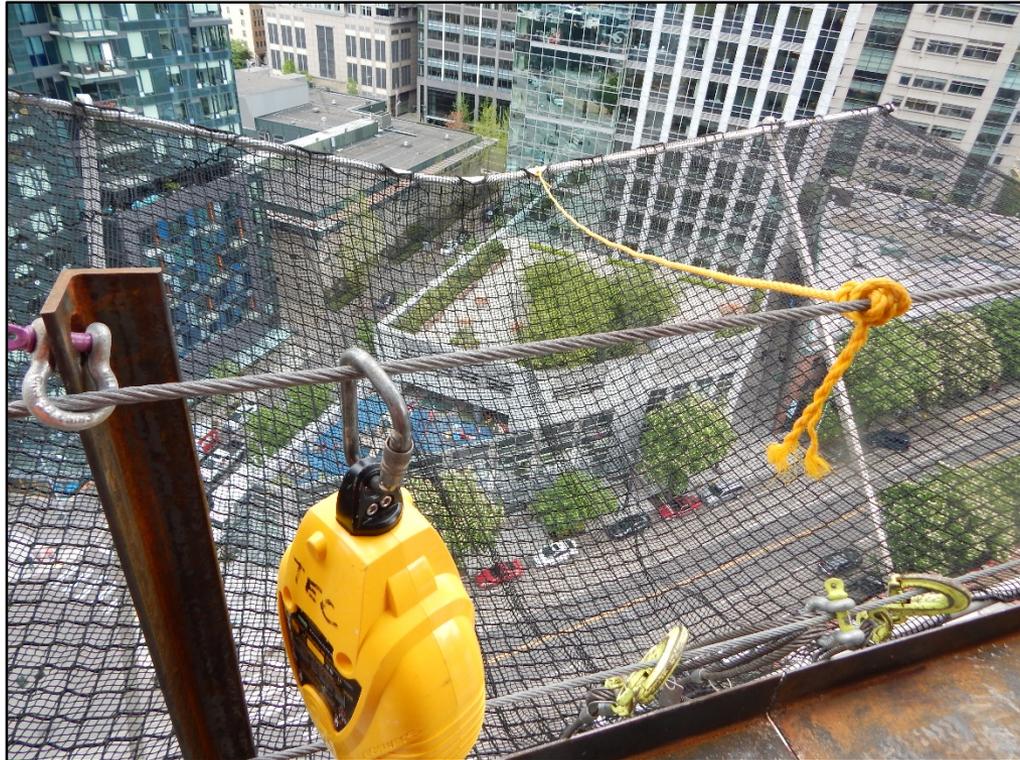
Photo 4. Debris net the ironworker landed in after falling 80 feet. The debris net was intended to catch falling objects, not people. The impact of the ironworker's fall bent the net's frame.

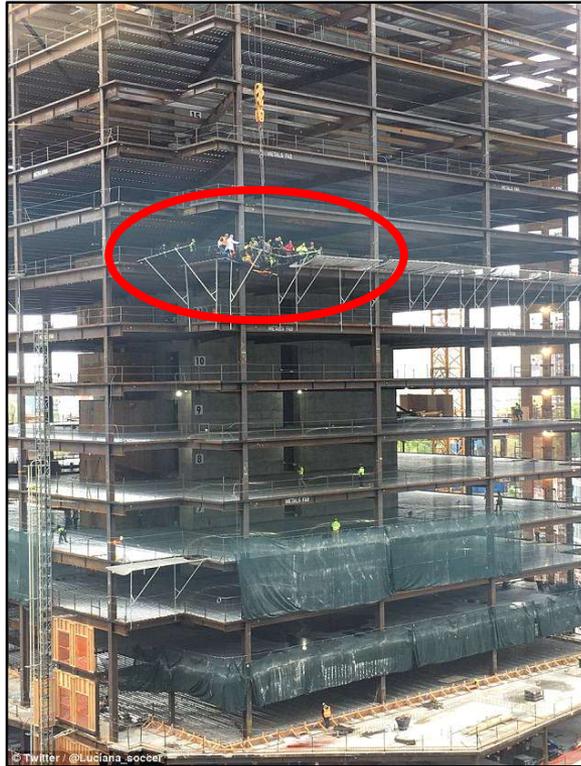
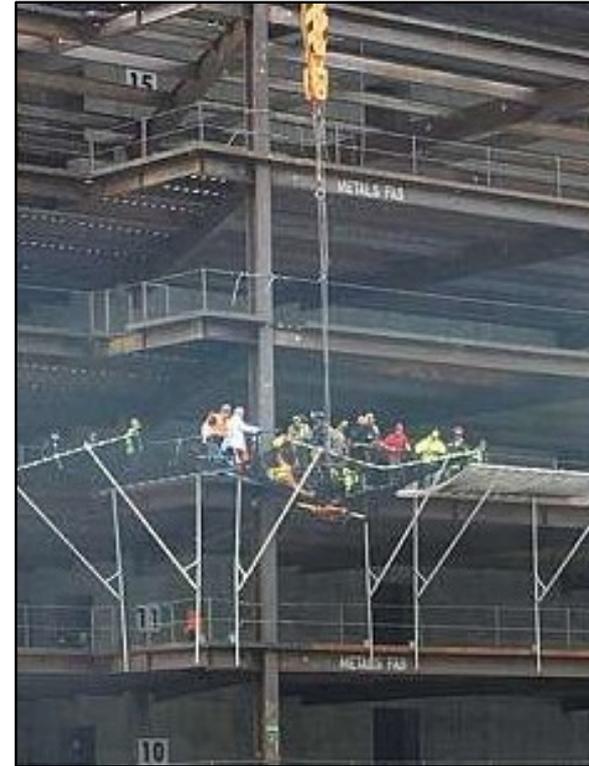
Photos 5 and 6. Injured ironworker being rescued from the debris net.
(Photo credit: Twitter @Luciana_soccer)

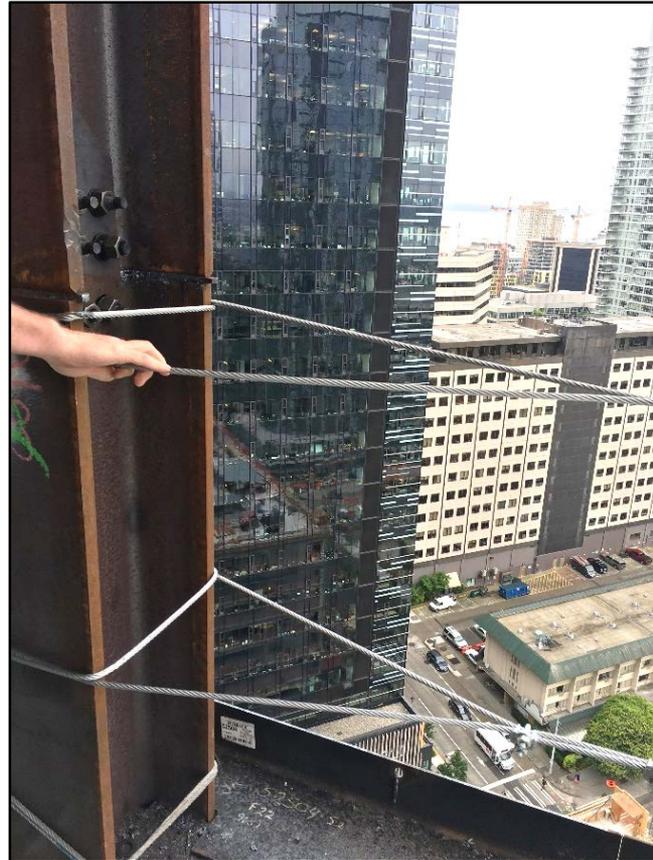
Photo 7. Post-incident pre-tensioned cable rails wrapped around a column.

Following the incident, the employer began corrective measures including: installing the bent plates as soon as structurally possible; decreasing the gap from 3 feet to 18 inches; moving the rail posts a few inches inward when possible; and wrapping cable rails around columns.
