Assembler / Fabricator Dies When Struck by “L” Rack Loaded with Glass Mirrors in Washington State

Fatality Investigation

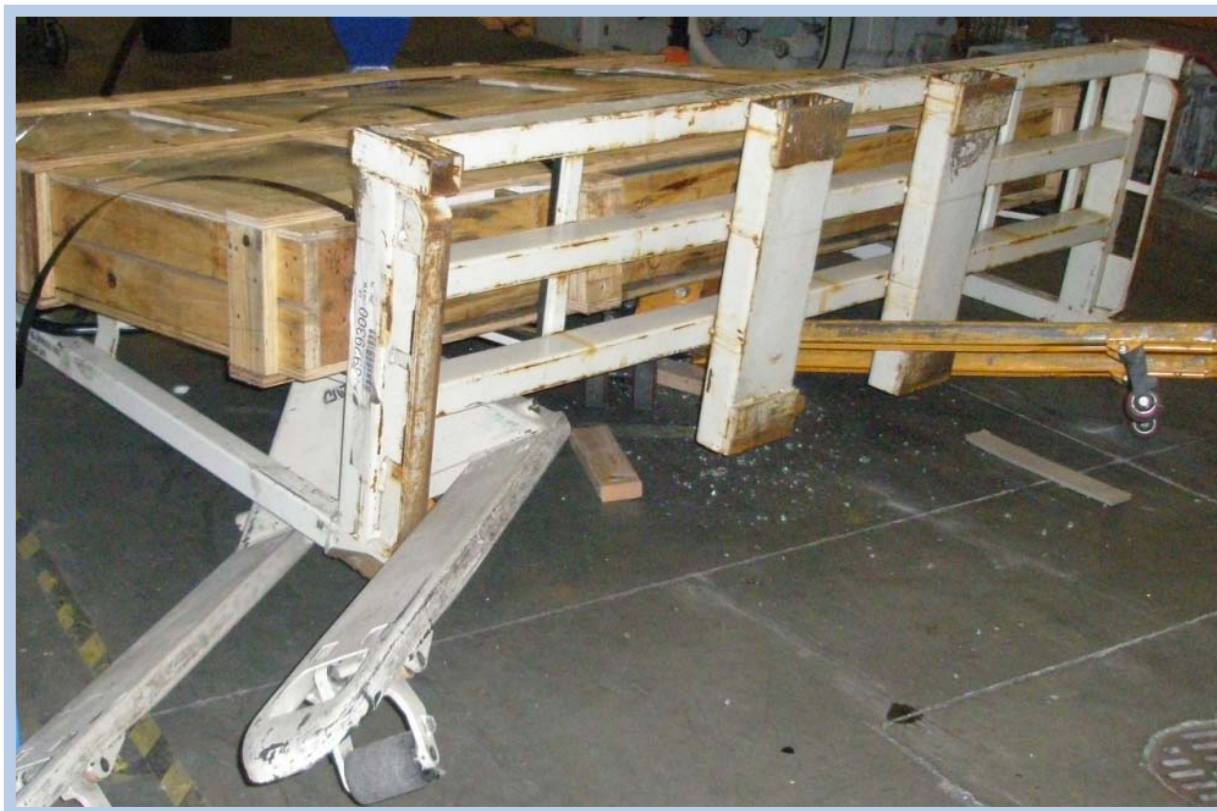
Assembler / Fabricator Dies When Struck by “L” Rack Loaded with Glass Mirrors in Washington State
