FATALITY INVESTIGATION REPORT

REPORT #: 52-47-2021

REPORT DATE: 03/04/2021

Chip Truck Driver Struck by Passing Truck

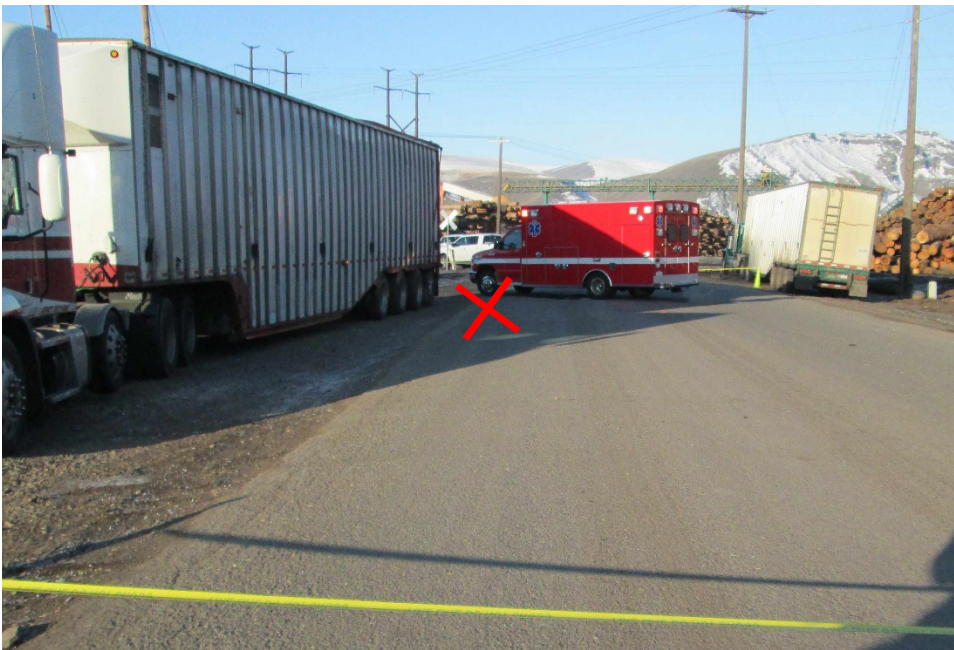
Photo 1: Incident Scene – driver’s tractor-trailer in turnout in left side of photo with ambulance parked across the roadway. Green witness tractor-trailer parked on shoulder in the right side of the photo. The “X” indicates approximate location driver was found following incident.

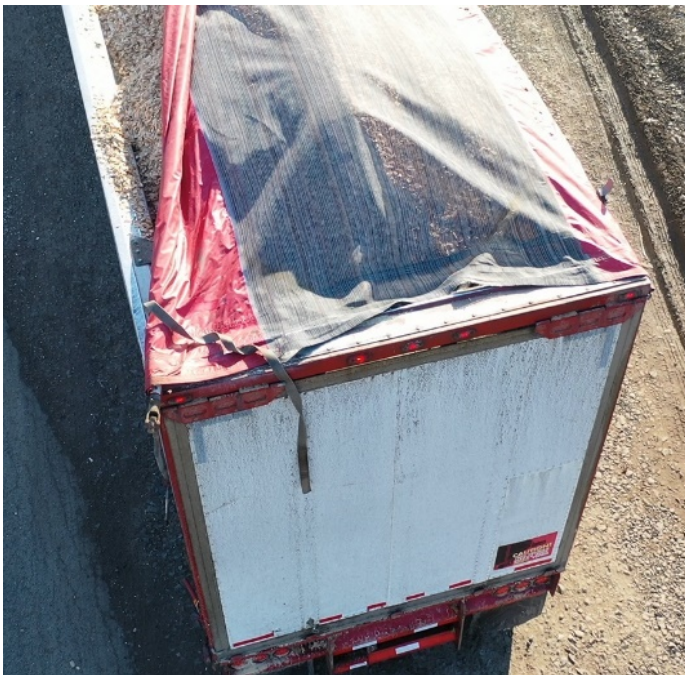
The trailer was loaded with piles of wood chips extending beyond the height of the trailer in several places. The piles could be seen over the top of the trailer. Typically if a trailer is filled with piles above the height of the trailer, the wood chips settle down into the trailer flattening the piles as the truck drives from the mill to the tarping area. However, the chip piles did not settle this time. One employee interviewed said that sometimes drivers will hit their brakes a few times to settle the wood chips down if the piles are still too high. It is unknown if the driver of the truck did this. Others interviewed indicated that the piles appeared higher than usual. This could have caused difficulty in cranking the tarp roll bar over the piles and closing the tarp over the trailer.

Photos 2 and 3: Photo 2 shows tarp system including tarp, roll bar, and strap on top rear of trailer. Note how wood chips are piled above the height of the trailer and strap is twisted on top of tarp. Photo 3 shows hand crank used to close tarp over the trailer.

Recommendation: Ensure trailers are loaded at the proper capacity so tarps can be safely closed and fastened.

Discussion: Employers should develop policies and train drivers to avoid loading trailers with material to a height that makes tarping difficult. This should include drivers working with mill workers and loader operators to not overfill trailers. If the employer had a policy to not overfill the trailer and the driver had instructed the mill workers accordingly, tarping the load may have been easier. Wood chip loading is done by visual assessment at the mill. The height of this load did exceed the height of the trailer and did not settle after driving to the turnout. While the trailer was loaded to the proper capacity for the weight limit, the height of the load likely made the trailer difficult to tarp. The proper load height should be considered. Even with automatic tarping systems or trailer arches, materials loaded too high inside the trailer would cause an equipment fault and require the driver to exit the vehicle to troubleshoot.

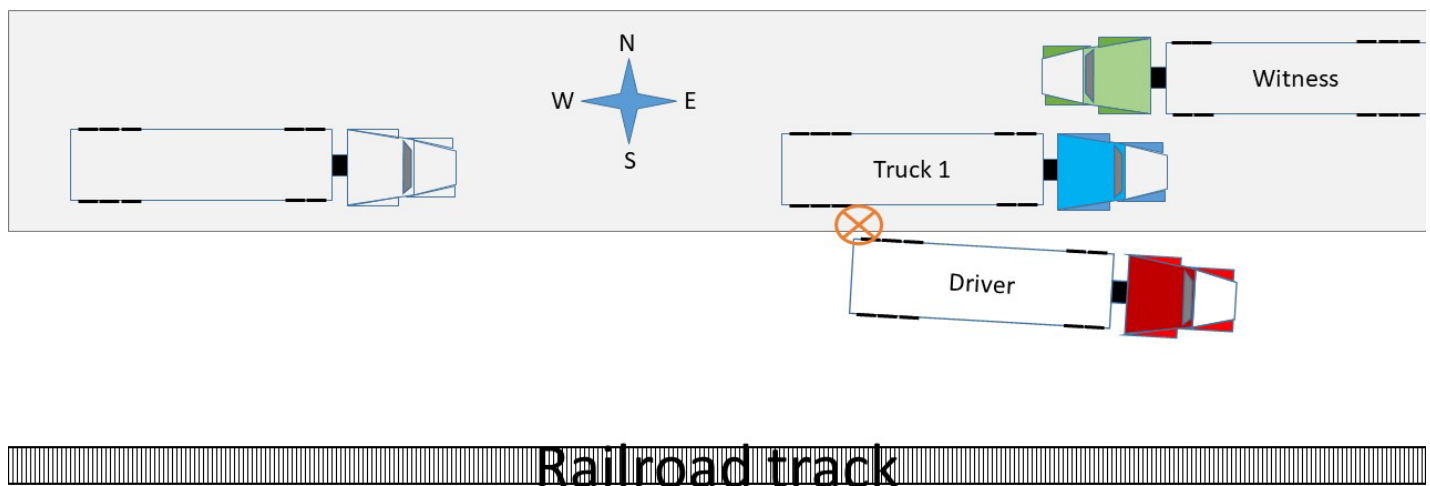
Diagram 1 (Not to scale): Approximate location of tractor-trailers at time of incident based on first responder report. Circle with “X” indicates approximate location chip truck driver was seen when tarping his trailer.

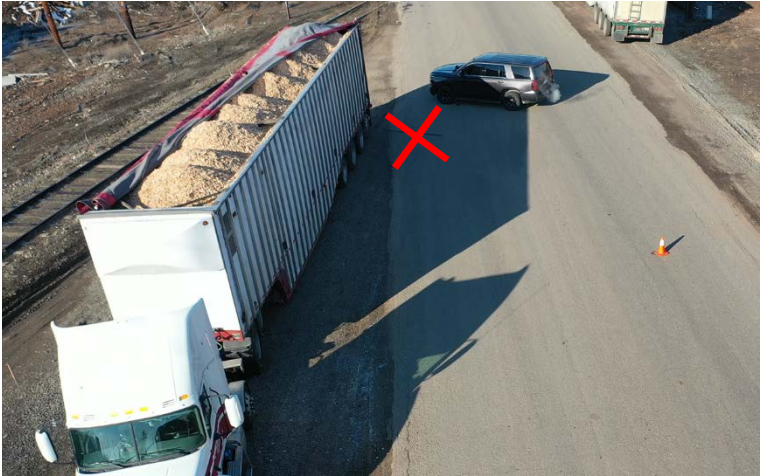
The tractor-trailer was parked in the turnout at a slight angle to the road with the trailer closer to the road. Photographs from the scene and drone footage show the rear tarp strap was twisted and on top of the tarp. The area where the driver appeared to be struggling to tarp the trailer was close to the road. The driver may have lost his balance while trying to reach the rear strap with the long reach tool and stumbled backwards just as the blue tractor-trailer was passing slowly on the road and was run over by its trailer.

Photo 4: Tractor-trailer with piles of wood chips, partially covered with tarp at rear but not at front. Tractor is parked further away from the road, while rear of trailer is angled closer to roadway traffic. Long reach tool is seen at rear of trailer in road by tires. The “X” indicates approximate location driver was found following incident.

Recommendation: Develop policies for how and where to safely park and tarp trailers.

Discussion: In this incident the customer did not have a tarping station available. Some customers do have them. Employers should develop policies that require drivers to use available tarping stations. When stations are unavailable, policies should be developed for drivers to safely park and work outside of their trucks. The area should be separate from the roadway and designated by signs, warning devices, or barriers such as concrete blocks, railings, or gates. This helps reduce the risk of drivers being hit by a moving vehicle. In Washington State, approximately 36% of motor vehicle fatalities occur to drivers outside of their vehicles. While personal protective equipment such as hi-visibility vests improve safety for drivers, reducing the interaction between drivers and vehicles is the best way to prevent these incidents.

In this incident, the driver could have also parked his tractor-trailer further from the road, which would have allowed more room for working at the rear of the trailer.

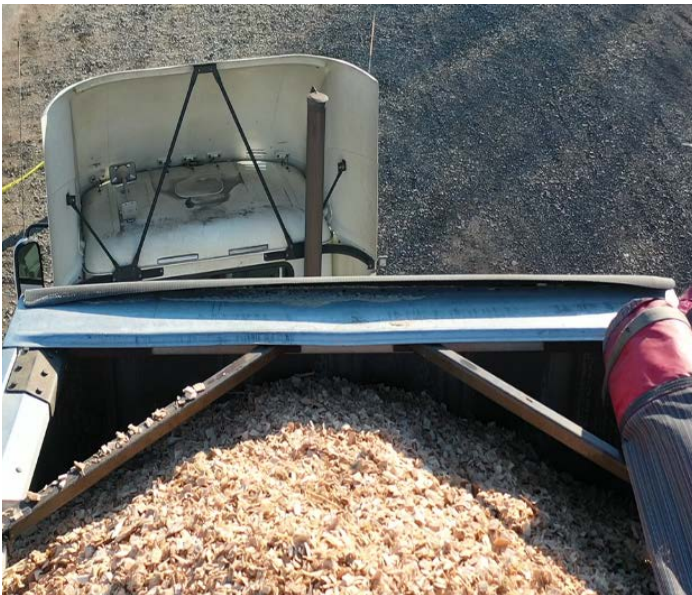
Another issue that may have caused the driver to struggle while covering the trailer with the tarp is the lack of an elastic stretch cord at the front of the trailer. Elastic stretch cords run across the front of the trailer and help guide and pull the front of the roll bar across the loaded trailer as the tarp is cranked in the rear. This cord is not required by law. Scene photographs show the tarp is positioned diagonally with the rear of the tarp closed and the front open. A guide cord may have helped the driver to fully close the tarp.

Photo 5: Driver’s trailer with manual tarping system missing the elastic stretch cord across the top end cap at front of trailer.

Recommendation: Maintain tarp systems and consider using an automatic tarping system that eliminates the need to manually close a tarp over a load.

Discussion: The elastic stretch cord was missing from the front of the trailer’s tarp system. The cord helps guide and close the tarp as the driver operates the rear crank. If the tarp had closed as intended, the tarp straps should have hung down the side of the trailer. Scene examination shows the rear tarp strap tangled at the top of the trailer, which meant the driver needed to reach for and untangle it. While the incident was not witnessed, it is suspected that the driver may have stumbled backwards while trying to reach the tarp strap. The long reach tool was in the middle of the road, which he could have been tugging on forcefully when he stumbled backwards into the passing trailer. Automatic tarping systems are available for these trailers. These allow the trailer to be covered with a tarp by pressing a button inside the truck cab. The driver does not have to interact with traffic or struggle with tarp straps. This also reduces driver’s risk of falls and musculoskeletal injuries which are associated with manual tarping.

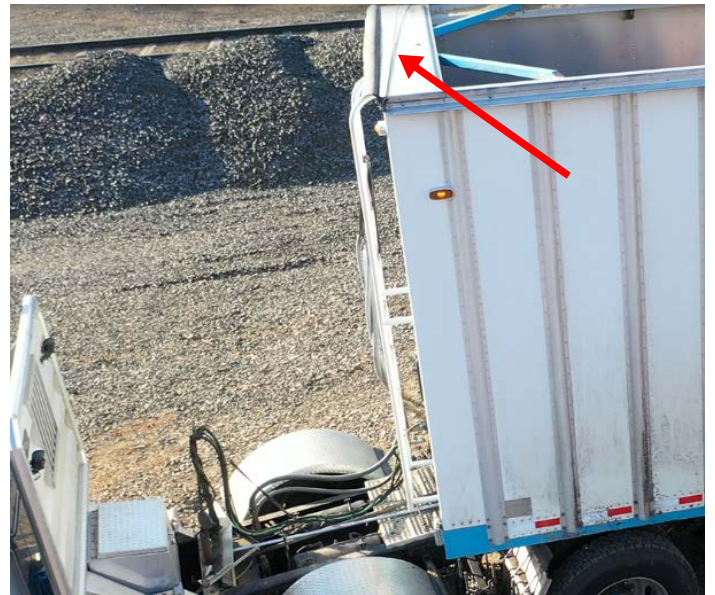
Photo 6: Tractor-trailer that stopped near the incident scene. Arrow points to intact elastic stretch cord across the top end cap at front of trailer.

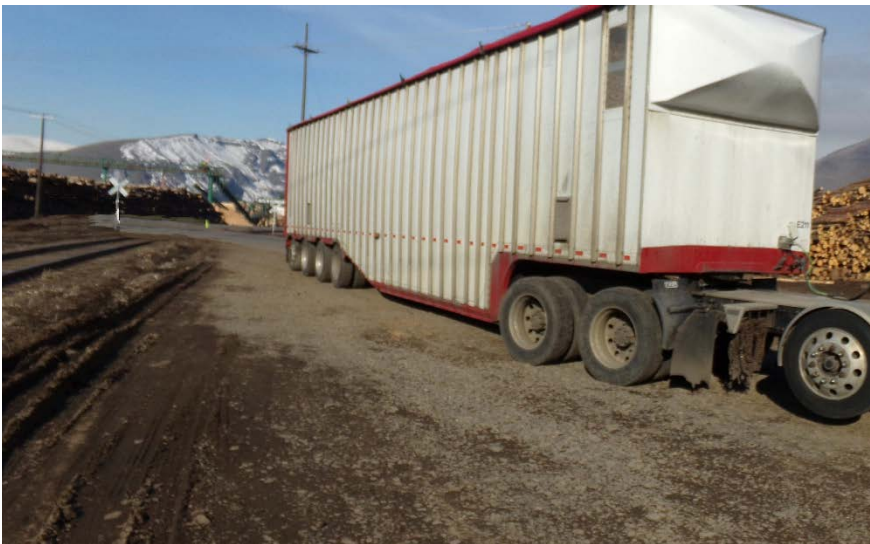
Photo 7: Photo of location in turnout where the driver parked with more area toward the railroad track and in front that could have been used to park farther from the road.
