REPORT #: 52-49-2021

REPORT DATE: 10/04/2021

Hay Press Operator Struck by Machine's Guillotine Blade

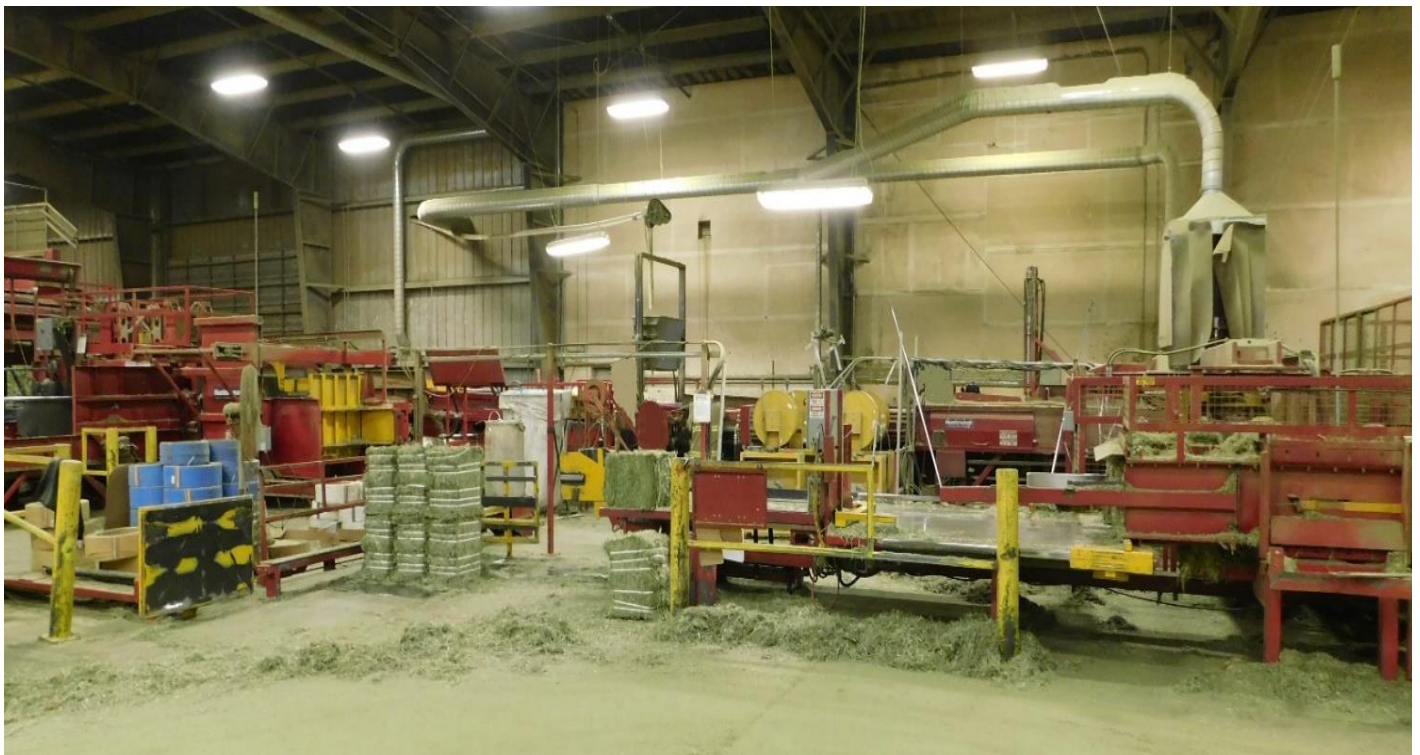
The machine involved in the incident was a FC10000 series export forage compactor manufactured by Hunterwood Technologies. This machine is commonly referred to as a “hay press” (photo 1). Hunterwood Technologies represents 70% to 80% of the North American sales market. The hay press processes field baled hay into high-density bales for shipping. The employer purchased the machine new in 2012 and had used it continuously since the time of purchase. The hay press is fully automated and controlled from a touchscreen interface panel located at the operator’s station near the press. After field baled hay is loaded with forklifts into an input system, the machine uses an elevator, kickers, paddles, hydraulic plungers, and a chain-driven conveyor to feed the hay into a main press (photo 2). The hay is weighed, sliced, compressed, strapped and ejected as a large compressed bale weighing 240 pounds. The kicker then moves the ejected bale into a cutter box that slices it into four small 60-pound compressed bale cubes. The smaller bale cubes are wrapped and shipped to venders. The press is equipped with a hazard control system that includes a start key control, emergency stops (E-Stops), fenced zones, gates, interlocks, fixed guards, photoelectric sensors, light curtains and warning signs (photo 3). All moving devices are painted in yellow. The employer’s equipment mechanics maintained the press and checked it at least once per day.

Photo 1: Incident hay press

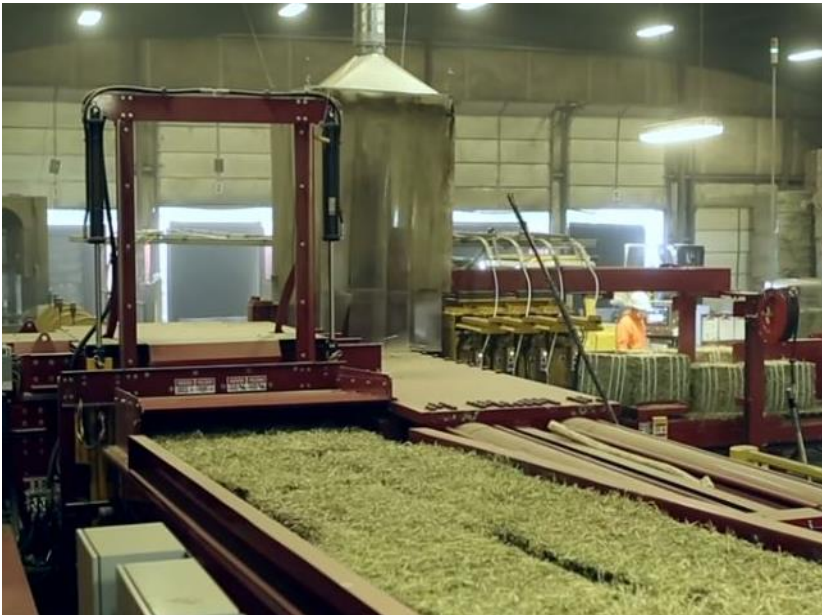
Photo 2: Chain-driven conveyor moving field baled hay into the machine's main press that processed them into smaller compressed cubes for shipping to customers.

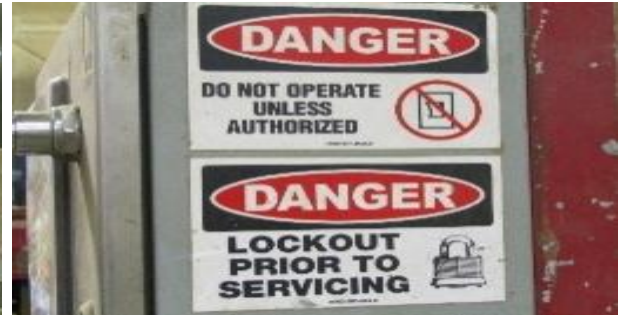
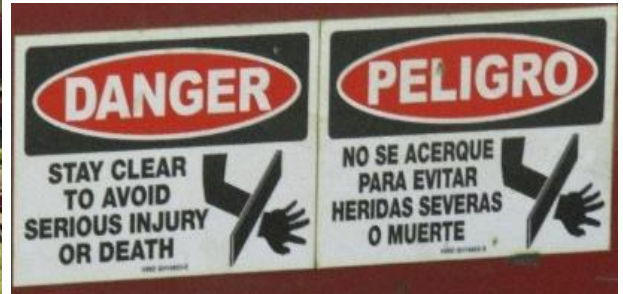
Photo 3: Warning signs in English and Spanish on incident hay press.

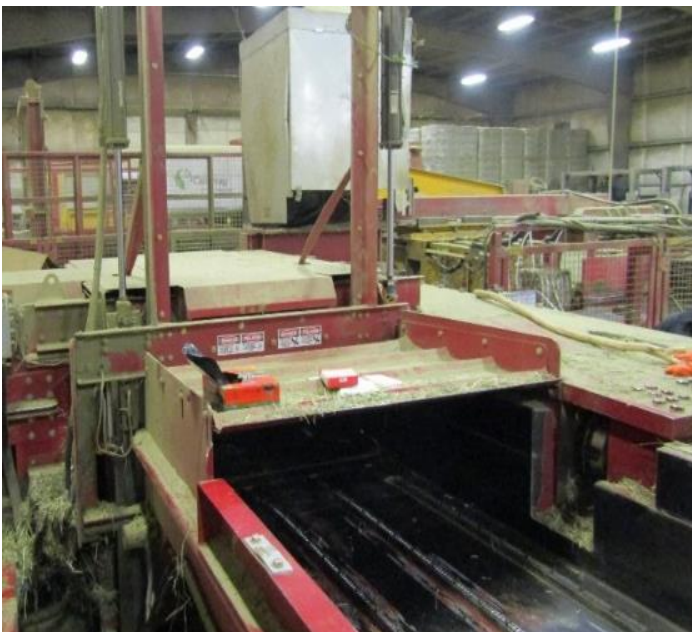
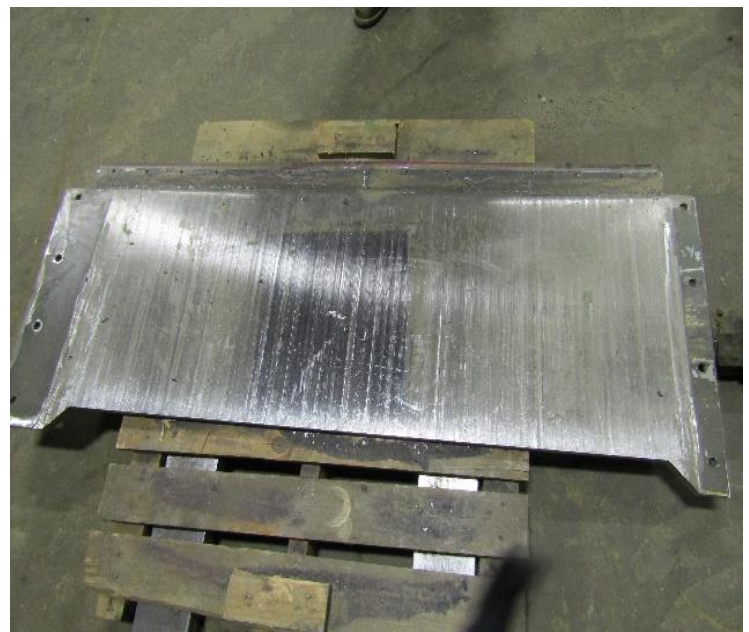
During normal hay press operation, the machine's conveyor moved field baled hay into the hooded intake opening of the main press where a scale pan, steel guillotine, compress chamber, and ejection device were located (photos 4 and 5). When the hay reached a programmed weight, the scale activated the hydraulic guillotine to raise up and slice off a section of the hay that was then pushed into the compress chamber by a loading plunger. High pressure cylinders in the compress chamber squeezed the sliced hay into a single bale and ejected it through a gate into a set of strap paddles. The paddles held the bale while the machine applied straps before finally cutting the hay into smaller cubes. The last bale remained in the strap paddles because no other hay followed it from the conveyor into the compress chamber to push it out.

Photos 4 and 5: The left photo shows the hooded intake opening of the main press where the machine's scale pan, steel guillotine, compress chamber, and ejection device are located. The right photo shows a steel guillotine blade of the same type that struck the operator inside the main press.

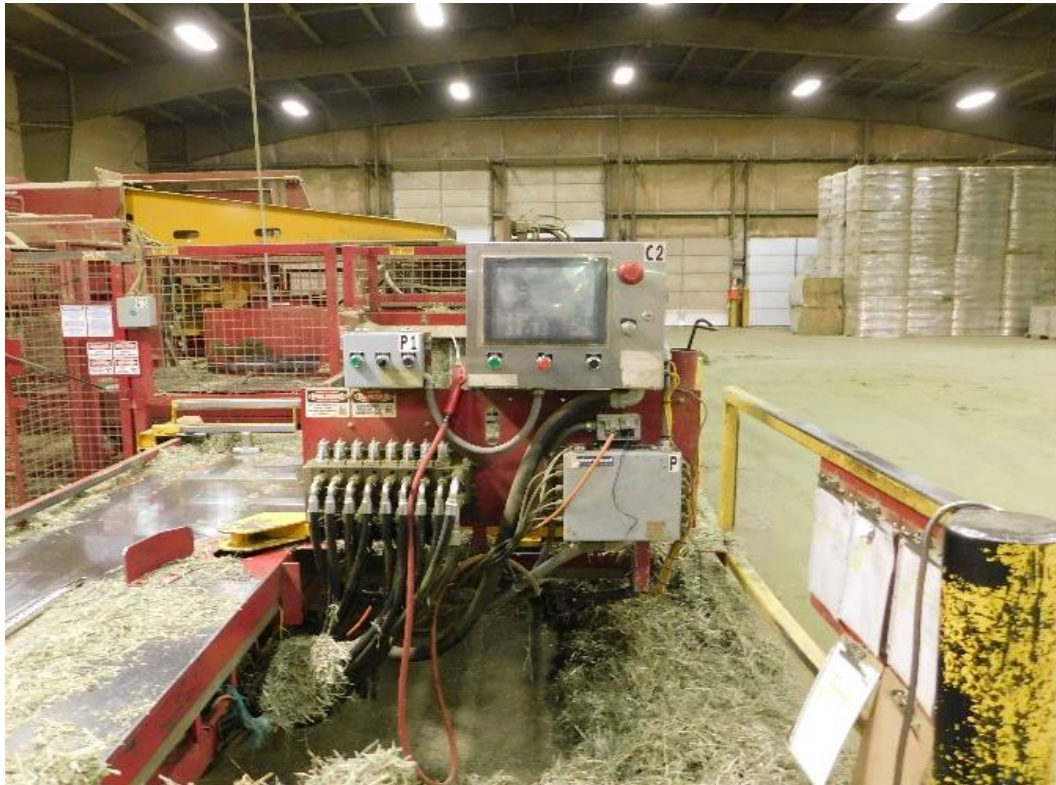
The pre-maintenance preparation required the operator and floor techs to clear out the last remaining bale from the paddles as all hay had to be removed from the press. The task involved manually sliding two smaller cut bales or a metal box through the main press to push out the last bale held by the strap paddles. Having the employer's permission, operators usually chose to use the lighter bales rather than the heavier, bulkier metal box, which the employer created for the purpose. Before the task could be performed, the hay press had to be de-energized using a full LOTO procedure to prevent device activation while an employee was inside the machine.² The procedure required the operator to switch off and remove the start key from the control panel at the operator's station (photo 6) and place it in his pocket until it was safe to restart the machine.

Photo 6: Operator's station with touchscreen interface panel.

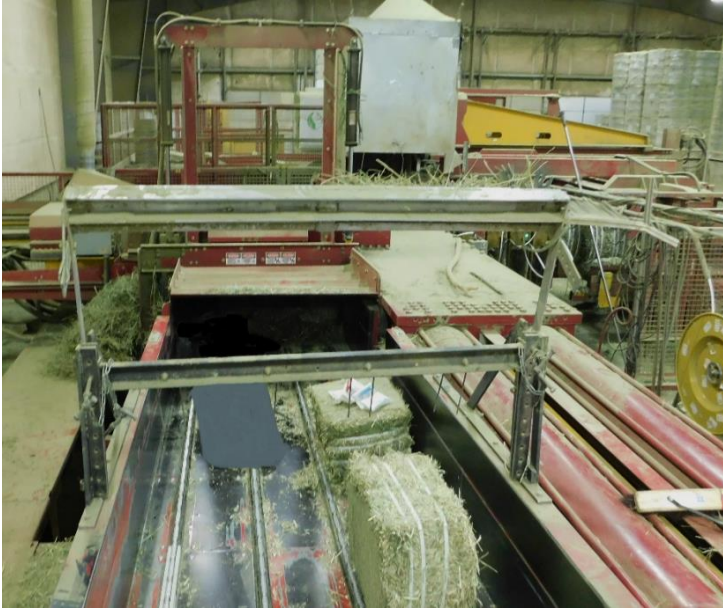
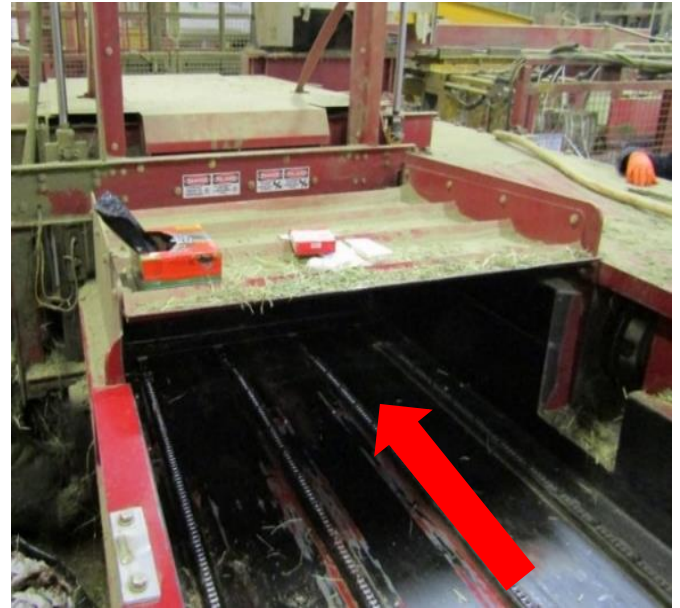
Without performing the required LOTO procedure, the operator crawled into the main press' 54-inch-wide by 24-inch-high hooded intake opening to push the bales through to clear the compress chamber (photos 7 and 8). Warning signs written in English and Spanish were located directly above the opening. No one noticed him enter the opening. As the operator crawled headlong across the scale pan (photo 8), the combined weight of his body and the bales reached the scale's 218-pound programmed trigger weight that activated the guillotine that struck and nearly decapitated him (photo 9). When the supervisor heard a floor tech scream and yell to the operator after the guillotine engaged, he pressed one of the machine's E-Stop buttons, shut off the power at the operator's station and removed the key from the control panel (photos 10 and 11). The operator was pronounced dead at the scene.

Photos 7 and 8: The left photo shows hay press after the incident showing hay bales on the machine's conveyor. The left photo shows where the operator crawled into the hooded intake opening of the main press to push hay bales through in order to prepare the machine for scheduled maintenance.

Recommendation: Enforce and evaluate employee compliance with machine manufacturer’s LOTO requirements when servicing or maintaining machines and equipment.

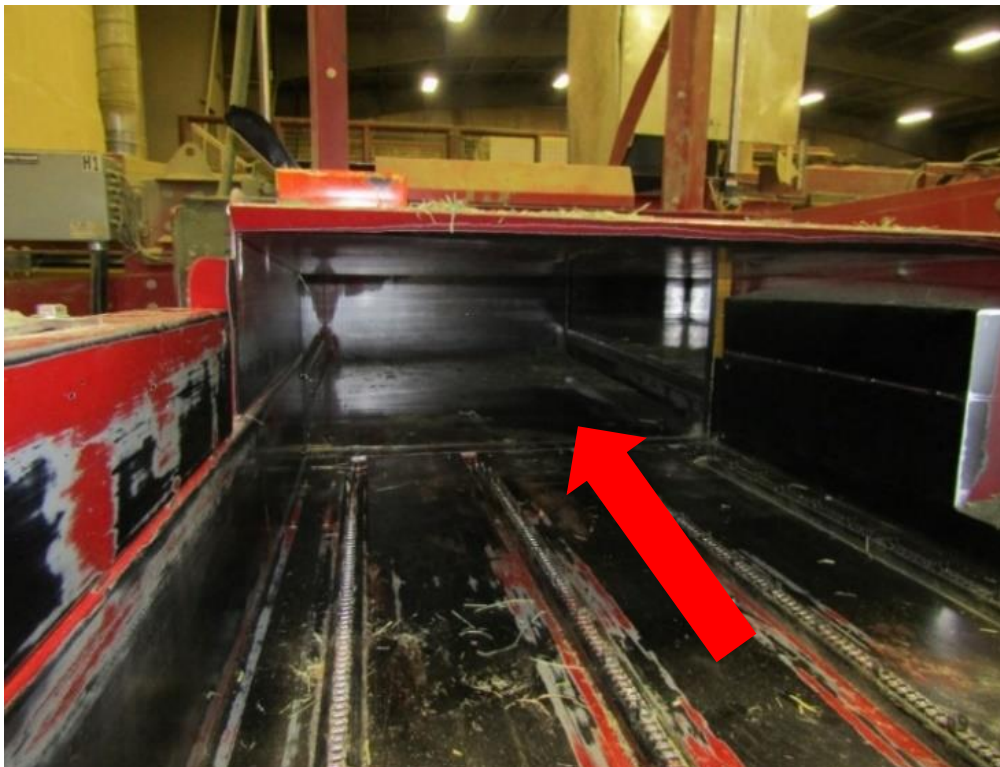
Photo 9: The red arrow shows where the operator crawled onto the scale pan that triggered the guillotine to raise up and nearly decapitate him.

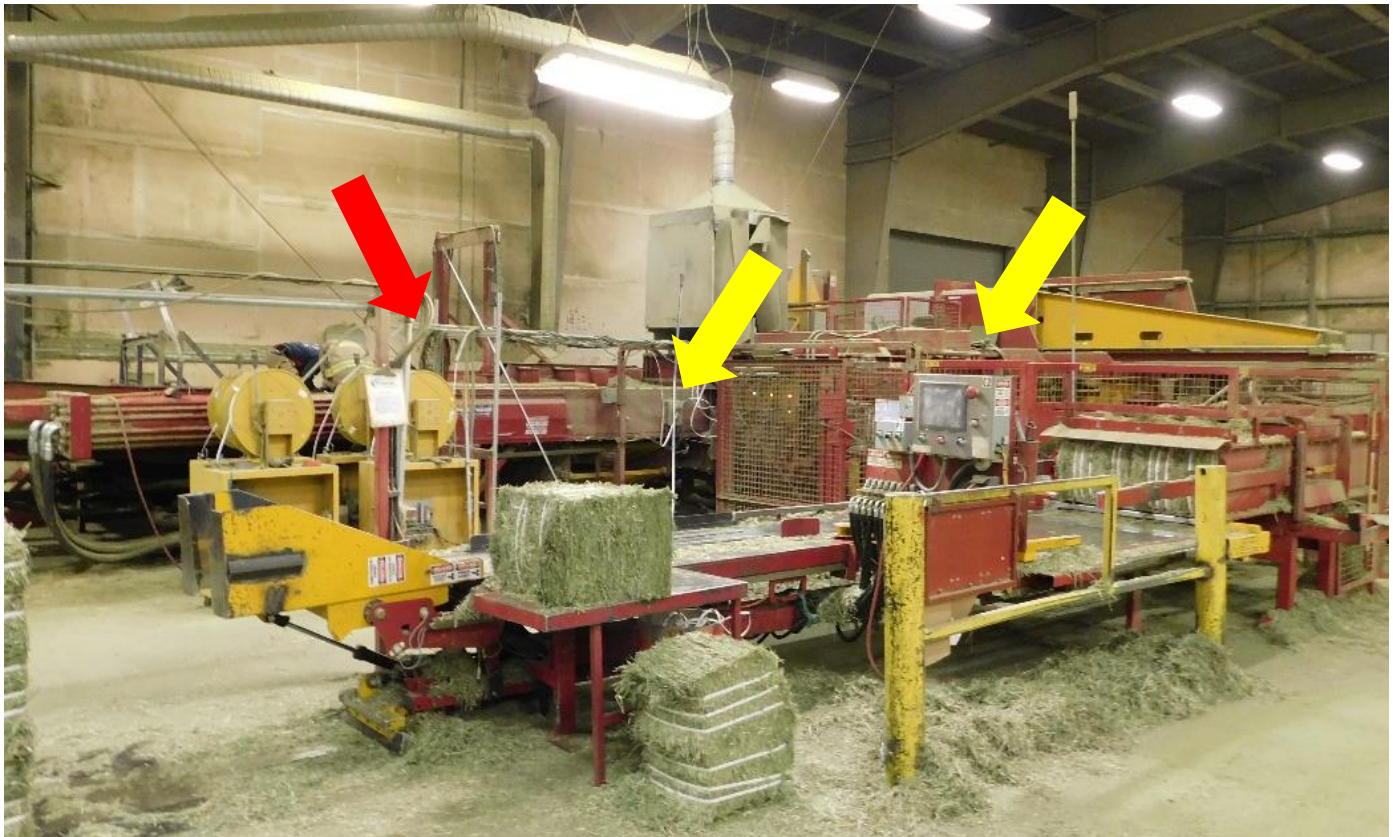
Photo 10: Red arrow shows the location of the guillotine where the operator was found. The yellow arrows show the locations of red emergency stop (E-Stop) buttons at the main press and operator's station.

Discussion: The incident hay press had red E-Stop buttons mounted in several areas. The E-Stops nearest to the hooded intake area of the main press where the fatality occurred were located on the left panel of the conveyor loading area, on the right wall of the main compress chamber and at the operator's station approximately 40 feet away (photos 10 and 11). Employers can request the machine manufacturer to send a technician for consultation in performing a risk assessment to understand and possibly customize the machine's safety control system. Such an assessment can identify better locations to install an E-Stop, such as mounting one closer to the hooded intake opening of the main press. It can also consider the use of wireless remote control E-Stops so workers won't have to run to a wired E-Stop that may be located at a large distance from the hazard. A consultation could also identify a safer way to remove the last bale from the compress chamber, such as installing an access door on the right wall of the main compress chamber that would eliminate the need for an employee to enter the hooded intake opening. Installing an additional E-Stop and an access door would not eliminate the requirement to de-energize the hay press through a full LOTO procedure.

Recommendation: Perform risk assessments with the machine manufacturer to understand or customize machine safety control system features, such as emergency stop (E-Stop) locations and access doors.

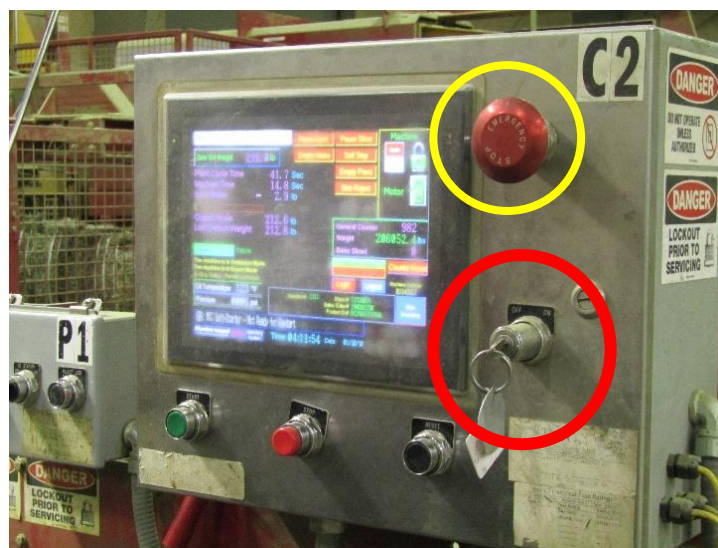
Photo 11: Operator's station control panel. The red circle shows the key that controls the power to the hay press. The yellow circle shows the emergency stop (E-Stop) button.
