## FATALITY INVESTIGATION REPORT

**REPORT #:** 52-51-2022

**REPORT DATE:** 01/20/2022

### Compost Plant Operator Caught in Rotating Conveyor Belt

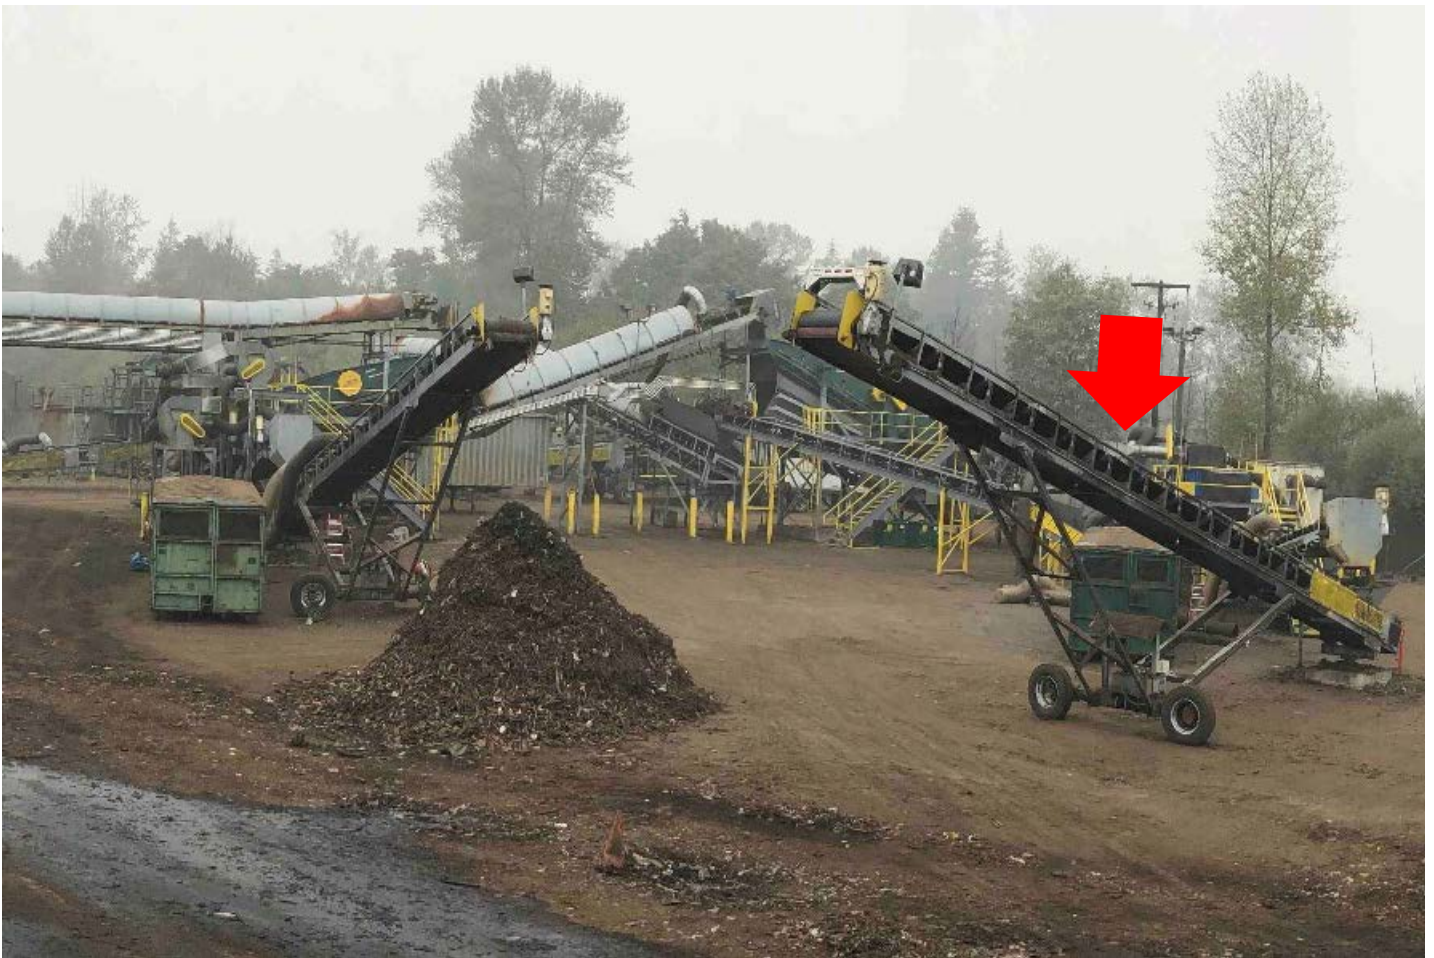
**Photo 1:** Biomass screening system equipment in screen plant where worker was fatality injured. Red arrow indicates radial stacker conveyor involved in the incident.

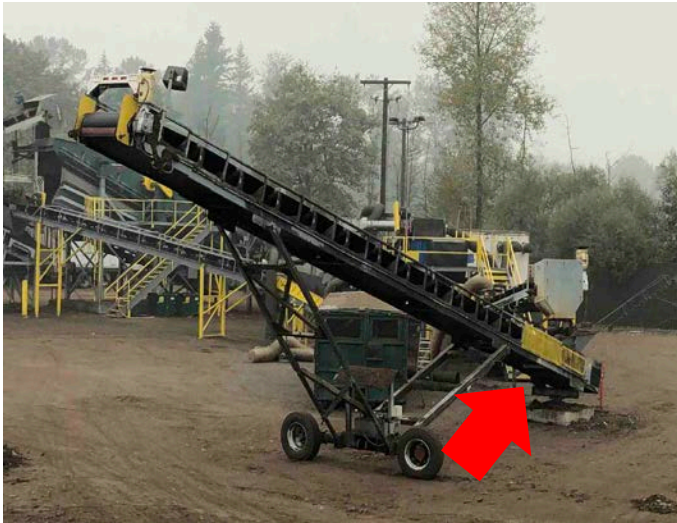
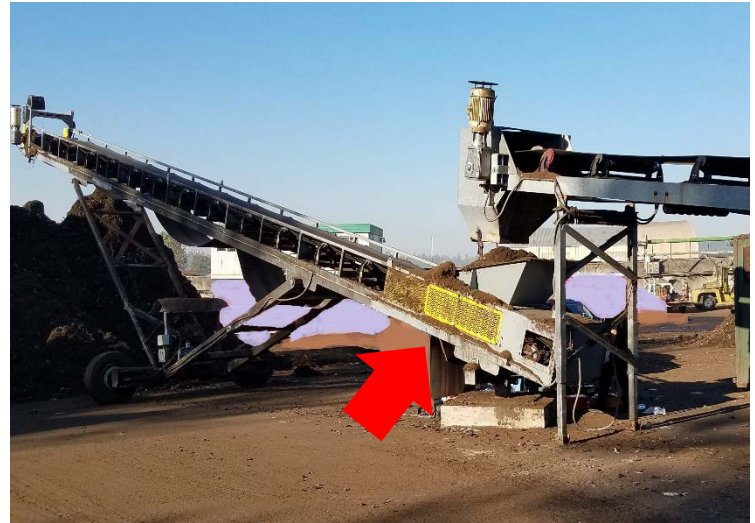
**Photos 2 and 3:** Left photo shows front side view of radial stacker conveyor involved in the incident. Right photo shows rear side view of stacker. Red arrows show the conveyor's tail end location where the lead screen plant operator was pulled in between the return idler roller and conveyor belt.

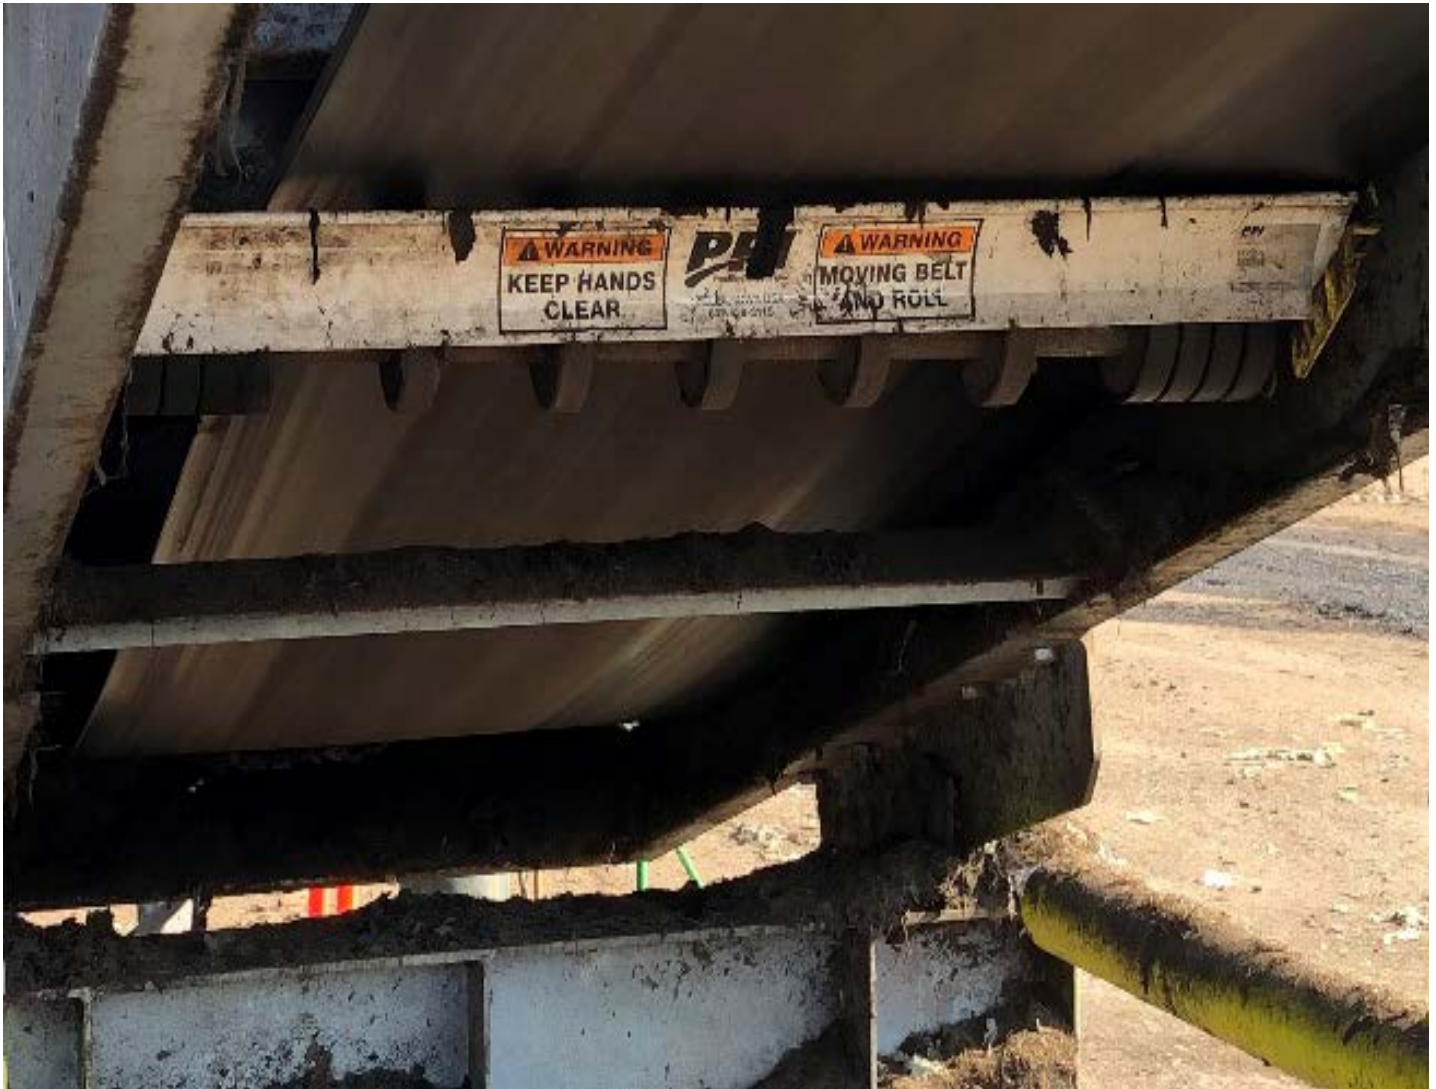
**Photo 4:** Plastic guard with warning signs that was missing on the return idler roller on the radial stacker conveyor involved in the incident. The photo also shows a rubberized disk idler roller that replaced the steel roller involved in the incident. Disk rollers help minimize material build-up and the need for frequent cleaning.

The compliance safety and health officer's (CSHO) incident investigation found that the return roller's plastic guard was missing. During interviews by the CSHO, other screen plant workers could not indicate how long the guard was missing or where it was located. Plant supervisors speculated that the lead may have been pulled into the conveyor by his sweatshirt hood or the scraper handle, if he was using it to clean debris off the roller. The stacker shut down because an amperage spike tripped its conveyor motor's protection switch when the lead became caught in the machine.

Discussion: The plastic guard was missing on the radial stacker's return idler roller that pulled the lead operator into the machine's conveyor belt. The lead was 6-foot tall. The space between the bottom of the roller and the ground was 4-foot 6-inches, suggesting that the lead bent down to walk under the conveyor. The lead's assistant found him with his head, left shoulder and arm caught between the roller and conveyor belt with his feet dangling off the ground. The lead's sweatshirt hood was also entangled in the roller, and a metal spade scraper tool was caught between the roller and belt with its 5-foot wooden handle pressed against the lead's throat. These circumstances made it hard for co-workers who responded to release the man without using knives to cut his sweatshirt hood and the conveyor belt and their combined physical strength to break the scraper's handle.

The plastic roller guard came with the stacker. The employer's APP prohibited workers from defeating or removing any safety devices and safeguards, and only the employer's equipment mechanics were allowed to remove them. While screen plant workers were required to conduct daily summary reports and pre-trip inspections, machine guards and safety devices were not included in the report form's checklist. During the CSHO's investigation, screen plant workers were unable to locate the missing guard nor indicate how long it was gone. Although workers could not explain why the guard was missing, they stated that machine vibrations had previously caused it to loosen and fall out of its holding brackets that were mounted to the stacker's steel frame. The CSHO also found that the employer did not enforce its APP's restrictions on workers to not walk under energized conveyors. This led to exposing at least nine other workers to the unguarded roller's nip, caught-in or -between hazards. Although walking under the conveyor put the injured lead at greater risk, his injuries could potentially have been prevented had the guard been in place as required.

**Recommendation:** Ensure that equipment safety guards are not removed, displaced, or carried off.

To help ensure that required equipment safety guards are always in place and effective, management should provide safety training, hazard inspection checklists, and hazard report forms that enable workers to quickly identify and report missing or damaged guards. Management, supervisors, and mechanics should make sure that workers do not use equipment that has missing or damaged guards until they are reinstalled, repaired, or replaced. Workers should also be trained to know about conveyor entanglement hazards caused by loose clothing, long hair, and jewelry, as well as the hazards of using hand tools to clean rotating rollers and belts. Additional hazard controls include replacing steel return idler rollers with rubber disk types (photo 4) to minimize material build-up and installing cable bollards to prevent workers from walking underneath energized conveyors. Employers should always enforce all APP policies and JHA solutions that restrict workers from walking under or near energized conveyors unless a full LOTO procedure is properly in place.<sup>2, 3, 4</sup>

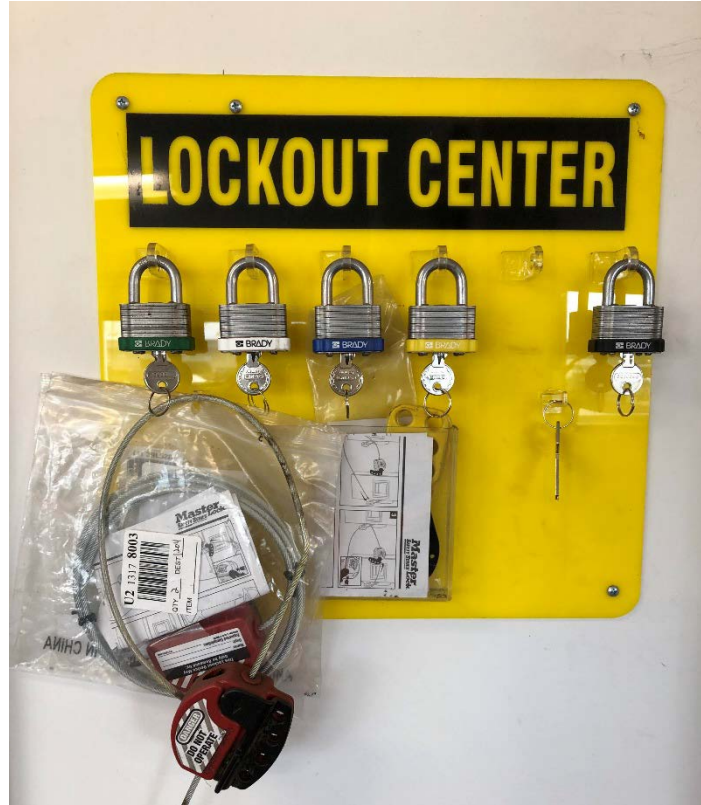
**Photo 5:** LOTO station with padlocks that was in the operations trailer 75 feet away from the incident location.

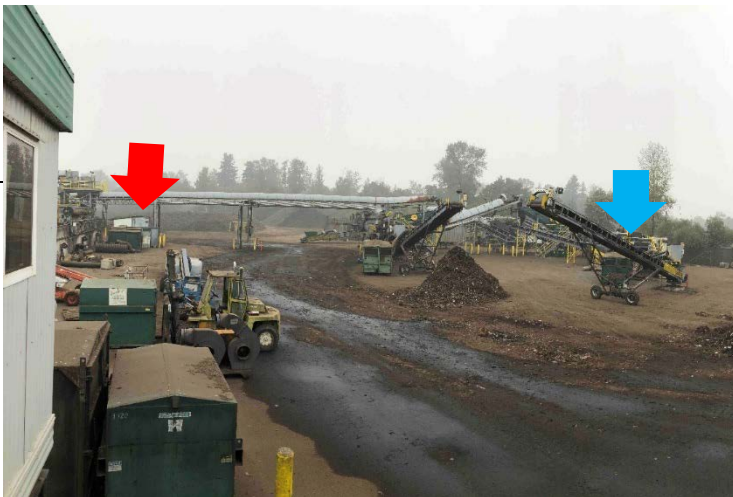
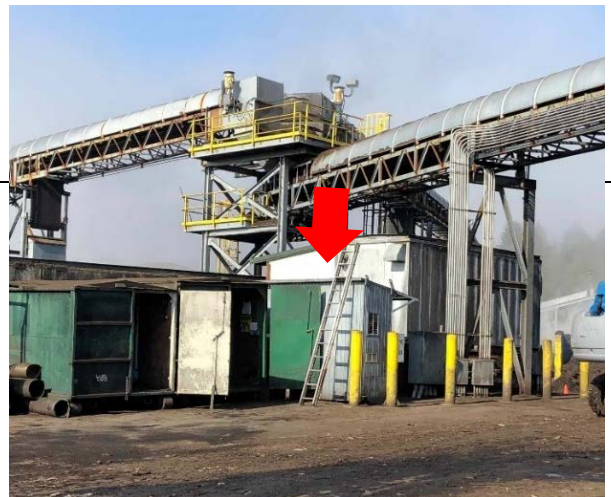
**Photos 6 and 7:** Red arrow in left photo shows central control panel shed location, and the blue arrow shows incident location approximately 70 feet away. Red arrow in right photo shows close up of central control panel shed.

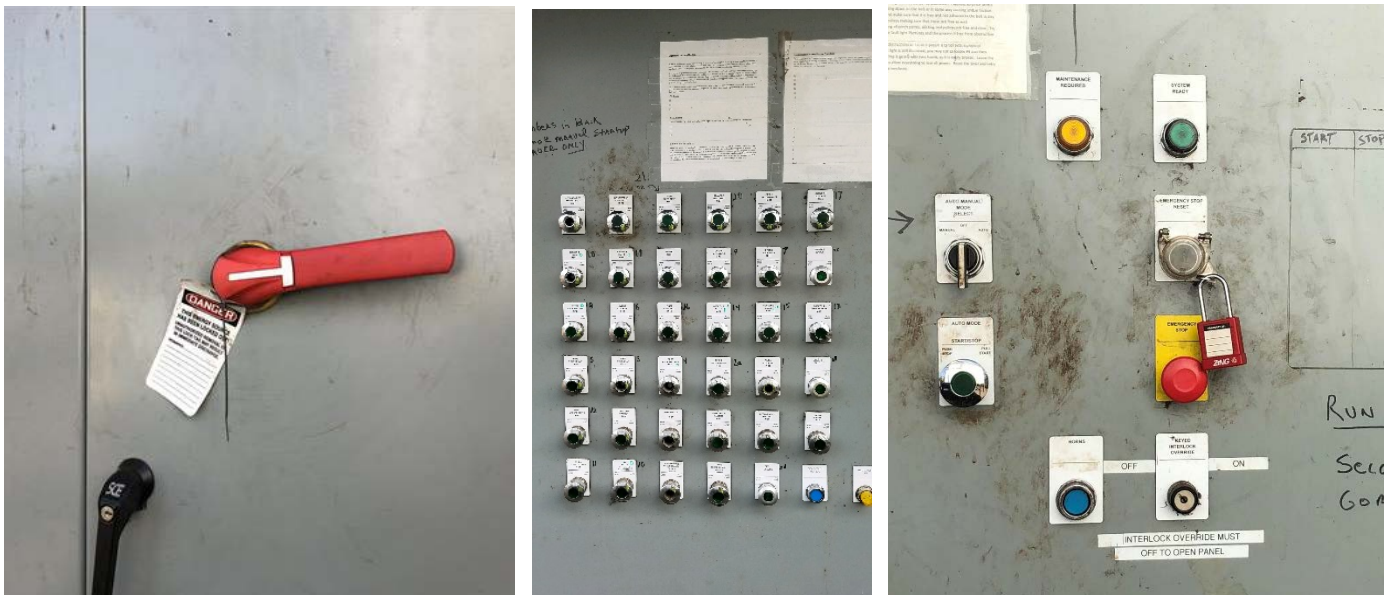
**Photos 8, 9, and 10:** Left photo shows blank LOTO danger tag on main power switch in central control panel shed. Tags should be signed, dated, timed, and have contact info, at a minimum. Center photo shows power buttons on central control panel for the biomass screening system equipment. Right photo shows red E-Stop button and mechanic's padlock with no identifying information on E-Stop reset button. Photos taken after incident.

Discussion: The employer's energy control program required workers to use the same LOTO procedure for many different kinds of screen plant equipment, including the radial stacker conveyor involved in the incident. The procedure contained general instructions to shut down a machine, deactivate and lock out the energy isolating device, dissipate or restrain stored or residual energy, and disconnect the machine from the energy source. It did not instruct workers how to test specific locked out equipment to ensure it was disconnected from its energy source(s) nor how to identify, apply, test, and transfer LOTO devices. The LOTO procedure also did not specify applicable equipment where it noted that the safe removal of some forms of blocking may require re-energization of the equipment first and that some equipment could not be locked out but only tagged out to prevent unsafe start up. The CSHO noticed that a danger tag on the main power switch and padlock on the central control panel's E-Stop reset button did not identify who applied the LOTO devices when they de-energized the stacker after the incident (photos 9 and 11). While the employer's LOTO procedure instructed equipment mechanics to use red color-coded locks, a facility supervisor and screen plant operator told the CSHO that authorized workers could use any locks and were not required to write identifying information on danger tags.<sup>5</sup>

The deficiencies in the employer's energy control program underline the importance of having specific, clearly written LOTO procedure instructions for each distinct piece of equipment that is combined with other equipment in biomass screening systems and other multistage production systems. While a system's different types of equipment may appear to share certain hazardous energy features, each separate piece may be made by different manufacturers and have unique hazards and LOTO requirements that should be recognized. The employer should provide LOTO procedure checklists for each piece of equipment to help ensure that workers are correctly following all LOTO requirements. Instructing workers to use the same LOTO procedure on different types of equipment raises injury risk because the procedure may be missing steps that are required to safely de-energize specific equipment. Workers may also be led to perform other safety procedures incorrectly if they see that management has not developed safety instructions adapted for specific equipment. Energy control programs should also assign distinctly marked or color-coded locks and keys to specific individual workers, such as supervisors, operators, and mechanics, and require authorized workers to properly fill out danger tags with their name and signature; date, time, and contact information; and details about when and why the LOTO was performed and may be removed.

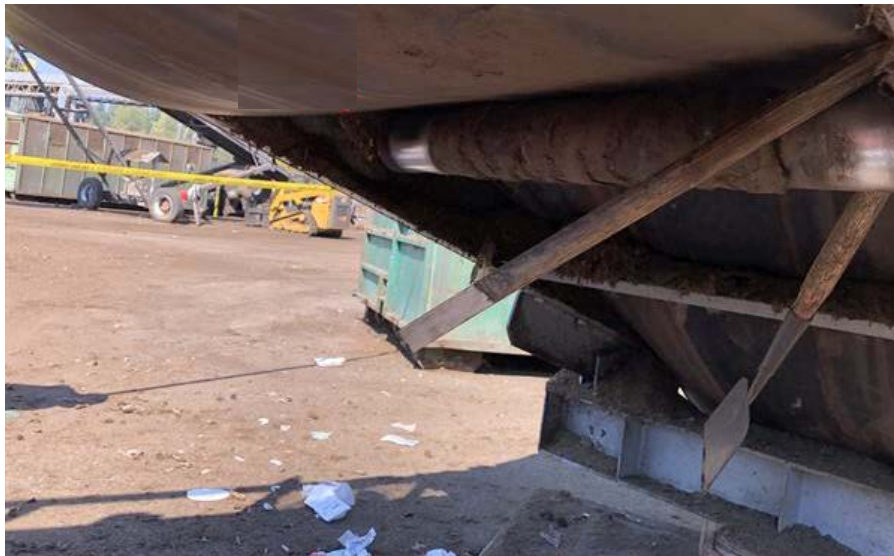
When the assistant went to get the leaf blower, the lead walked toward the tail end of the stacker involved in the incident. No one saw the lead walk under the stacker. About thirty seconds later the assistant heard the stacker shut down. He yelled out to the lead but got no response. He then walked to the stacker about 20 feet away and saw the lead's head, left arm and shoulder caught between its return idler roller and conveyor belt. The lead's sweatshirt hood was entangled in the roller, and his feet were dangling off the ground. A spade metal scraper with a 5-foot wooden handle was also caught between the roller and belt and pressed against the lead's throat (photo 11).

**Photo 11:** Conveyor belt and unguarded steel return idler roller with metal spade scraper tool that was pressed against the lead operator's throat. Responding workers cut the belt and broke the tool's wooden handle to release the operator. Photo taken after incident.
