Groundskeeper Crushed when UTV Tips Over

REPORT #: 71-228-2022s

REPORT DATE: October 14, 2022

FATALITY NARRATIVE

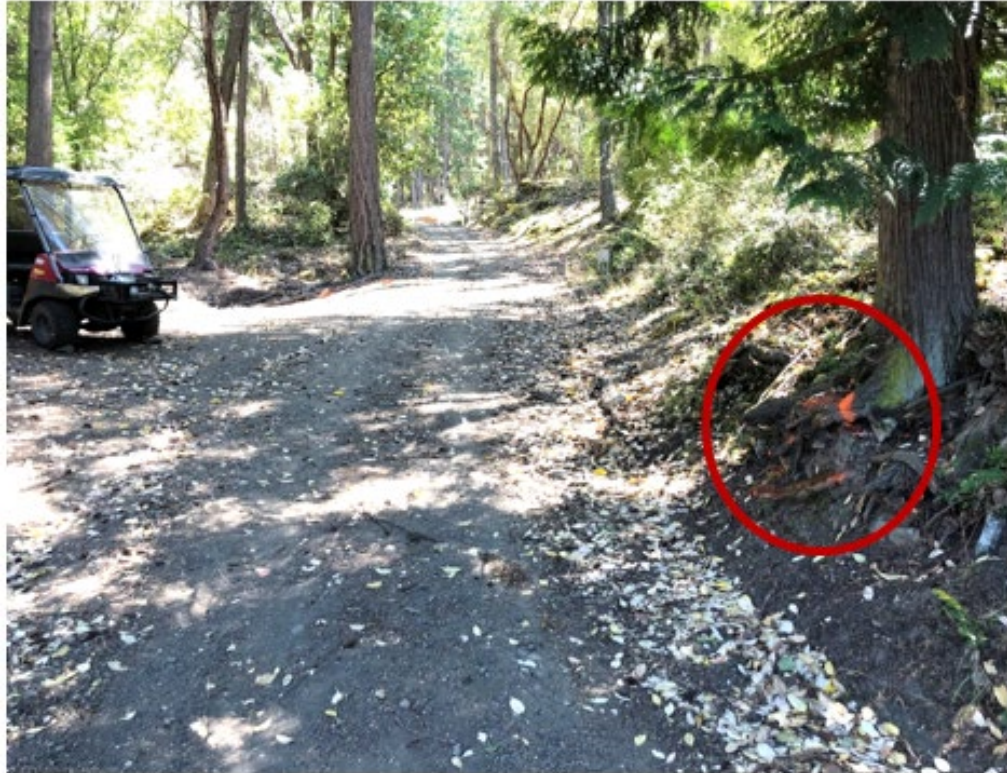
As she drove the UTV downhill along the access road, the UTV swerved, and the front driver's side tire hit a tree root on the roadside embankment. This resulted in the UTV tipping over onto its passenger side.

Photo 1. Property access road along which the groundskeeper was operating the UTV. The UTV entered the road shown in the upper left of photo. The groundskeeper then drove it downhill along the road until it swerved and hit the tree root ball on the embankment (indicated by orange paint) and the UTV tipped over.

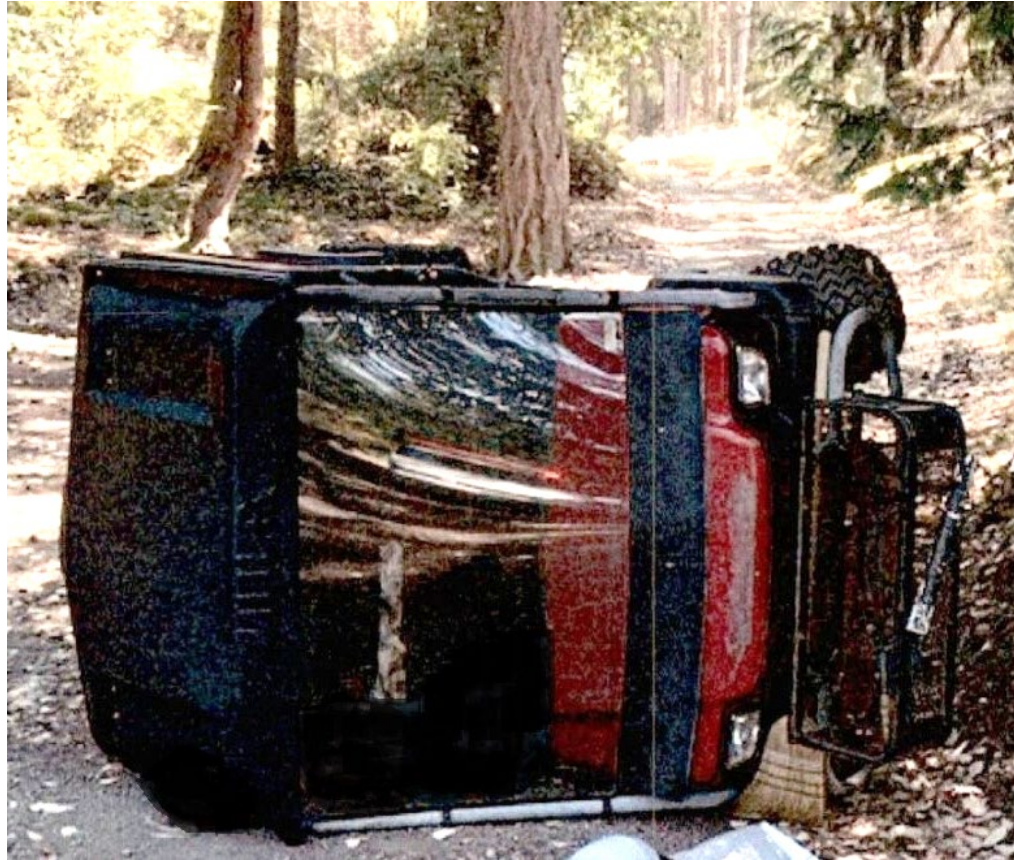
The groundskeeper, unrestrained by a seatbelt, was ejected from her seat, pinned and crushed under the UTV's frame/rollover protective structure (ROPS). She died at the scene.

Photo 2. Incident scene showing UTV overturned on its passenger side. The unrestrained groundskeeper was ejected from her seat, pinned and crushed under the cab frame/rollover protective structure (ROPS).

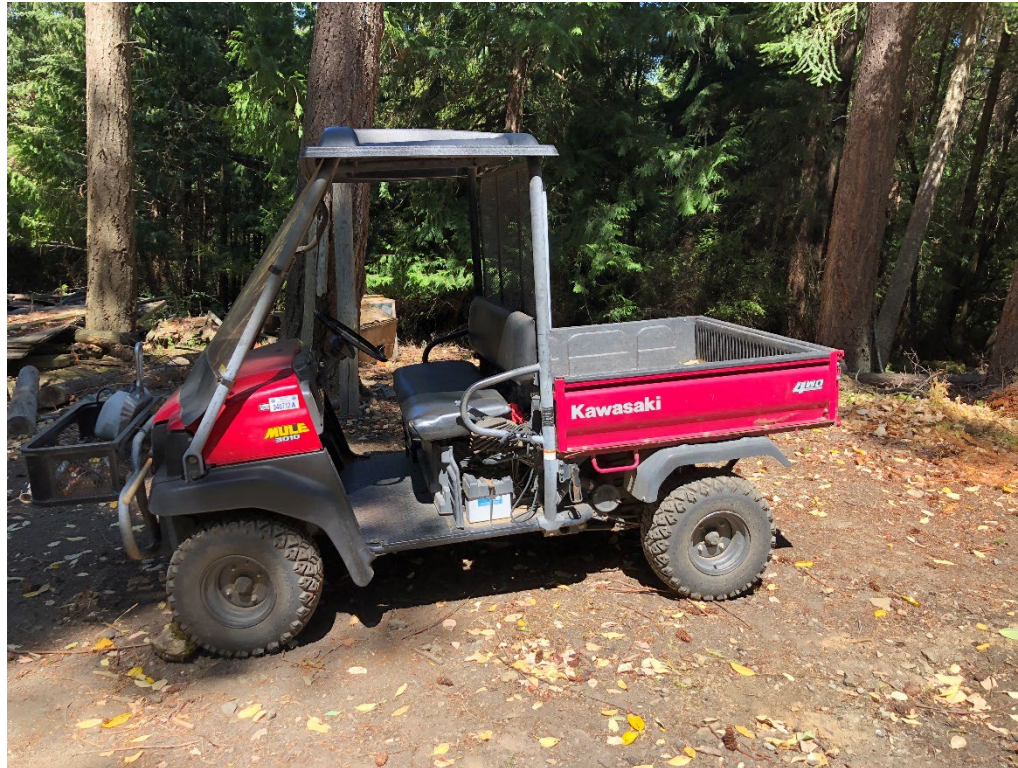
- The incident UTV's manufacturer provided lap-style seatbelts had been removed shortly after it had been purchased by the employer in 2007.
- The groundskeeper had been operating the UTV in order to carry out various tasks on the property without a seatbelt for 14 years.

Photo 3. Incident UTV with seatbelts removed.

- Do not remove or alter manufacturer provided safety features.
- Do a job hazard analysis (JHA) of tasks involving UTV vehicles as part of an APP. Workers should be involved in creating the JHA.
- Ensure that workers:
 - Always wear a seatbelt when operating or riding in a UTV.
 - Are trained and follow manufacturer guidelines for safe operation of equipment.

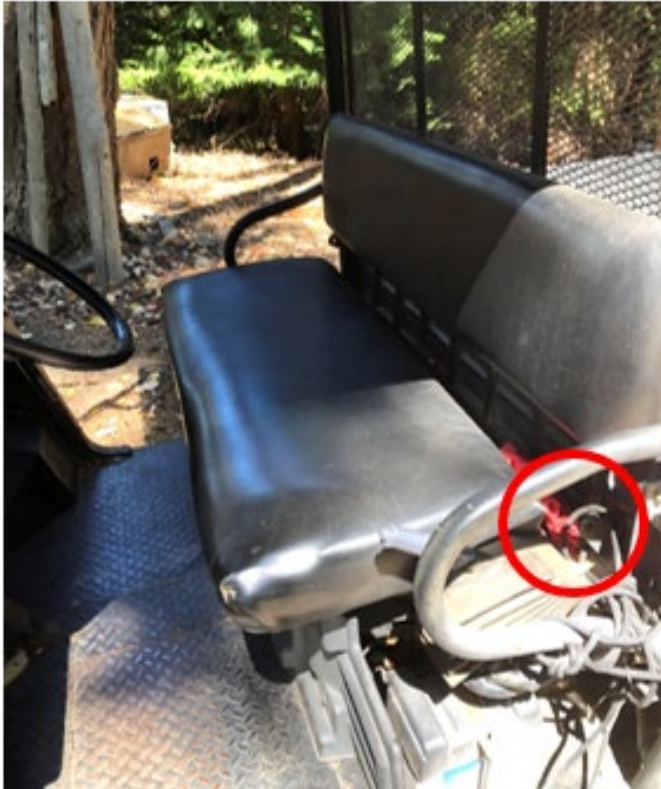
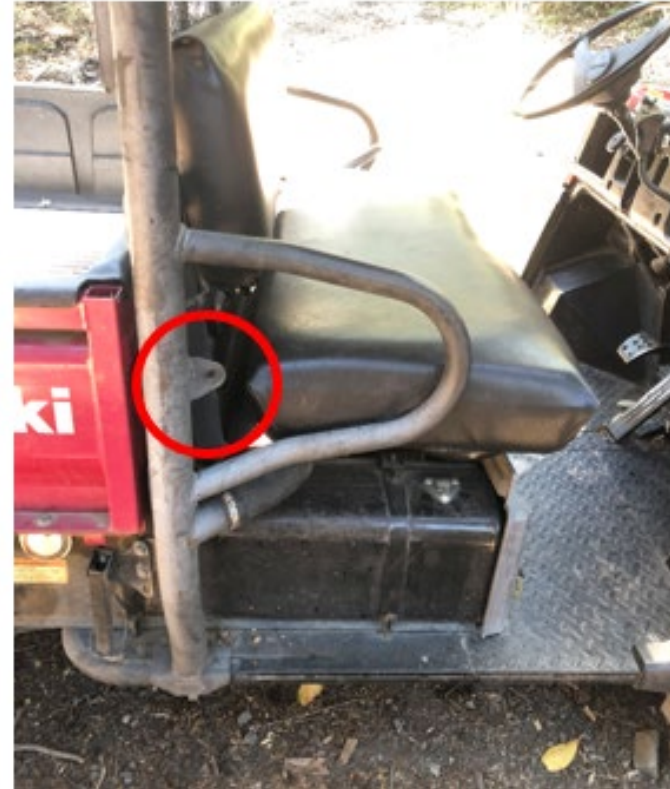
Photos 4 and 5. Incident UTV from which lap-style seatbelts had been removed by employees. Photo on the left shows the bolt hole for the seatbelt for the driver's side. The photo on the right shows the seatbelt bolt hole for the passenger side.
