INCIDENT FACTS

71-186-2019

Two story single-family house under construction

Framer Setting Roof Trusses Falls 20 Feet

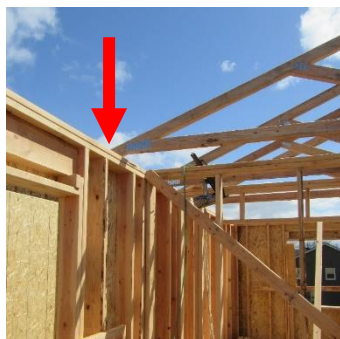
Interior view of house. The arrow points to where the framer was likely standing when he fell.

State investigators found that the framer fell 20 feet from the house's six-inch-wide top plate. He was not using fall protection. Investigators also found that the employer did not have a written fall protection work plan; workers did not understand fall protection requirements; the accident prevention program did not address job-specific safety; a safety walk-around was not done; and the framer did not receive a safety orientation.

- Do not perform work while standing on top plates.
- Use interior or exterior mounted bracket scaffolds, boom or scissor lifts, and platform ladders or stepladders.

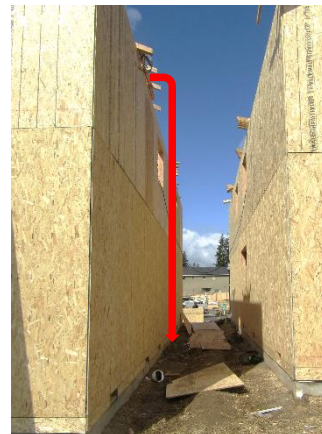
Location where framer fell.
