# **SERVICES** FATALITY NARRATIVE

#### Window Cleaner Falls 50 Feet

REPORT #: 71-181-2019s

REPORT DATE: May 1, 2019

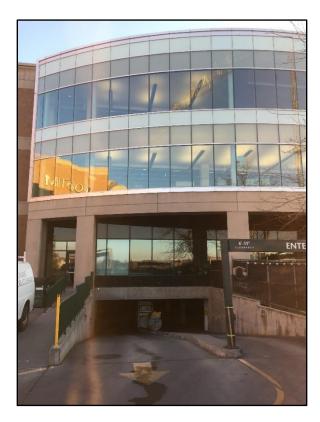
The window cleaner fell from the top of the library building as he positioned himself over the edge of the roof's parapet.

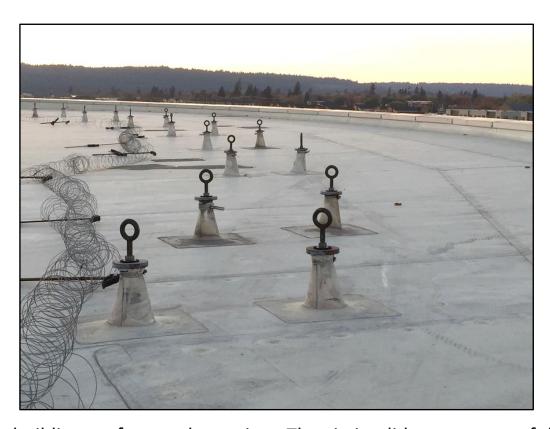
In addition, he did not tie back the roof rig to any of the certified rooftop anchorage points available nearby.

Library building rooftop anchor points. The victim did not use any of these.

Make sure that single-point adjustable Boatswain's chair suspended scaffolds have tiebacks that are equivalent in strength to the scaffold suspension ropes and that the tiebacks are secured to a structurally sound anchorage on the building.

See WAC 296-874-30008

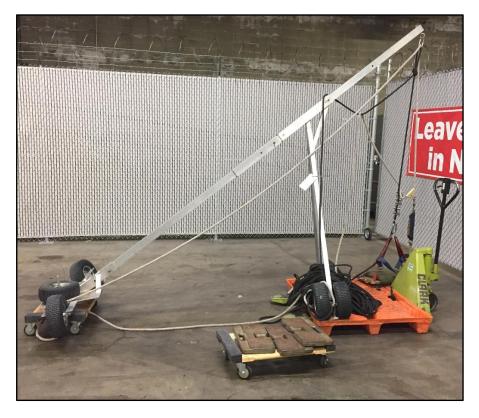
He was wearing a fall protection harness with a lifeline that he tied off to the back of the roof rig instead of one of the anchor points.

Incident roof rig. The white line is the lifeline which the window cleaner tied-off to the back of the roller rig as shown in the photo. The black line is the descent line for his boatswain's chair.

Make sure that workers suspended from a boatswain's chair or rope decent system use an independent fall arrest system where the fall arrest anchorage is separate from the suspension system anchorage.

See WAC 296-878-15025(3)

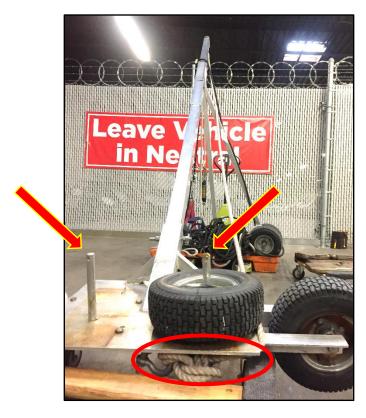
He seated himself in the boatswain's chair and positioned himself over the edge of the roof's parapet. The roof rig was designed to have counterweights on it, but he had not attached them—they were found on the rooftop after the incident.

Without the counterweights in place and the roof rig not tied back, the weight of the window cleaner pulled the roof rig off the roof and he and the rig fell 50 feet, landing on asphalt.

The red circle shows where the window cleaner tied off his lifeline on the rear of the roller rig. Arrows show where the counterweights should have been attached.

You must leave counterweights attached to the outrigger beams until after the scaffold has been disassembled.

See WAC 296-874-30006(3)
