#### **Operator Dies When Orchard Tractor Rolls Down Embankment**

**REPORT #: 71-191-2020s**

**REPORT DATE:** February 1, 2020

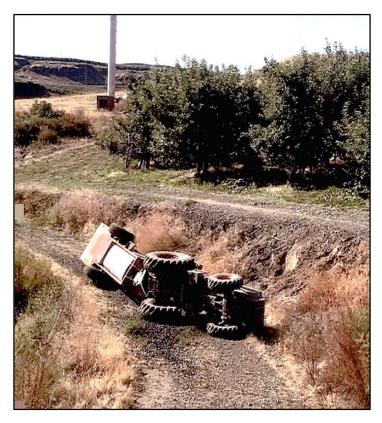
Photo 1. Overturned tractor with sprayer at bottom of embankment.

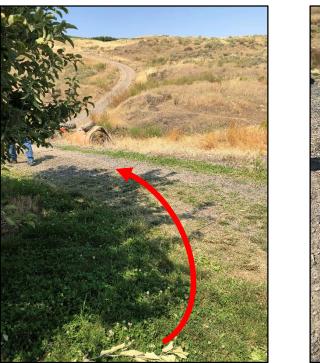
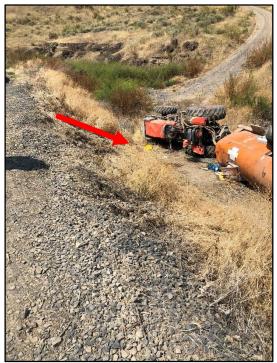
- The operator had most likely misjudged the turning distance of the tractor and steered too wide as he came out of the row onto the road.
- The weight of the tractor and sprayer caused the edge of the road to crumble, leading it to roll down the embankment.
- In addition, the lighting near daybreak may have affected his visibility of the embankment at the edge of the road.

**Photo 2 & 3.** Approximate path of the tractor as it exited the row of apple trees, went along the service road, and where its front right tire went over the side of the embankment, causing the tractor to roll down the 6-foot embankment. Note the loose gravel and unclear border between road and embankment.

- Employers should mark edges of hazardous embankments with visual cues, such as elevated reflective stakes, fencing, or permanent barriers to alert equipment operators.
- Workers should be trained to use extreme caution when using tractors on or near sloped terrain, ditches, or embankments.

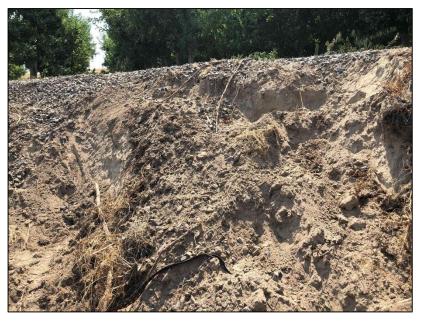
**Photo 4.** The area of the embankment that crumbled under the tractor's weight.

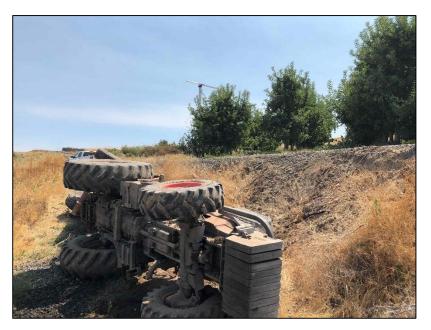
**Photo 5.** The overturned tractor and sprayer at the bottom of the 6-foot embankment.
