FATALITY INVESTIGATION REPORT

REPORT #: 52-48-2021

Operator Falls from Boom Lift while Tree Trimming

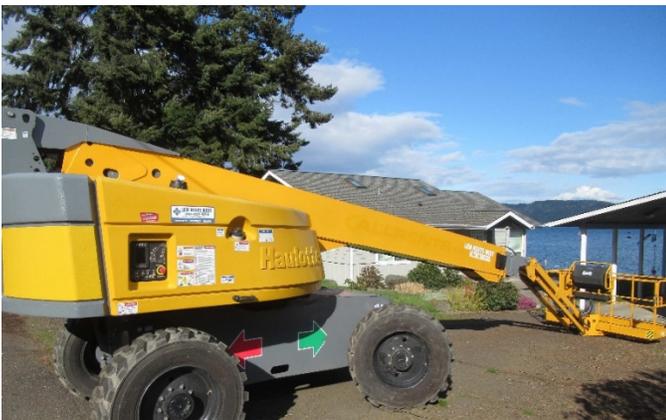
Photo 1: Incident scene driveway of residence with boom lift that workers were using to limb trees.

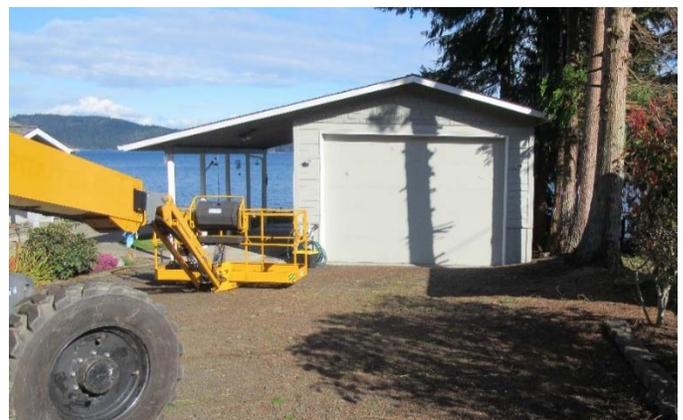
Photo 2: Incident scene driveway and garage of residence. Workers were in the boom lift basket limbing trees on the right side of the garage.

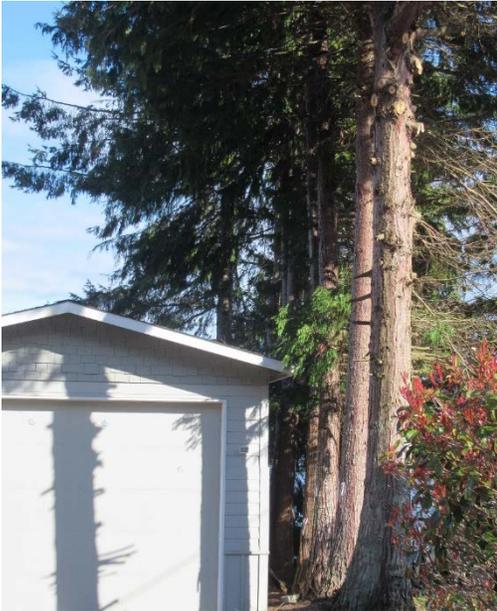
Photo 3: Incident scene garage of residence that hired the employer to remove the trees. Workers were in the process of limbing the tree on the right side of the garage in preparation to remove the tree when the operator fell from the basket.

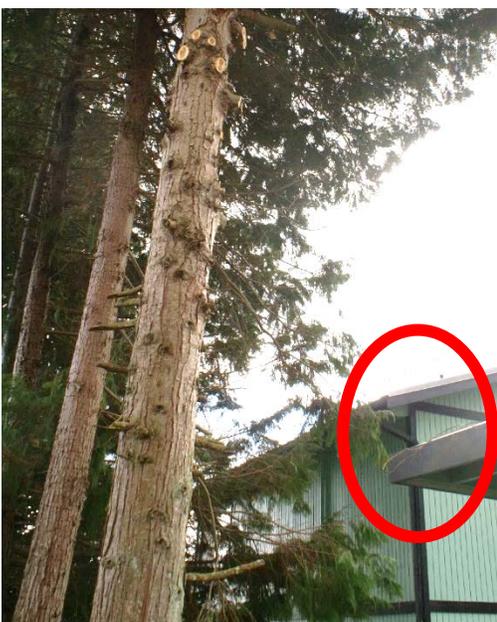
The area where they needed to locate the boom lift basket to work was between the garage of the residence whose owner contracted the job and the home and shed of the adjacent residence. The shed was 8 feet tall and located in front of the garage (see photo 4). This meant they would need to position the boom lift basket above the garage and the shed in order to limb the trees.

Photo 4: Tree that workers were in the process of limbing. The building on the right side of the tree is the adjacent residence. The roof of a small shed can be seen in the foreground (circled). The limb scars indicate that some of the limbs were several inches in diameter. Note the amount of space between the tree and the structures that would have allowed the crew to rig and lower cut branches to the ground.

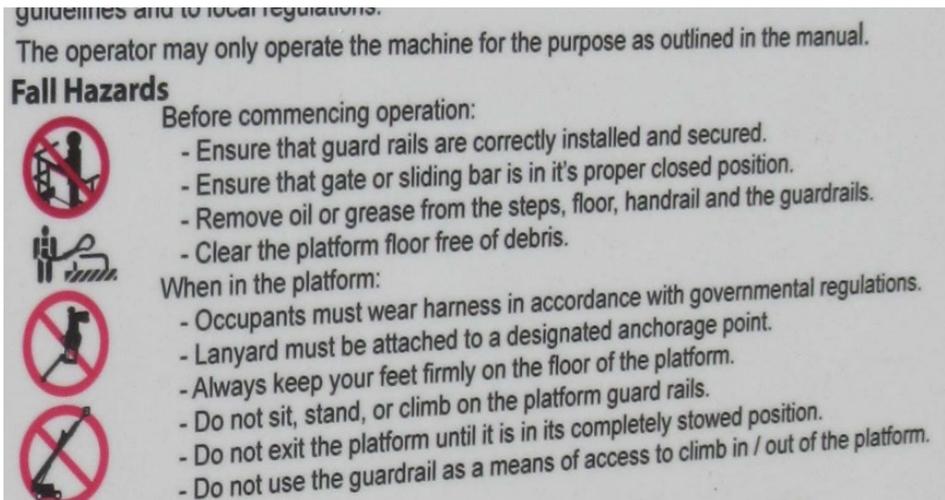
Before the crew started the job, they did not have a meeting to discuss the job in general or any task-specific hazards they may encounter. They did not review the boom lift operator's manual or manufacturer's safety precautions (see photo 5) before operating the boom lift. The employer brought the personal fall protection equipment, but he did not communicate to the workers that they should wear them while working in the basket. The coworker stated that they did not wear the fall protection because they thought it got in the way of their work.

Photo 5: Photo of “Fall Hazards” section of the warning sign affixed next to the control panel in the boom lift basket. The sign explicitly states that when in the platform, occupants must wear a harness and its lanyard must be attached to a designated anchor point.

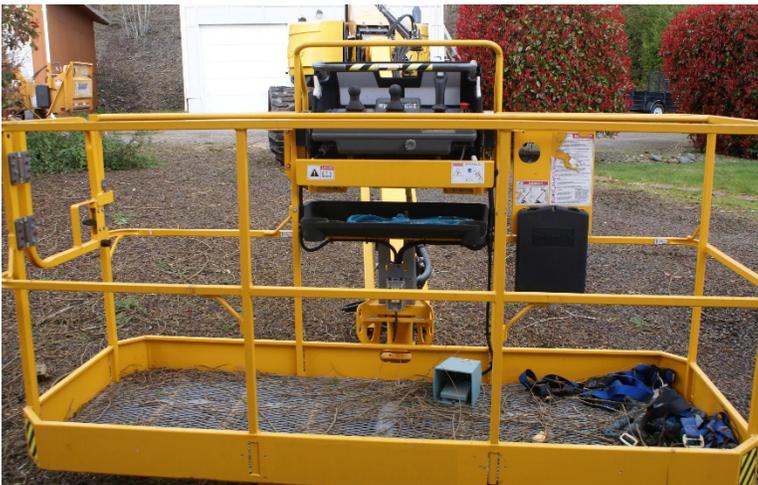
Shortly after arriving on site, the operator and his coworker entered the basket (see photo 6). The operator controlled the boom lift from the basket and elevated it to approximately 20 feet above the ground where they could reach the lower limbs of the tree. The bottom of the basket was approximately 12 feet above the roof of the shed. They decided they needed to pull the cut branches into the basket to keep them from falling and damaging the roof of the garage and the shed. The company owner remained on the ground to operate the chipper.

Photo 6: View of front of boom lift basket. The basket had a capacity rating for two workers or a maximum of 500 lbs.

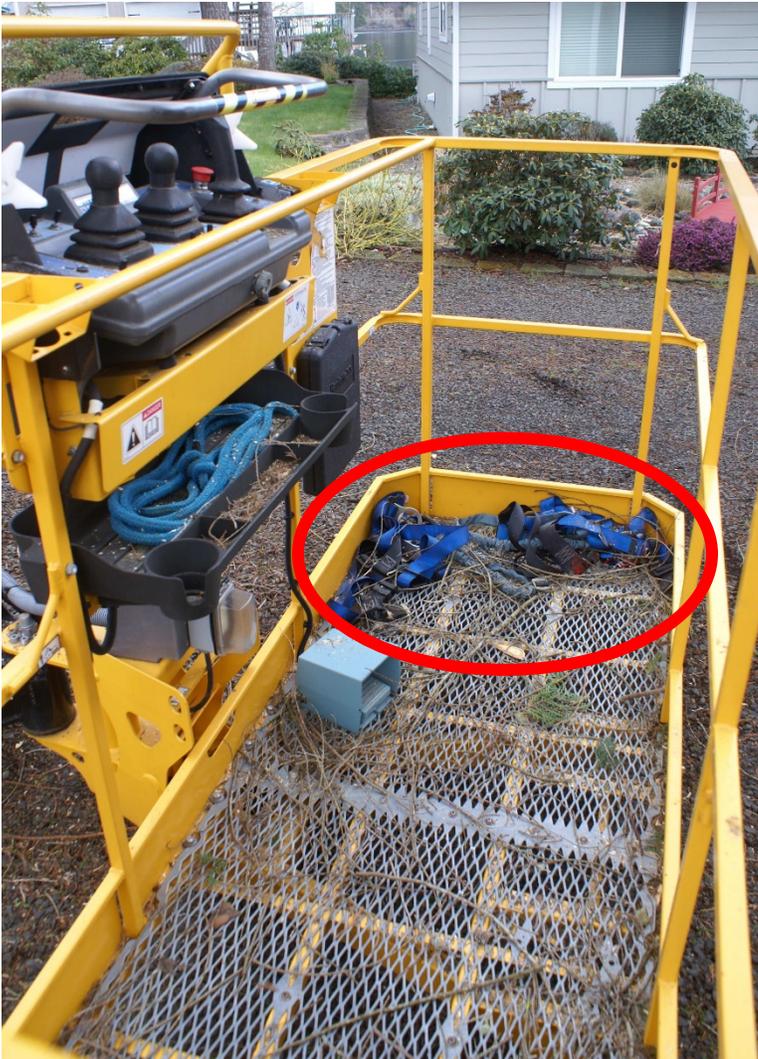
They were wearing hard hats, safety glasses, and safety boots so there was an awareness of and attention to safety hazards. It is unknown if they were using any other safety equipment at the time of the incident. They were not wearing their fall protection harnesses even though they were in the basket (see photo 7).

Photo 7: The two rented fall protection harnesses in the boom lift basket (circled). Also pictured are the control panel and the foot pedal that was required to be depressed in order to operate the basket.

Recommendation: Ensure that workers always wear personal fall protection when they are exposed to fall hazards while working in boom lifts.

There is an explicit WAC¹⁰ and OSHA standard¹¹ that requires fall protection for workers in boom lift baskets. The requirement is not specific to the tree-care industry but applies to all workers on boom-supported elevating work platforms. It states that employers must make sure workers wear a full body harness and lanyard fixed to manufacturer provided and approved anchorage points.

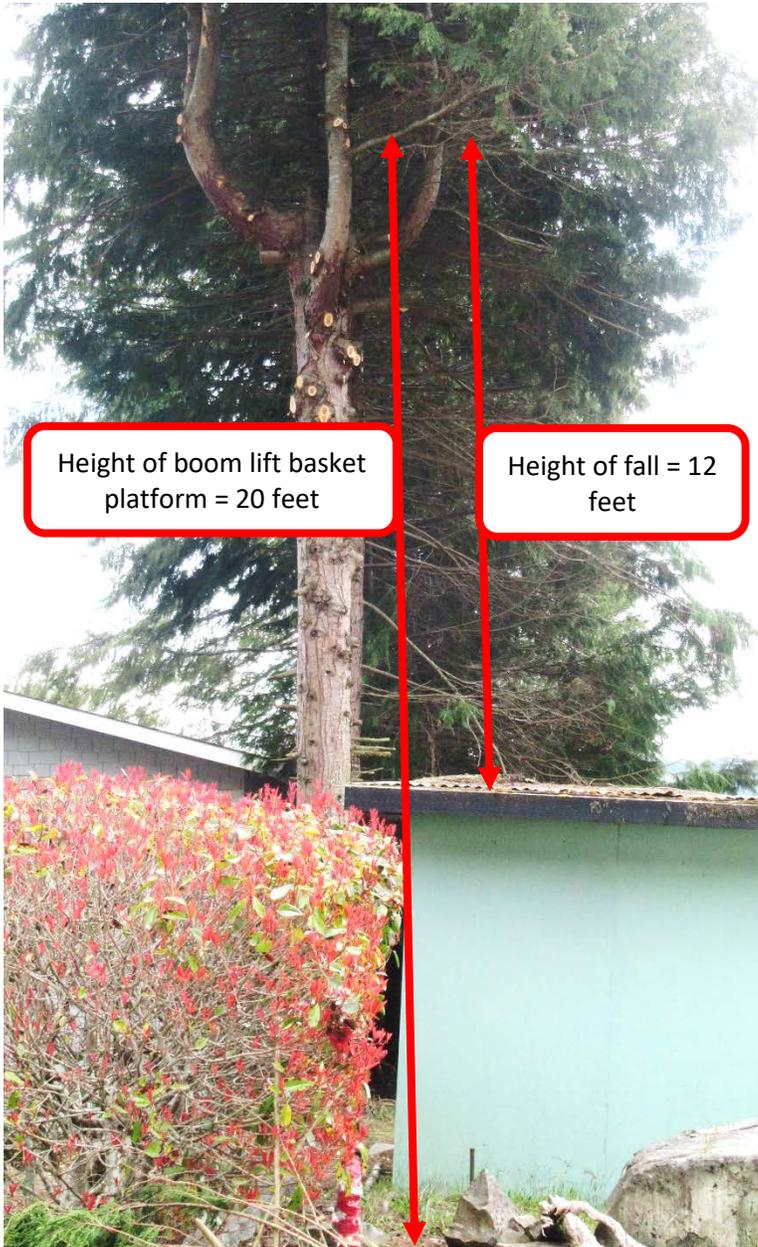
Photo 9: Incident scene tree that workers were limbing and shed that operator fell onto. Red arrows show approximate location and height of boom lift basket and operator's operator fall.

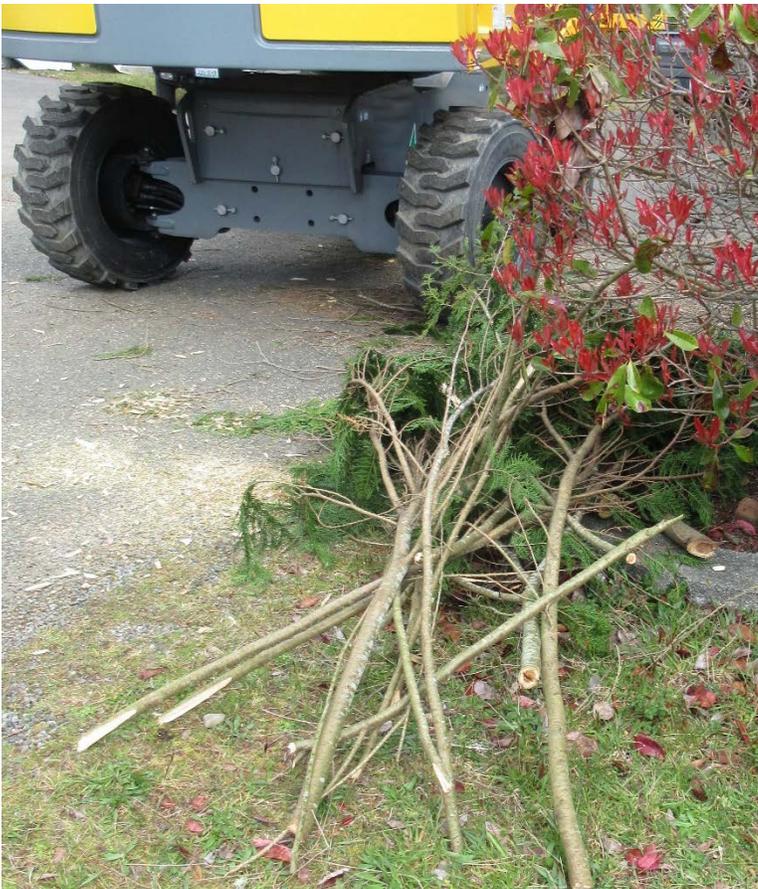
The remains of the cut limbs on the tree indicate that some of the limbs they had cut may have been several inches in diameter. This may have made the limbs difficult to bring into the basket. Some of the smaller limbs can be seen in photo 10. There is no evidence that the boom lift basket moved or shifted prior to the operator falling.

Photo 10: Some of the smaller limbs that the workers collected into the boom lift basket.

In addition, employers should train workers to limit the amount of items brought into the basket and to keep the basket clear of trip hazards. By gathering cut branches into the basket, the workers may have created cramped conditions or trip hazards. ANSI Z133-2017 specifically states that aerial devices shall not be used as cranes or hoists to lift, support, or lower tree parts unless where designed by the manufacturer to do so.
