**INCIDENT FACTS**

71-215-2022

## Communication Tower Worker Falls 260 Feet

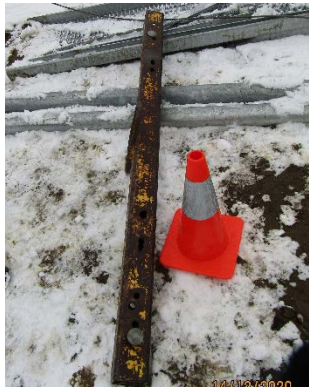
Gin pole jump plate used in the operation.

The crew was in the process of adding the final 20-foot section to the self-supporting tower. They were using a triangular lattice gin pole to “stack” the tower sections. They had just jumped, or raised, the gin pole into position in order to lift the final section. They used a jump plate to help lift and position the gin pole. The plate was a 6-foot long square steel tube with a steel loop welded in the center.

The climber was in the process of unbolting the plate so they could lower it to the ground. He removed the last bolt that secured the plate to the tower and then leaned back. When he did, he fell 260 feet to the ground. The climber did not connect either pelican hook of his fall arrest Y-lanyard to an anchor point on the tower. The plate was still attached to the winch line when it swung down and struck his coworker in the chest.

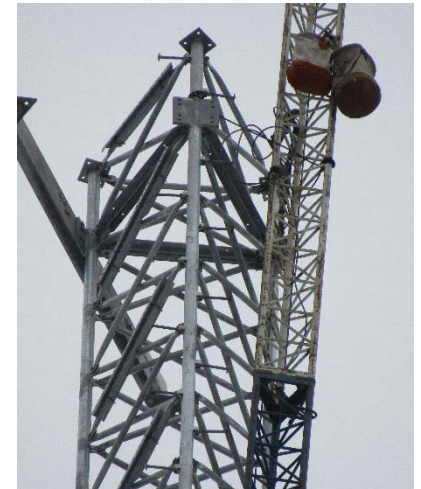
A 24-year-old tower climber fell 260 feet from a communication tower under construction.

Tower from which the climber fell with the smaller triangular gin pole suspended in the front.

- Establish and maintain a communication system among all workers on site and ensure workers on the tower communicate and confirm step-by-step procedures anytime they change positions or perform tasks that require them to detach and reattach their fall arrest systems.
- Frequently reinforce training on proper use of fall protection equipment with emphasis on always maintaining one point of attachment and reattaching immediately after detaching so that workers maintain 100% tie-off while on the tower.
