INCIDENT FACTS

71-232-2023

Farm Worker's Hand Mangled in Hop Harvester

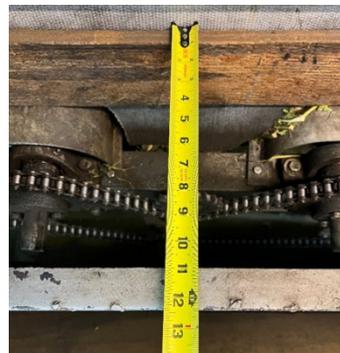
Close up of 11-inch unguarded gap above chain and sprocket drive where worker reached in and mangled his hand.

- The hop harvester's arm picker had a horizontal steel mesh guard that was too low to prevent someone from reaching over into an 11-inch unguarded gap above the chain and sprocket drive.
- The worker did not follow his training from the employer to notify a lead mechanic, who was nearby, to perform lockout/tagout (LOTO) procedure requirements before cleaning out debris.

- Unless guarded by location, all sprocket wheels and chains must be enclosed. See [WAC 296-307-28030\(3\)](#)

- If a machine cannot be guarded by distance and location, protect workers from hazards created by rotating or revolving parts by using one or more safeguarding methods. Make sure guards are:

- Regularly inspected and maintained, or replaced if not in serviceable condition.
- Make sure guards protect workers by preventing hands or other body parts from reaching through, over, under, or around the guard into the hazard area; and preventing objects or debris from falling onto or being thrown towards a worker.

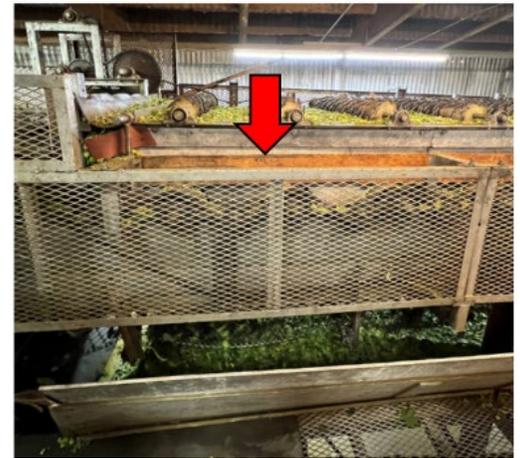
Hop harvester machine in which worker mangled his hand trying to remove debris. Arrow shows gap above horizontal steel mesh guard and chain and sprocket drive where worker reached in. Note machine's lack of hazard warning and LOTO signage.

- Install warning signs on and near machines to remind workers of operating hazards and LOTO requirements written in a language all workers can understand.
