LANDSCAPING SERVICES FATALITY NARRATIVE

Tree Trimmer Dies when Tree Removal Rigging Fails

REPORT #: 71-234-2023s

REPORT DATE: February 27, 2023

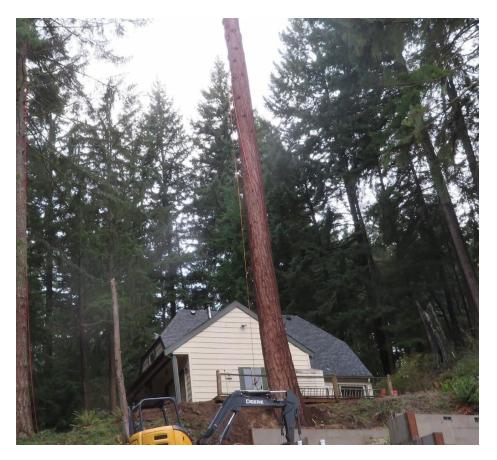
Photo 1. The 127-foot fir tree the crew was rigging and lowering in sections to the ground by rope.

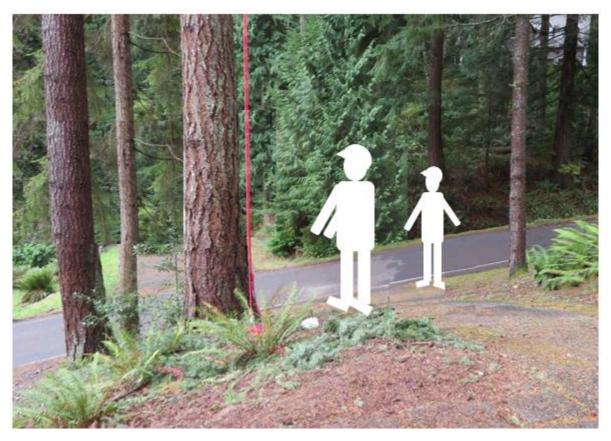
The climber cut off a 330-pound section from the tree. It fell about one foot before the rope holding it became taut. The weight of the section caused shock loading on the rope, which lifted the tree trimmer and the other worker off the ground.

The workers struggled to control the section as its momentum pulled them toward an embankment.

Photo 2. A post-incident recreation shows where the ground workers were positioned when they started lowering the tree section with a rope. The figure on the left is where the fatally injured worker was standing.

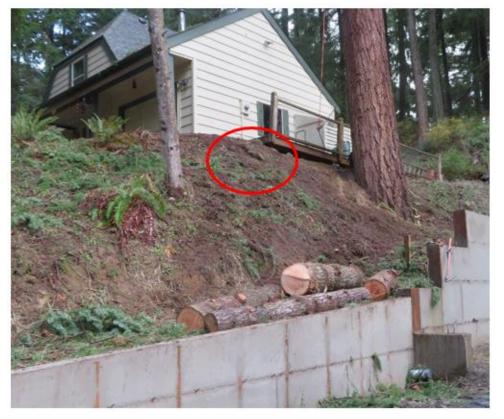
The tree trimmer lost his grip on the rope, stumbled, and fell backwards down the embankment, hitting his head on a rock.

Photo 3. Embankment down which the tree trimmer stumbled and fell backwards. The rock on which he hit his head is circled.

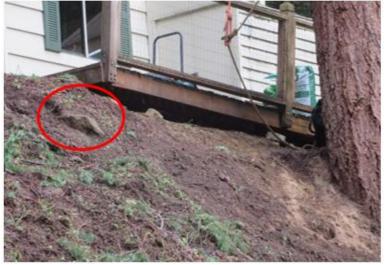
Photo 4. Close-up of rock on which the worker hit his head.

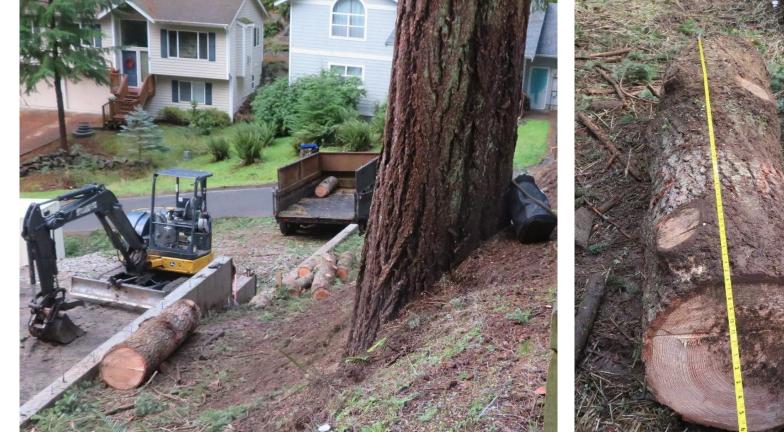
Photo 5. Incident scene with 330-pound section at bottom of embankment down which the worker fell.

Photo 6. The 330-pound, 6-foot long, 16-inch diameter section.
