# Freight Clerk Crushed by Trailer at Store Loading Dock

**REPORT #:** 71-235-2023s

**REPORT DATE:** March 20, 2023

# FATALITY NARRATIVE

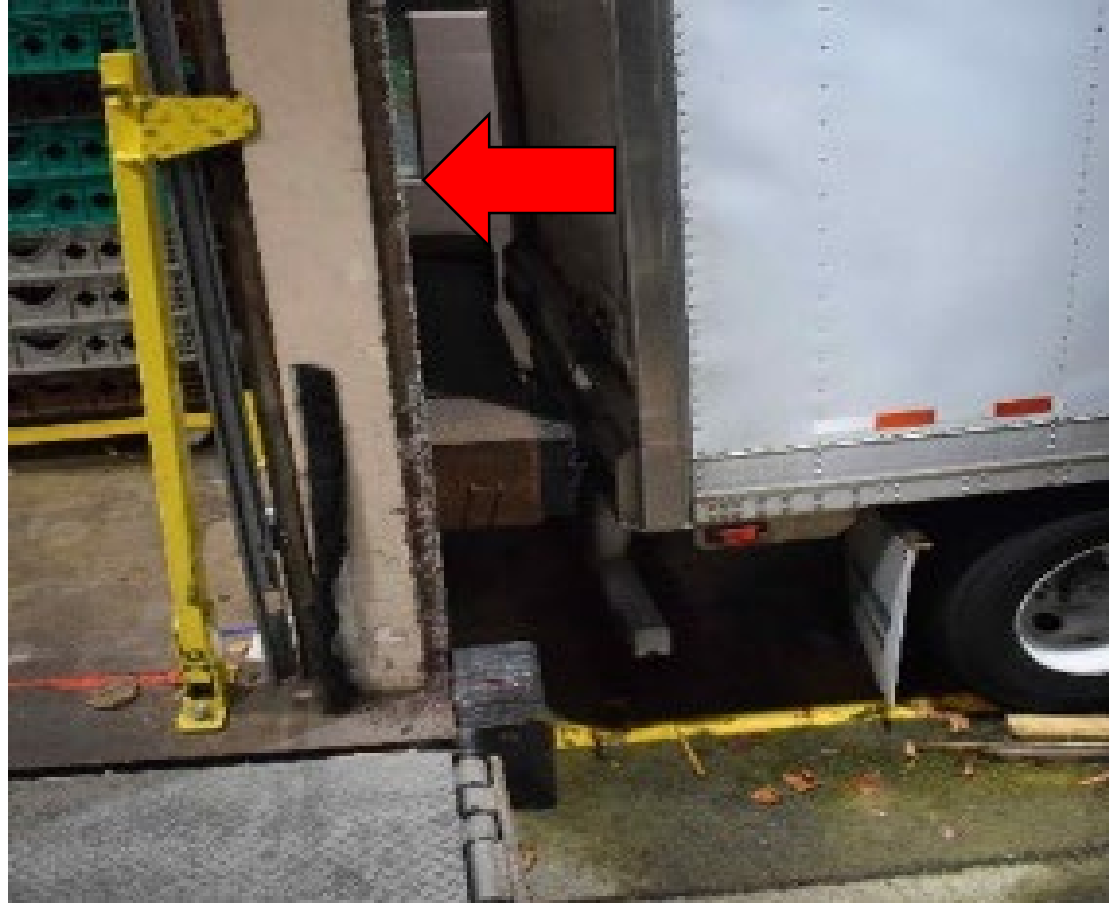
**Photo 1.** Arrow shows loading dock wall where the clerk was crushed by the trailer.

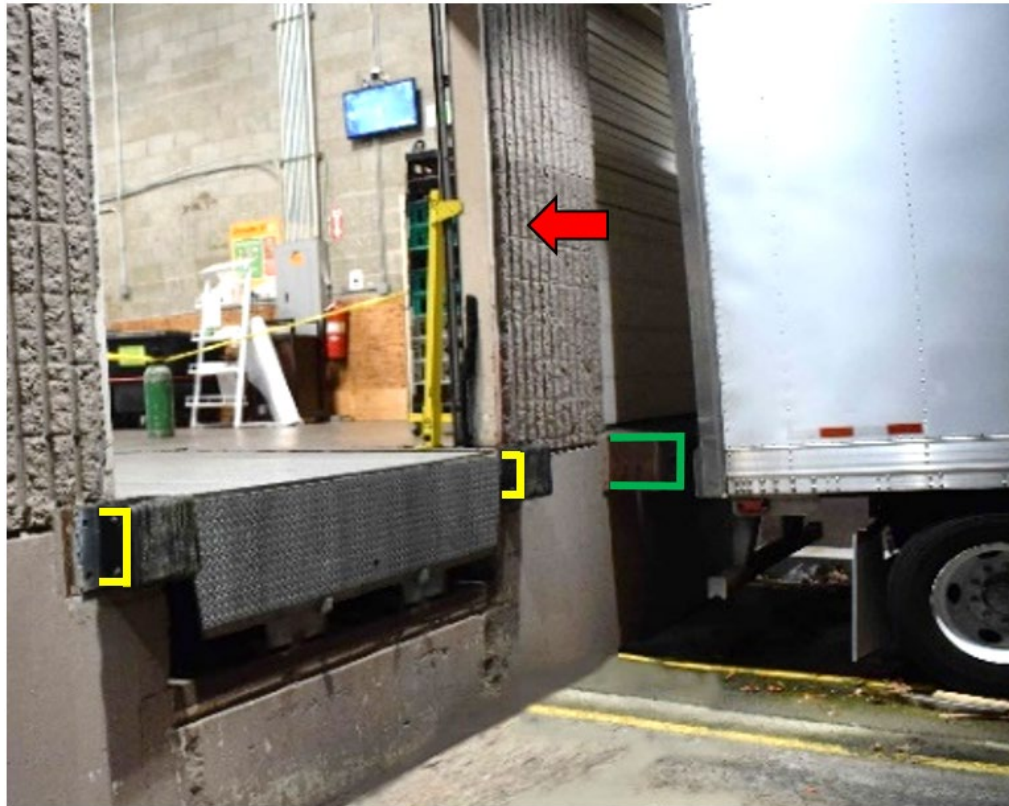
- The employer did not have loading dock safety policies, procedures, and training for workers.
- Workers routinely leaned out between loading dock walls and trailers to communicate with drivers.
- Trailer was parked away from dock bumpers and on a slight downgrade toward the loading bay.

**Photo 2.** Red arrow shows where clerk was crushed while leaning through a gap between the exterior wall and rear of the trailer. The gap resulted from the trailer being parked several inches away from the yellow-outlined 6-inch deep dock bumpers, possibly to make space to unfold the dock leveler lip. The green outlined dock bumpers at the loading bay on the right were larger.

- Construct or modify loading docks to have anti-crush safety zones by installing dock seals, barriers, and/or dock levelers designed to protect workers against vehicle crush hazards.
- Use traffic signal-style vehicle movement indicator lights at loading bays where the truck driver activates a red light to inform warehouse staff when it is safe to open bay doors, and warehouse staff activate a green light to inform the driver when the truck is ready to depart.

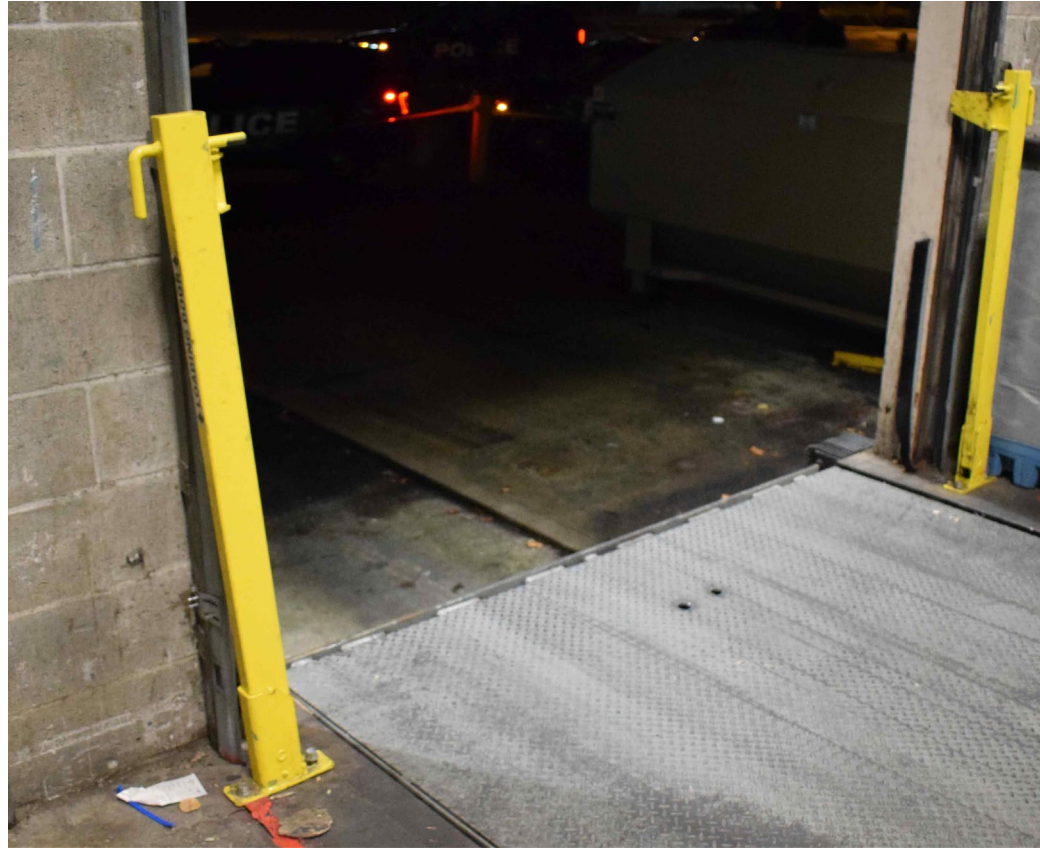
**Photo 3.** Interior view of loading dock where incident occurred. The injured clerk fell to the driveway outside after being crushed by the trailer against the exterior wall.

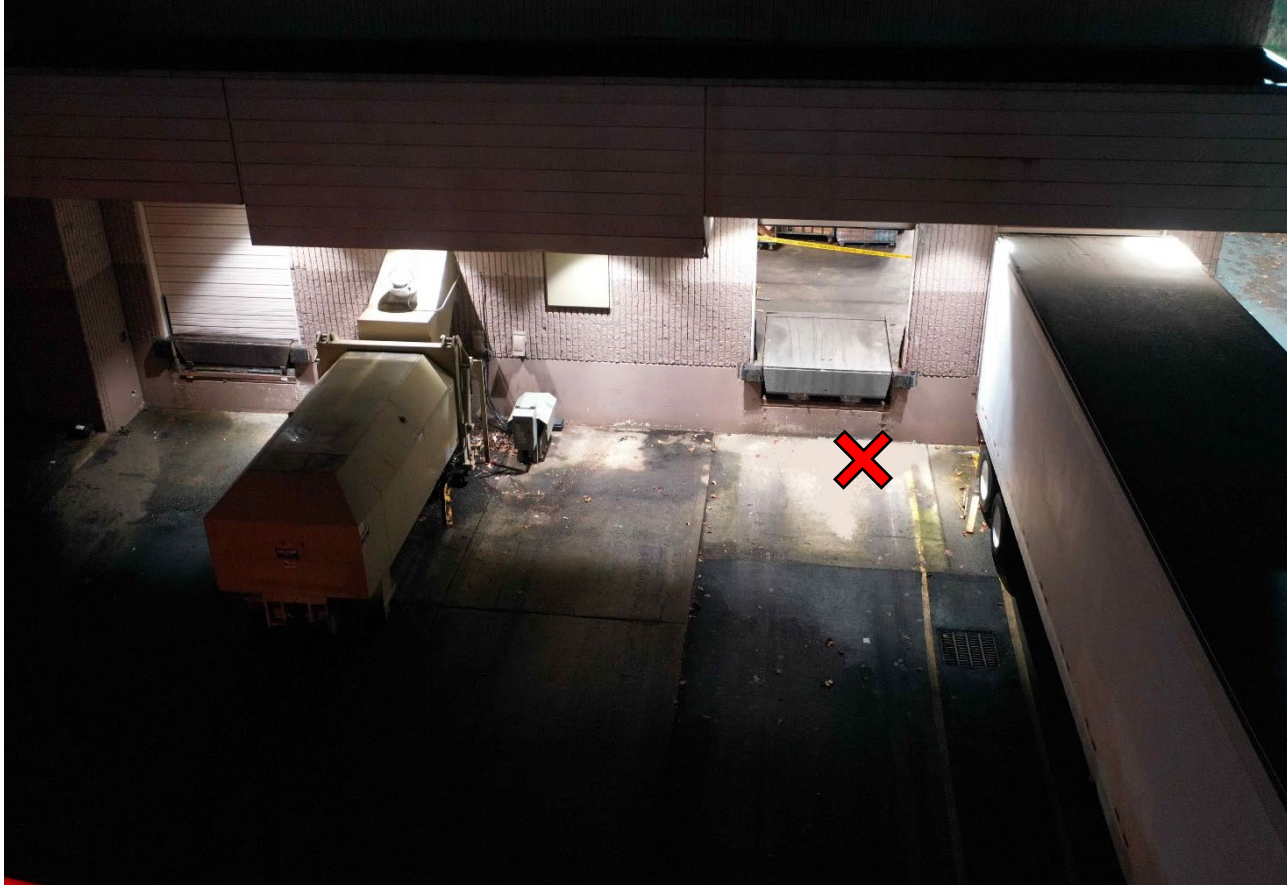
**Photo 4.** X shows where clerk fell after being crushed by trailer against loading dock wall on right side of open bay door.

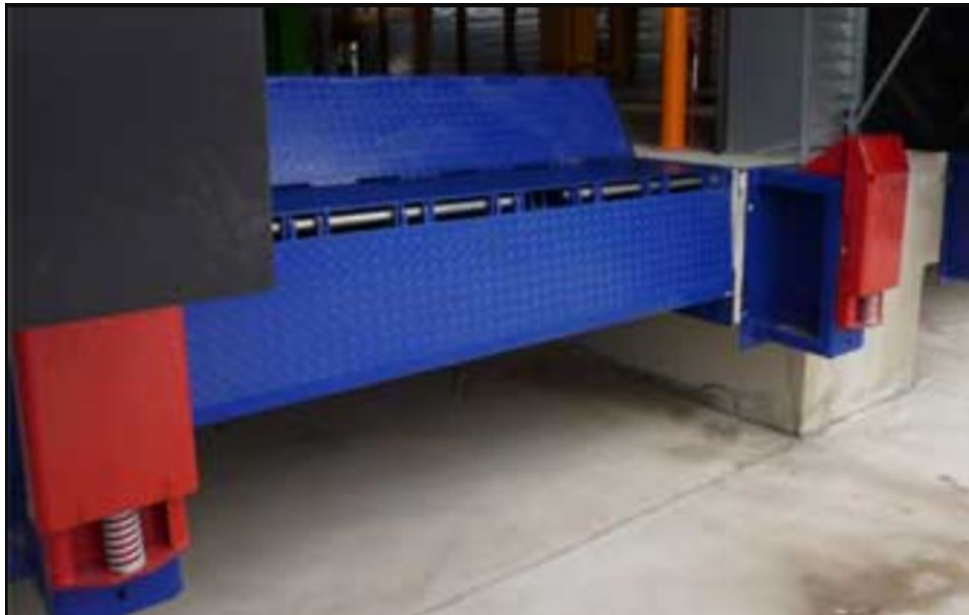
Photo 5: Loading dock leveler design with 20-inch anti-crush zone. Photo courtesy of EXPRESSO France SAS.

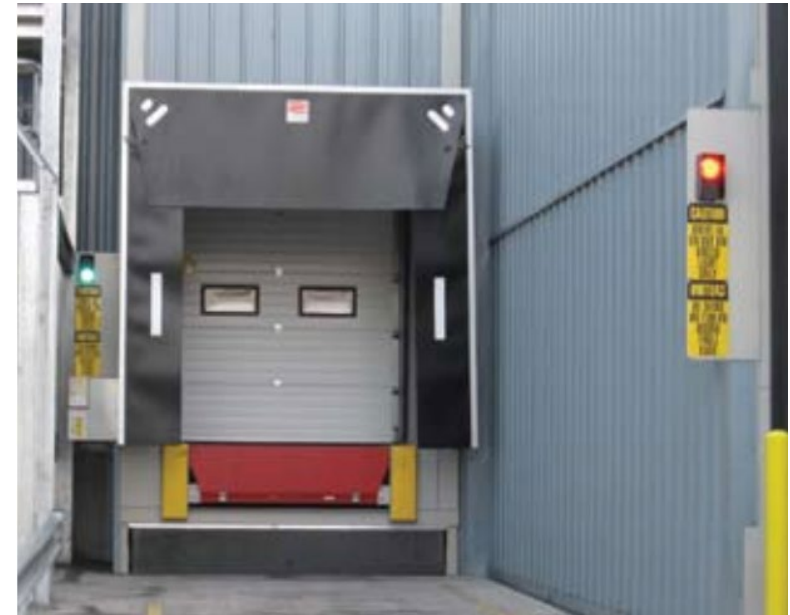
Photo 6: Loading dock with bay door seal, warning signs, and traffic signal-style vehicle movement indicator lights. Photo courtesy of Freight Transport Association.

- Require truck drivers to check in, leave keys, and wait in a designated safe place inside the shipping and receiving area where workers can talk with them away from hazards.
- Install signage at loading docks to warn workers and truck drivers about area hazards, such as pinch points.
