INCIDENT FACTS

71-258-2024

Framer Struck by Beam after Falling from Scissor Lift

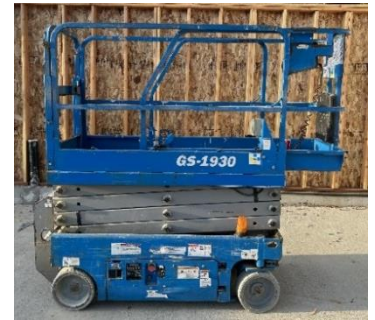
- The framer was not trained and authorized to use the lift. His co-worker also had limited knowledge of the hazards of placing and elevating materials on the platform guardrails.
- The employer and workers' supervisor knew of the lift manufacturer's warnings not to put materials on the guardrails. They were unaware of any safer material lifting equipment options.
- Lift operators and helpers at the site spoke Spanish and could not read the employer's job hazard assessment (JHA) for the installation task, which was written in English only. The company's accident prevention program (APP), including a scissor lift operator's checklist, was also in English only.

Scissor lift from incident.

- Use forklifts, cranes, or contractor material lifts to elevate construction materials, not scissor lifts.
- Develop and have supervisors enforce APP policies, JHAs, and standard operating procedures (SOPs), for safe use of elevating work platforms, such as scissor lifts.
- Have APP policies, JHAs, and training resources translated to the worker's preferred language.
- Train operators using the manufacturers' manual and highlight warnings not to put materials on guardrails or have them exceed the confines of the guardrails unless approved by the manufacturer.
- Discuss safe use of elevating work platforms at pre-job crew meetings and monthly safety meetings.
