## Framer Struck by Beam after Falling from Scissor Lift

**REPORT #:** 71-258-2024s

**REPORT DATE:** September 25, 2024

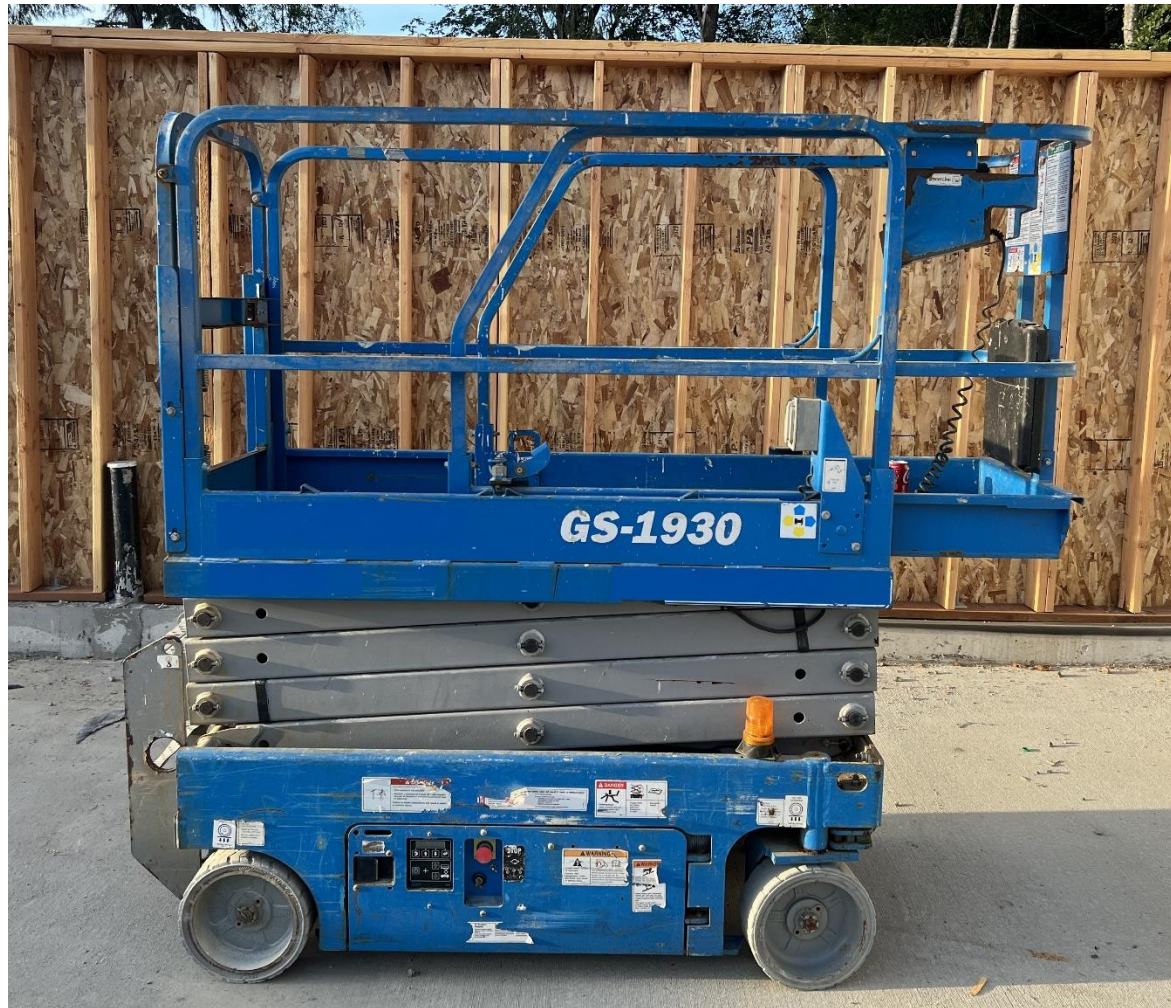
- The framer was not trained and authorized to use the lift. His co-worker also had limited knowledge of the hazards of placing and elevating materials on the platform guardrails.
- The employer and workers' supervisor knew of the lift manufacturer's warnings not to put materials on the guardrails. They were unaware of any safer material lifting equipment options.
- Lift operators and helpers at the site spoke Spanish and could not read the employer's job hazard assessment (JHA) for the installation task, which was written in English only. The company's accident prevention program (APP), including a scissor lift operator's checklist, was also in English only.

**Photo 1.** Scissor lift from incident.

- Use forklifts, cranes, or contractor material lifts to elevate construction materials, not scissor lifts.
- Develop and have supervisors enforce APP policies, JHAs, and standard operating procedures (SOPs), for safe use of elevating work platforms, such as scissor lifts.
- Have APP policies, JHAs, and training resources translated to the worker's preferred language.

- Train operators using the manufacturers' manual and highlight warnings not to put materials on guardrails or have them exceed the confines of the guardrails unless approved by the manufacturer.
- Discuss safe use of elevating work platforms at pre-job crew meetings and monthly safety meetings.

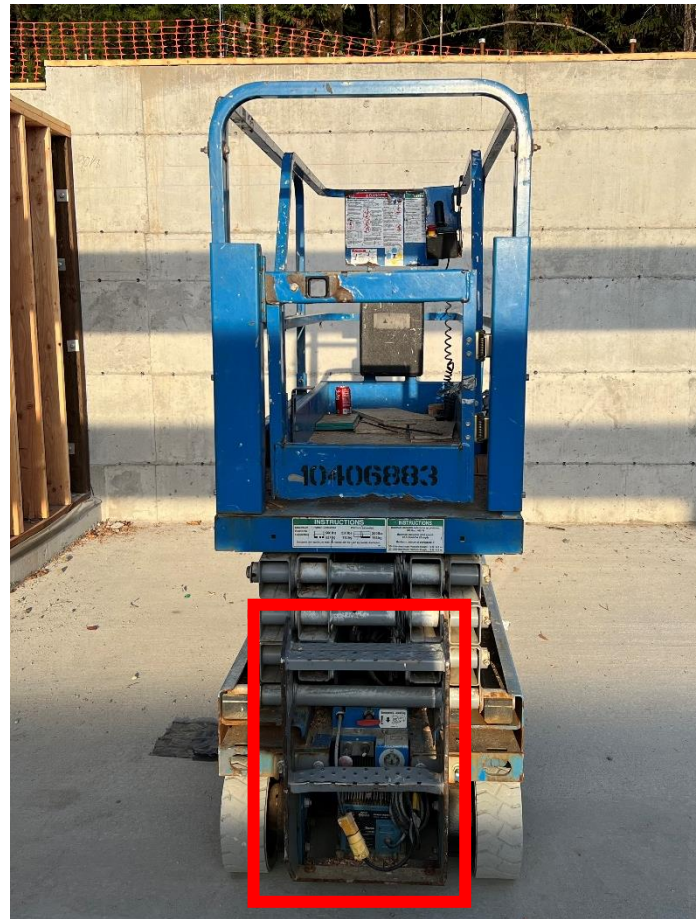
The workers were standing on the floor at opposite ends of the beam. The framer was out of view of his co-worker at the rear of the other lift. He unexpectedly went up the steps or climbed the side of his lift and fell on his back. The beam then fell off the lift on top of him. The co-worker saw the beam fall and ran over to help. He lifted the beam off the injured framer and notified two onsite superintendents who called 911 and began CPR. First responders came shortly after and pronounced the framer dead at the scene from severe head injuries.

**Photo 2.** Rear view of lift with steps shown in red outline.

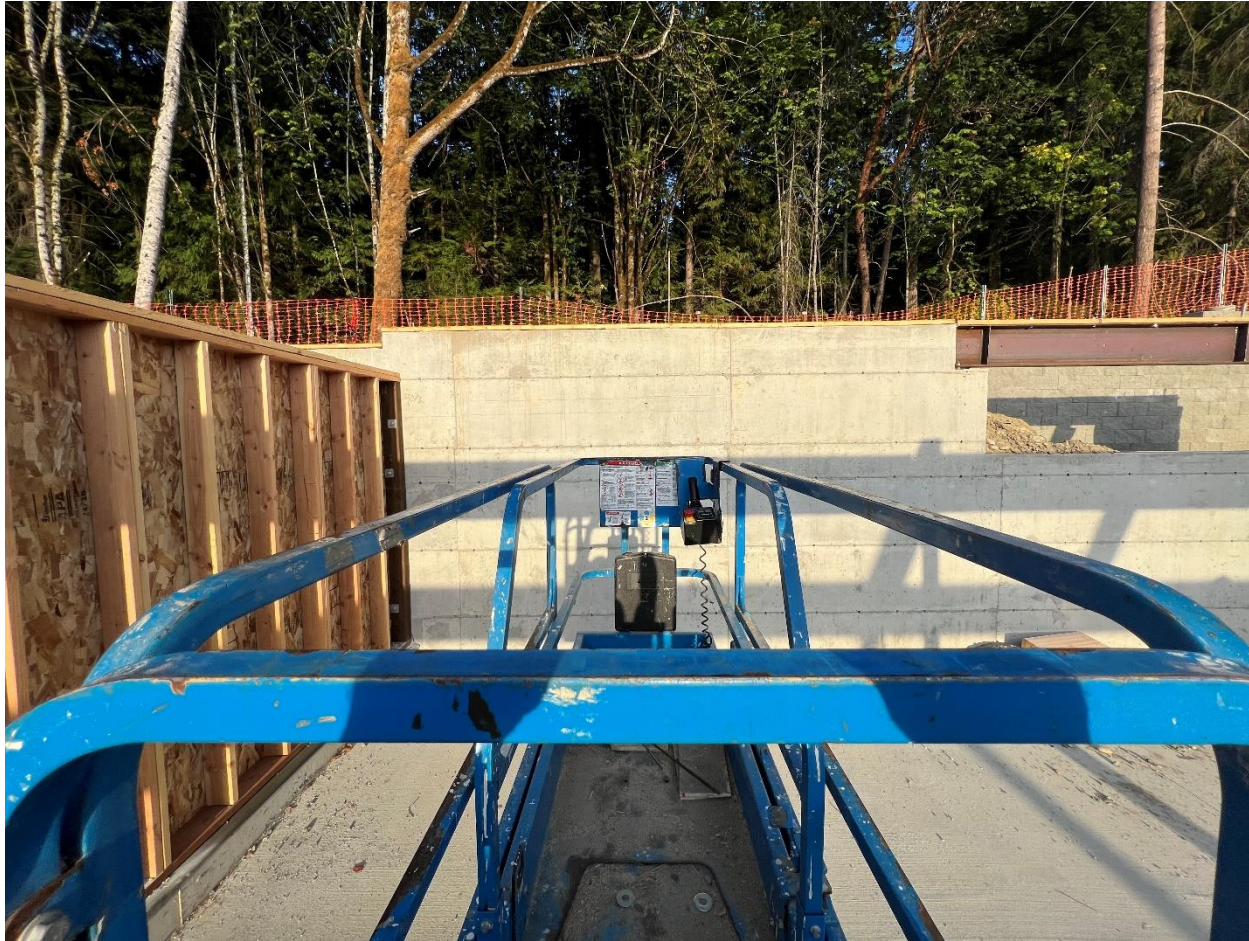
**Photo 3.** Top guardrail of lift platform.

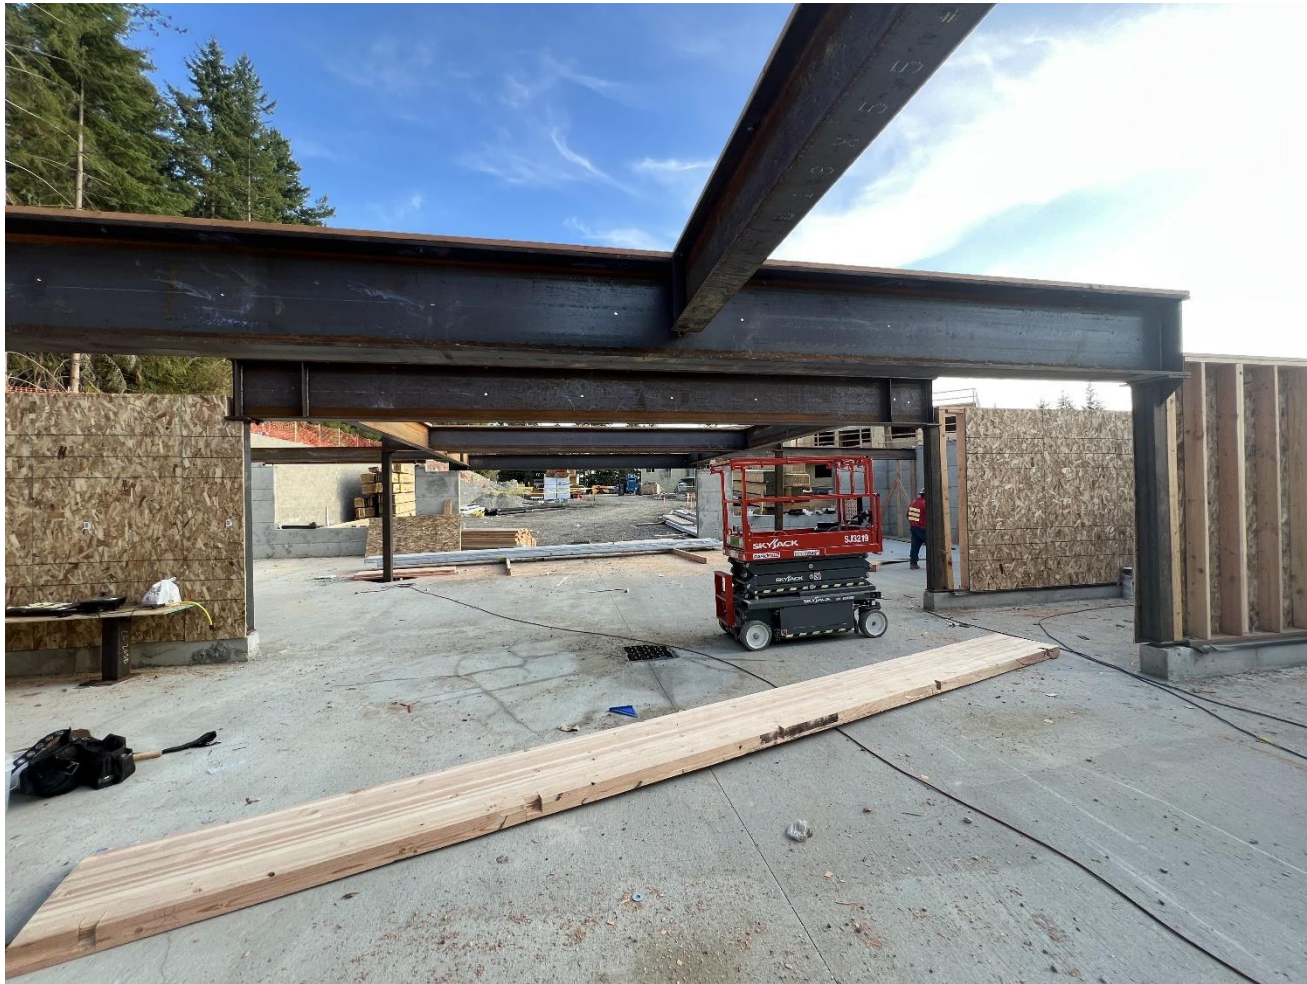
**Photo 4.** Fallen wooden beam and second lift at incident site.
