71-259-2024

## Truck Mechanic Struck by Trailer Air Suspension Spring

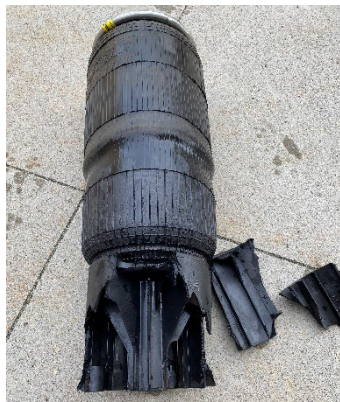
Air spring that struck mechanic.

The mechanic stayed under the trailer and gave the driver instructions while the spring was inflating. It was inflating for about three minutes when the driver heard a loud boom. The spring had ejected from its wedged position and struck the mechanic in the head. The driver yelled to the mechanic but got no reply. He ran to the trailer and found the mechanic unresponsive with severe head injuries. He then ran to the hospital's emergency room for help. Medical staff rushed to the scene, where other first responders were arriving. They pulled the mechanic out from under the trailer but could not save his life.

- The mechanic:
  - Did not follow the air spring manufacturer's instructions to fully secure the spring before inflating it. With only one bolt installed, the spring was not properly secured before being inflated.
  - Did not follow the manufacturer's instructions to use new bolts for the spring installation. The bolts found at the scene were worn out and one was sheared in half.
- The employer did not have a hazardous energy control plan or lockout/tagout (LOTO) program.

- Develop a hazardous energy control program for commercial vehicle maintenance operations, including LOTO requirements, as part of their written accident prevention program (APP). Policies should clearly identify hazards and provide precautions, controls, and how to verify zero-energy for all energized vehicle systems, including pneumatic potential energy stored within pressurized air in air suspension systems.

- Provide recurring hands-on training that gives mechanics the knowledge and skills to implement hazardous energy controls and LOTO requirements. Training should include showing mechanics how to properly follow the manufacturer's installation, maintenance, and safety instructions for different system components. Have mechanics demonstrate their knowledge and skills before allowing them to work on or near vehicle systems where hazardous energy is present. Conduct periodic refresher training and support it with toolbox talks and safety meetings.

- If lone remote work is unavoidable, require field service mechanics to call their supervisor to verify they have applied hazardous energy controls or LOTO before repairing an energized vehicle system.
