Truck Mechanic Struck by Trailer Air Suspension Spring

REPORT #: 71-259-2024s

REPORT DATE: October 14, 2024

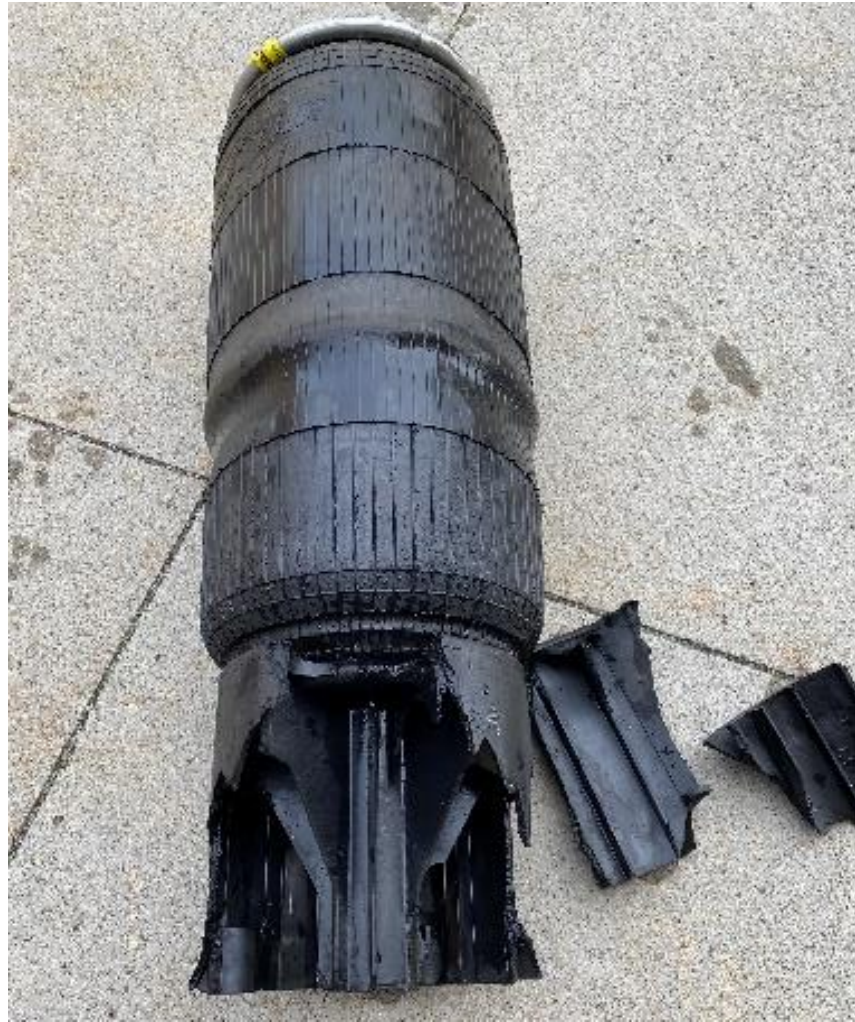
The mechanic stayed under the trailer and gave the driver instructions while the spring was inflating. It was inflating for about three minutes when the driver heard a loud boom. The spring had ejected from its wedged position and struck the mechanic in the head. The driver yelled to the mechanic but got no reply. He ran to the trailer and found the mechanic unresponsive with severe head injuries. He then ran to the hospital's emergency room for help. Medical staff rushed to the scene, where other first responders were arriving. They pulled the mechanic out from under the trailer but could not save his life.

Photo 2. Air spring that struck mechanic.

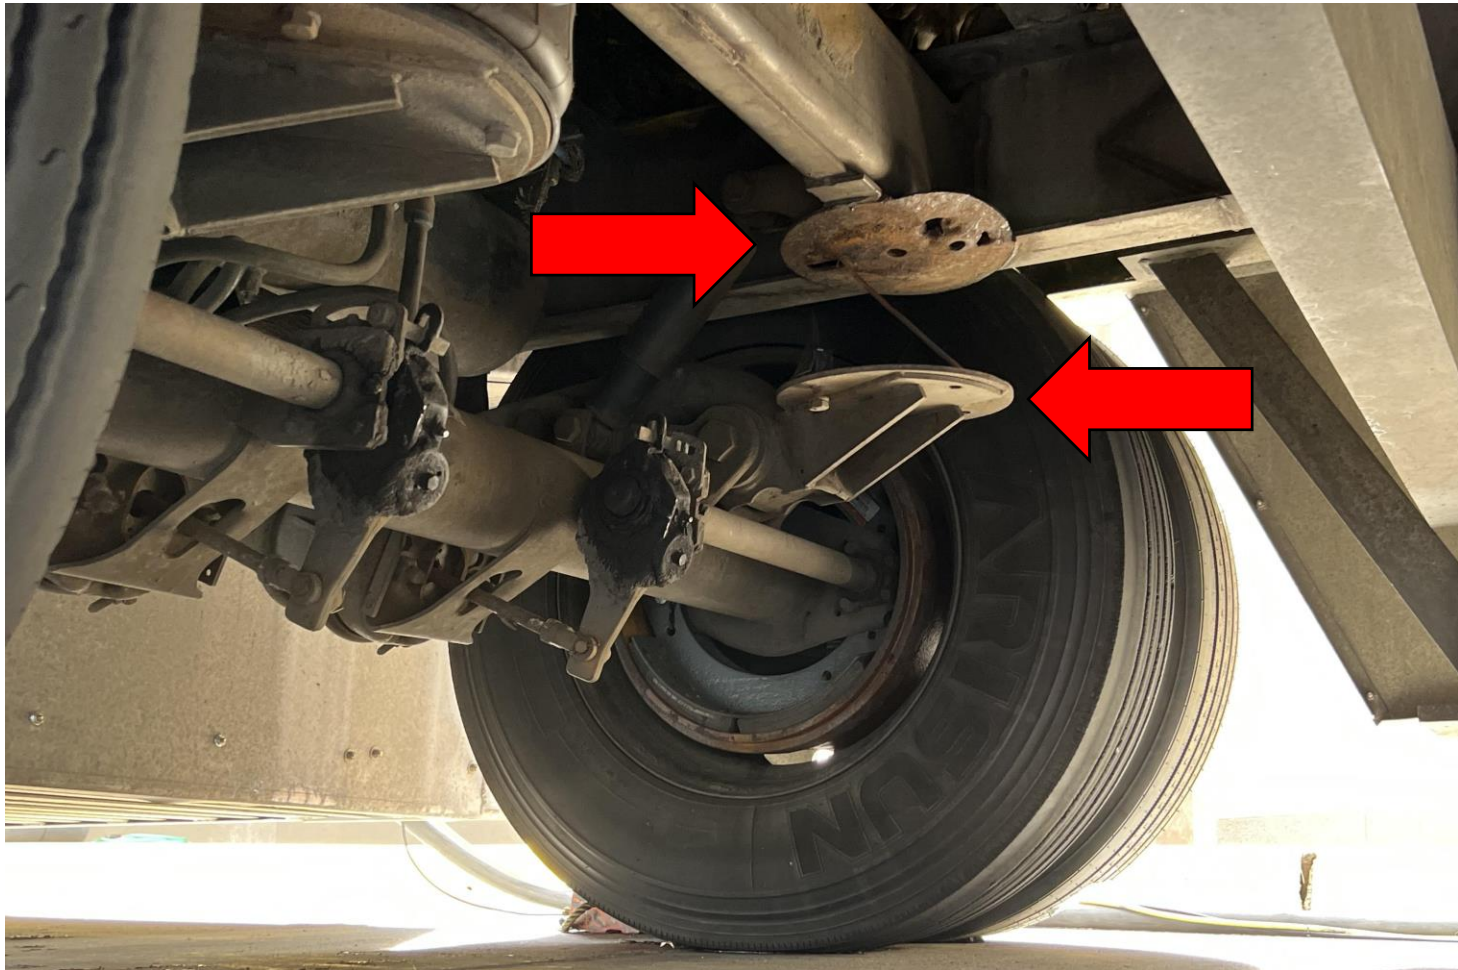
- The mechanic:
 - o Did not follow the air spring manufacturer's instructions to fully secure the spring before inflating it. With only one bolt installed, the spring was not properly secured before being inflated.
 - o Did not follow the manufacturer's instructions to use new bolts for the spring installation. The bolts found at the scene were worn out and one was sheared in half.
- The employer did not have a hazardous energy control plan or lockout/tagout (LOTO) program.

Photo 3. Upper and lower mounting plates where air spring was partly wedged and then ejected during inflation.

- Develop a hazardous energy control program for commercial vehicle maintenance operations, including LOTO requirements, as part of their written accident prevention program (APP). Policies should clearly identify hazards and provide precautions, controls, and how to verify zero-energy for all energized vehicle systems, including pneumatic potential energy stored within pressurized air in air suspension systems.

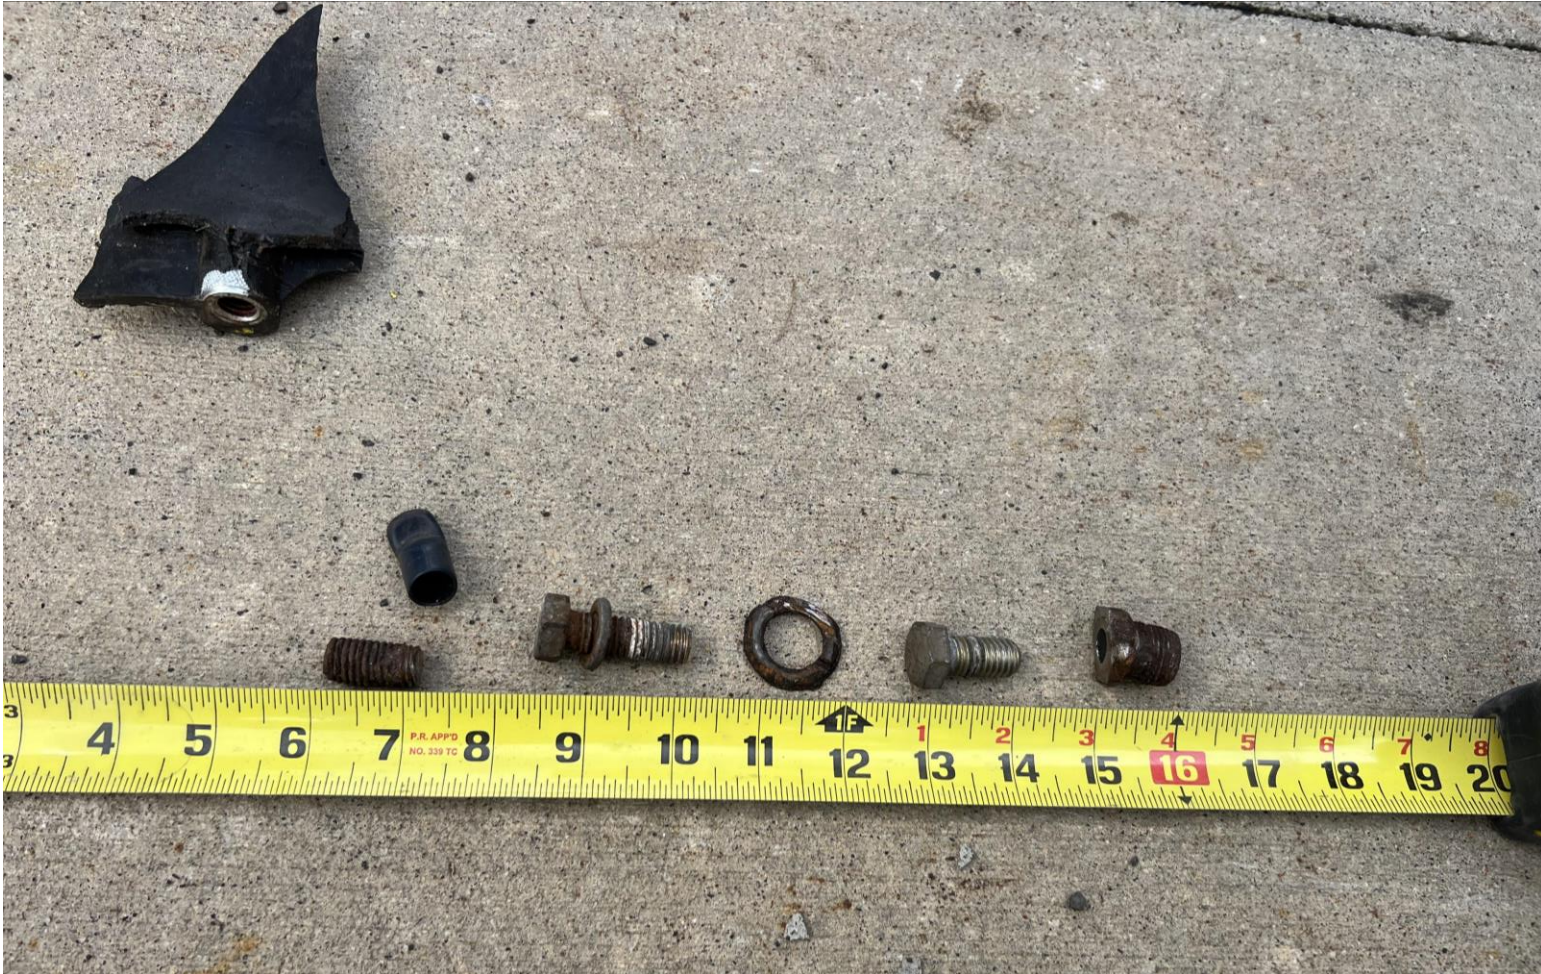
Photo 4. Worn, broken, and sheared air spring mounting bolts found at incident scene.
