Truck Mechanic Struck by Trailer Air Suspension Spring

REPORT #: 71-259-2024s

REPORT DATE: October 14, 2024

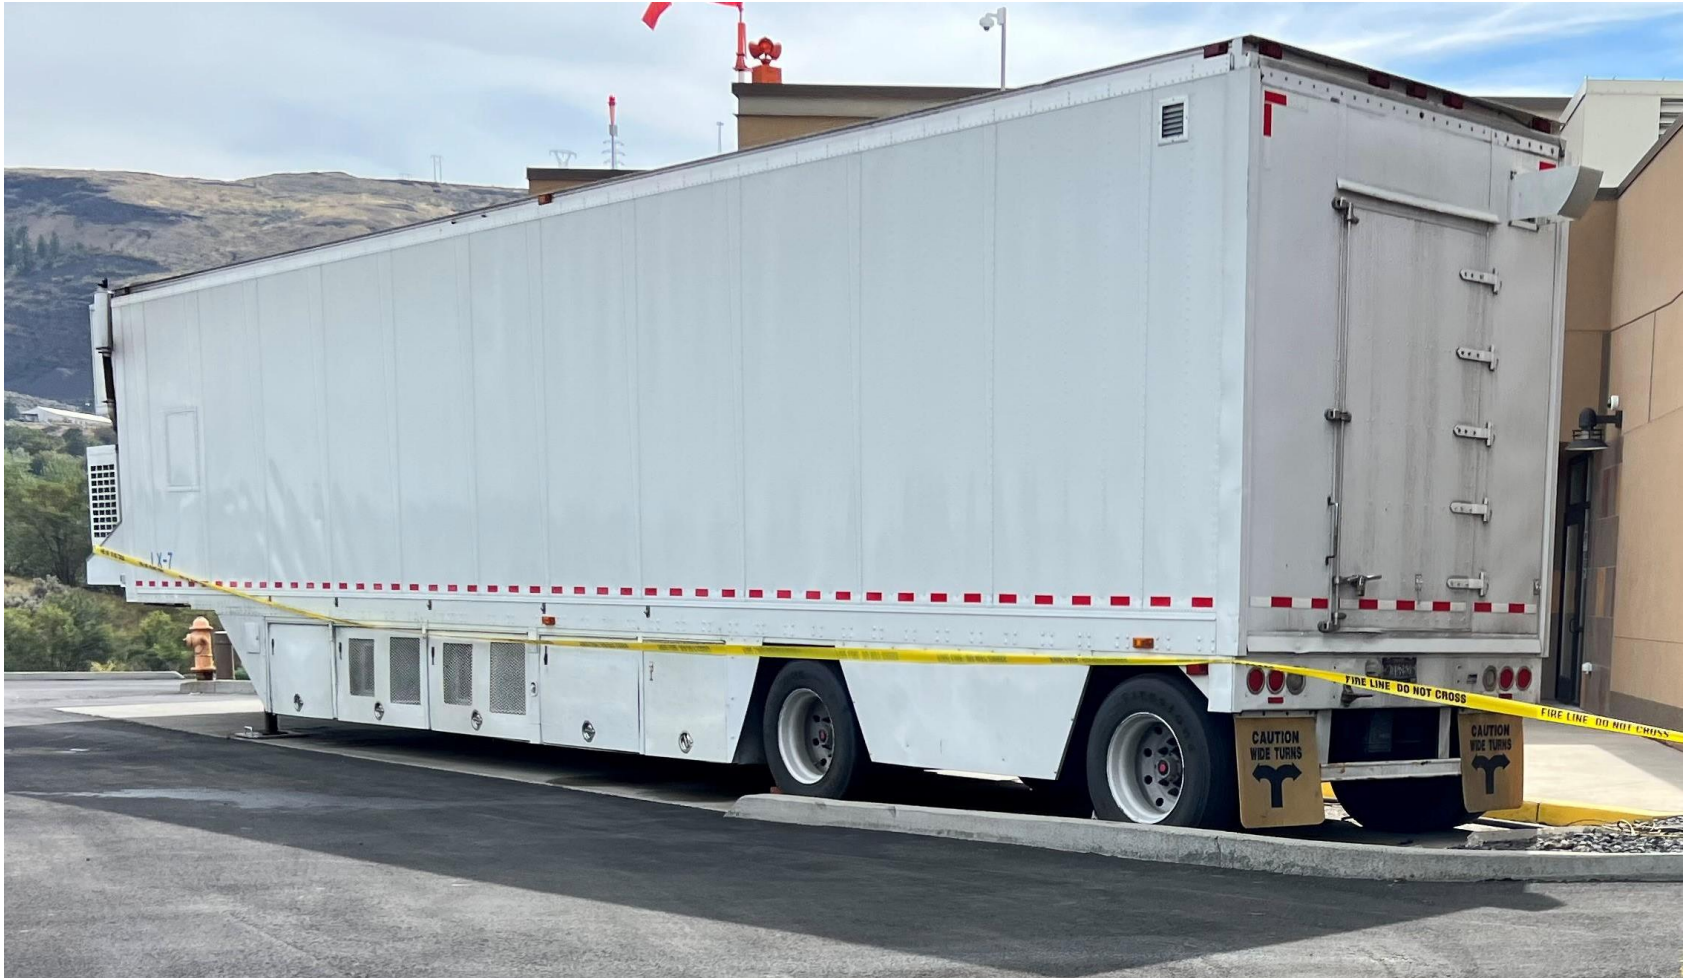
Photo 1. Trailer from incident.

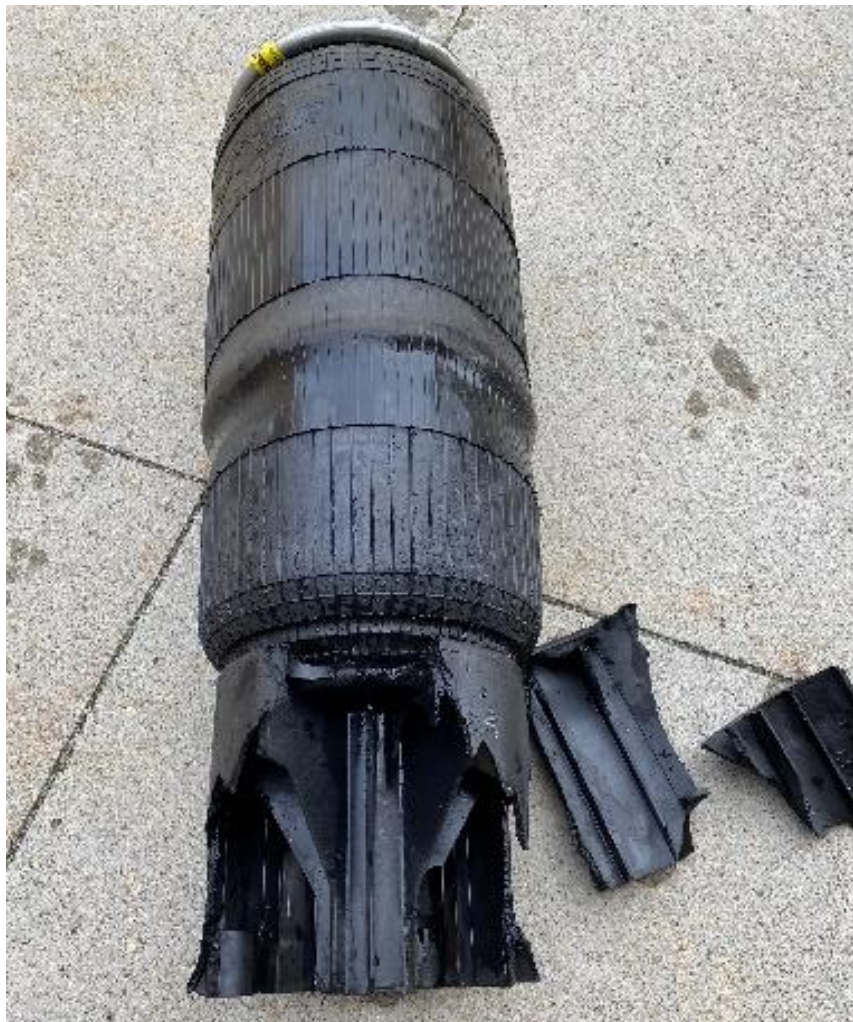
- The mechanic did not follow the air spring manufacturer's instructions to:
 - o Fully secure the spring before inflating it. With only one bolt installed, the spring was not properly secured before being inflated.
 - o Use new bolts for the spring installation. The bolts found at the scene were worn out and one was sheared in half.
- The employer did not have a hazardous energy control plan or lockout/tagout (LOTO) program.

Photo 2. Air spring that struck mechanic.

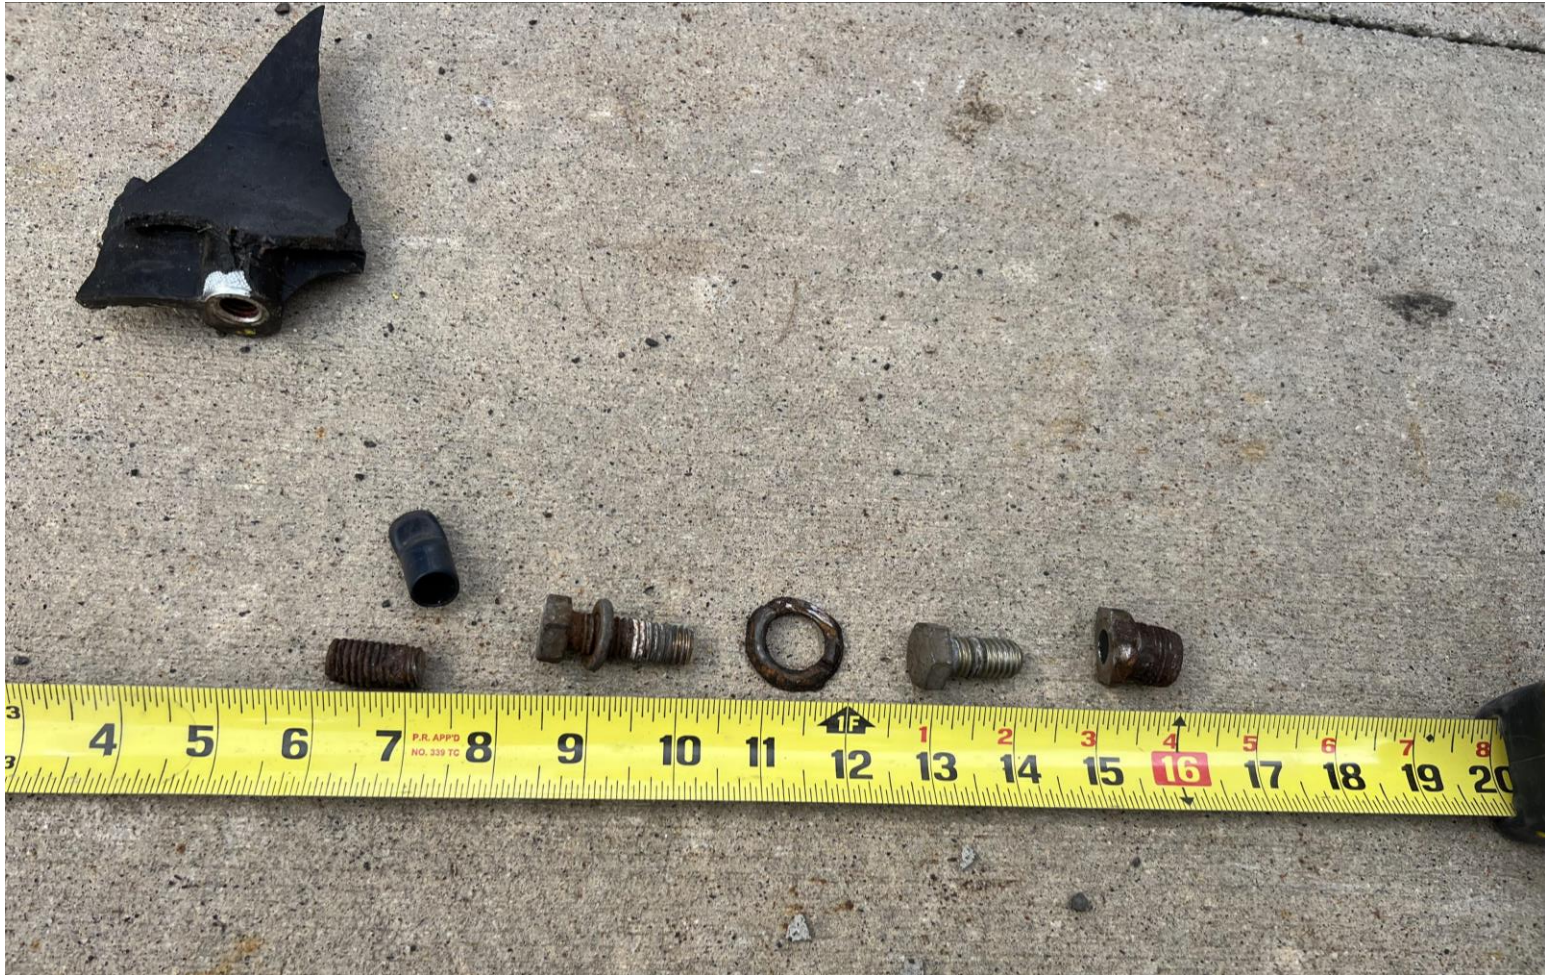
Photo 4. Worn, broken, and sheared air spring mounting bolts found at incident scene.
