INCIDENT FACTS

71-260-2024

Welder Fell 32 Feet from Storage Tank Roof

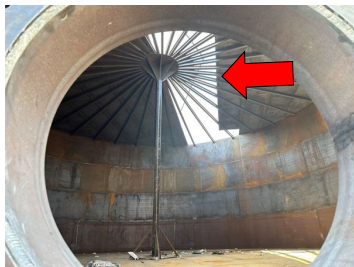
Hole in roof where welder fell.

While sitting on the rafter, he used a pry bar to bend and move the sheet into place for welding. As he pried, he fell backward through the hole between the rafter and leading edge. After landing on the ground, he was badly hurt but still conscious and breathing. Emergency responders arrived and had a critical care helicopter airlift him to the hospital. He died the next day.

- Use a crane instead of workers to move sheathing near roof leading edges.
- Develop FPWP and PFAS policies in their accident prevention program (APP). Policies should require pre-planning the use, training, and inspection of site-specific fall protection.
- Have supervisors review fall protection requirements with workers at pre-job crew meetings, routinely check that they are following them, and implement corrective action when needed.
- Demonstrate fall prevention leadership by prioritizing fall prevention at pre-job crew meetings, monthly safety meetings, annual stand-downs, and in company newsletters and social media.
