# CONSTRUCTION FATALITY NARRATIVE

#### Framer Falls 8 Feet from Rim Joist

**REPORT #: 71-264-2025s**

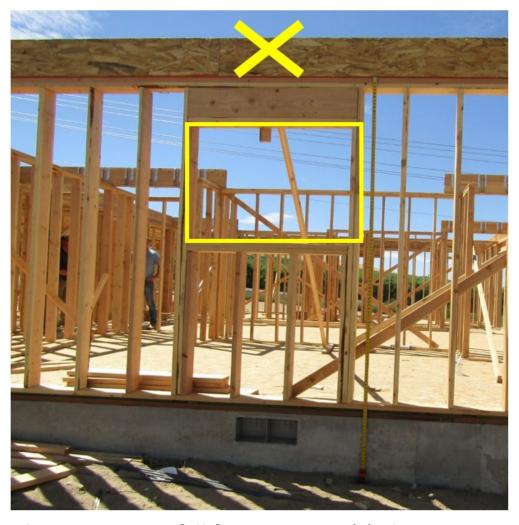
He sat down on a rim joist to wait. The joist was eight feet above the floor decking and had a window opening just below it. He was straddling the joist to support himself above the opening. He then leaned to the inside of the wall and lost balance. Unable to regain balance due to the opening, he fell headfirst to the floor decking below.

**Photo 1.** Framer fell from rim joist (x) above window opening to floor deck.

When workers must walk on top plates, joists, rafters, trusses, beams or other similar structural members, provide fall protection by using scaffolding, aerial lifts, edge protection platforms, guardrails, safety nets, or personal fall protection systems. Train workers to use these methods and equipment properly and periodically evaluate their fall protection knowledge and skills.

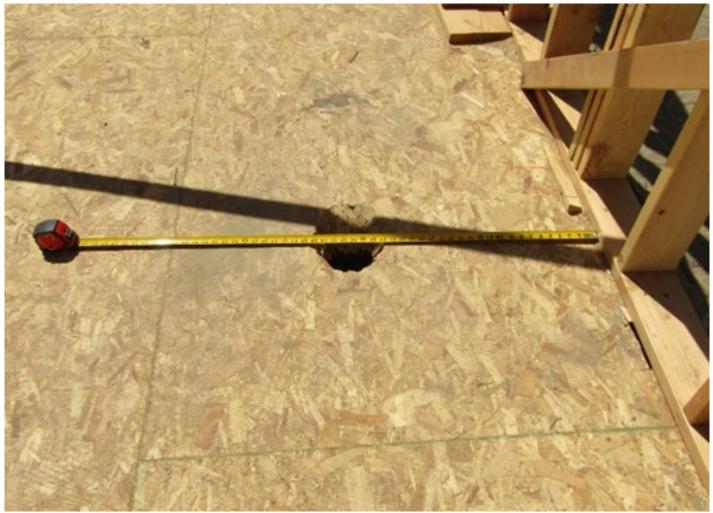
**Photo 2**. Hole in ¾-inch decking is from the impact of the framer's head.

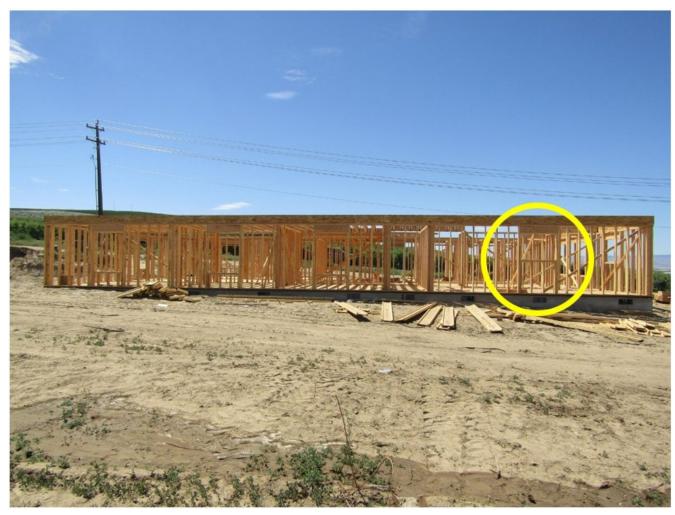
**Photo 3**. Circle shows area where framer fell.
