REPORT #:

71-266-2025

REPORT DATE:

Roofer Falls 45 Feet through Skylight

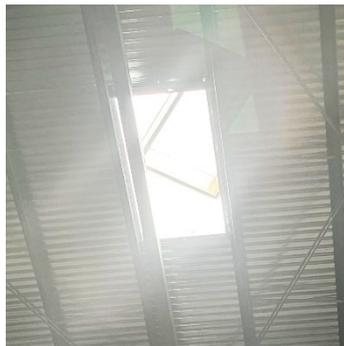
Interior view of skylight hole.

He was on a crew installing roofing insulation and skylights on a large industrial building under construction. Multiple contractors were hired for the project, which involved installing 77 skylights. Another contractor's framing crew had just cut a hole from a boom lift underneath the roof deck. They then hand signaled the roofers to carry a skylight lid to cover a hole. They selected an unsecured, approximately four-foot wide by eight-foot long lid and lifted it at opposite ends with the coworker holding the front. They took a half step forward when the coworker heard the roofer's end drop. He looked back and did not see the roofer, realizing he had fallen through a hole they did not know was under the lid.

- When roofers work around skylights and openings, provide fall protection guardrails, screens, covers, warning lines, safety nets, or personal fall protection systems and keep the area organized.
- Arrive on-site before work begins or appoint a supervisor to conduct a site hazard assessment with workers to identify fall hazards and develop protection methods and procedures in the FPWP.
- During the pre-job safety meeting, review the site hazard assessment and FPWP and emphasize workers' responsibilities to follow fall protection and roof and skylight safety requirements.

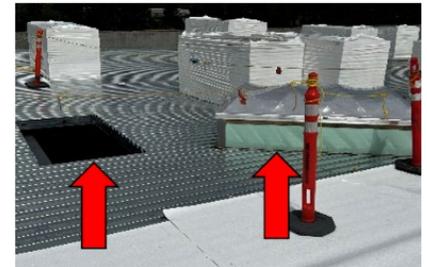
- Fall protection warning lines were in place at the roof edge and around a roof ladder access hatch but no fall protection was being used by roofers inside the lines where skylight holes were present. The boom lift basket, which had been moved from below the hole before the fall occurred, was being used as a fall catch platform. This practice was against the manufacturer's safety guidelines and state fall protection rules.

Skylight hole and lid on roof.
