## Roofer Falls 45 Feet through Skylight

**REPORT #:** 71-266-2025s

**REPORT DATE:** May 1, 2025

**SCENE:** Industrial building construction site

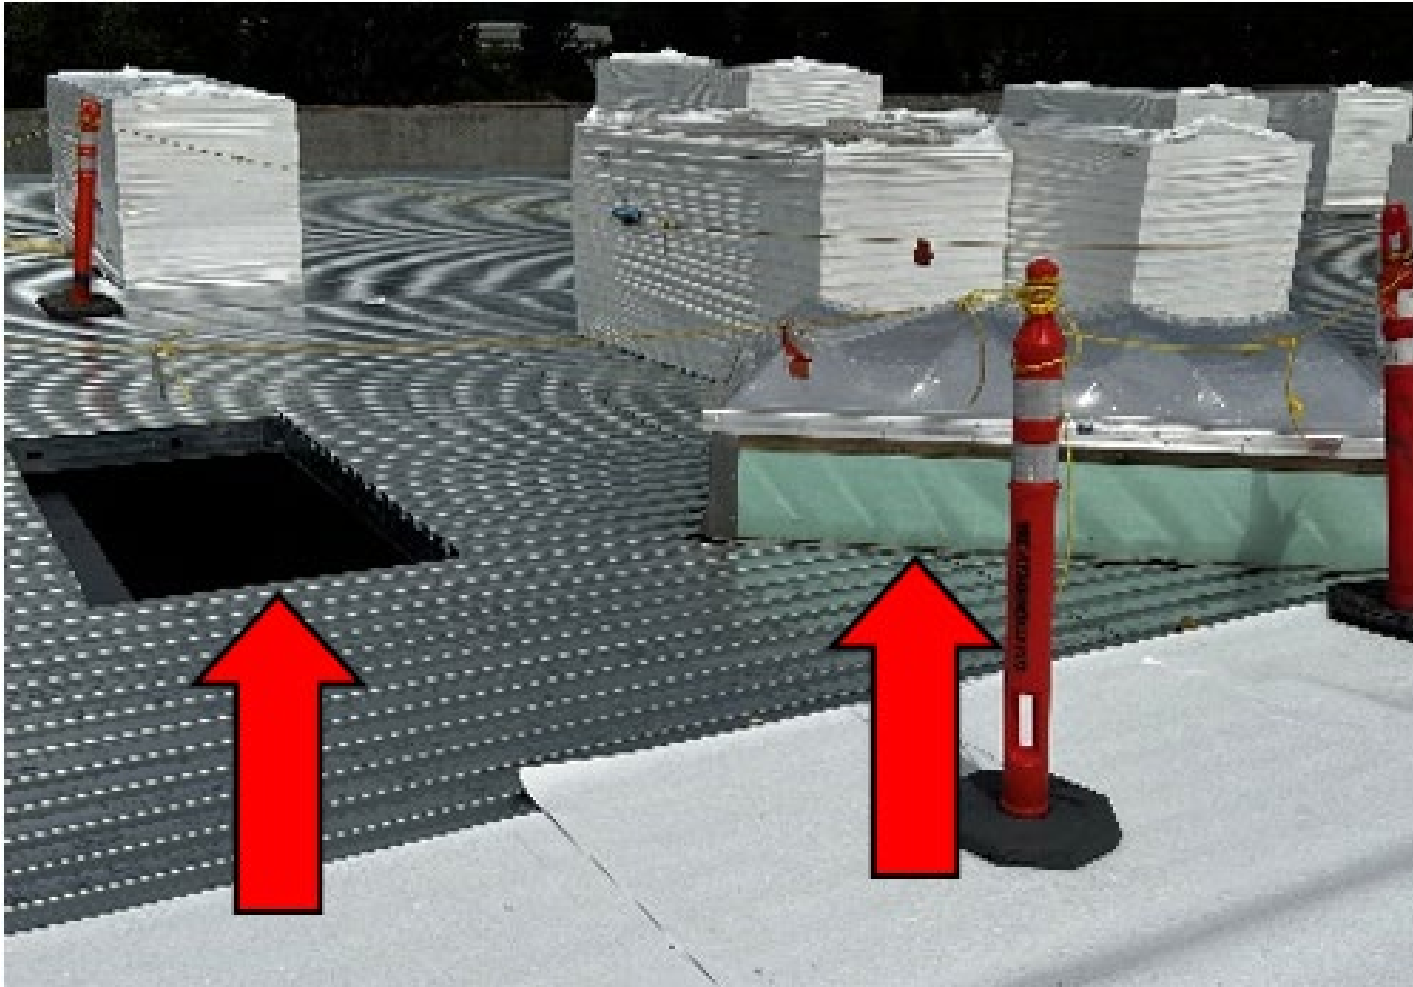
They selected an unsecured, approximately four-foot wide by eight-foot long lid and lifted it at opposite ends with the coworker holding the front. They took a half step forward when the coworker heard the roofer's end drop. He looked back and did not see the roofer, realizing he had fallen through a hole they did not know was under the lid.

**Photo 1.** Skylight hole and lid on roof.

- When roofers work around skylights and openings, provide fall protection guardrails, screens, covers, warning lines, safety nets, or personal fall protection systems and keep the area organized.
- Arrive on-site before work begins or appoint a supervisor to conduct a site hazard assessment with workers to identify fall hazards and develop protection methods and procedures in the FPWP.

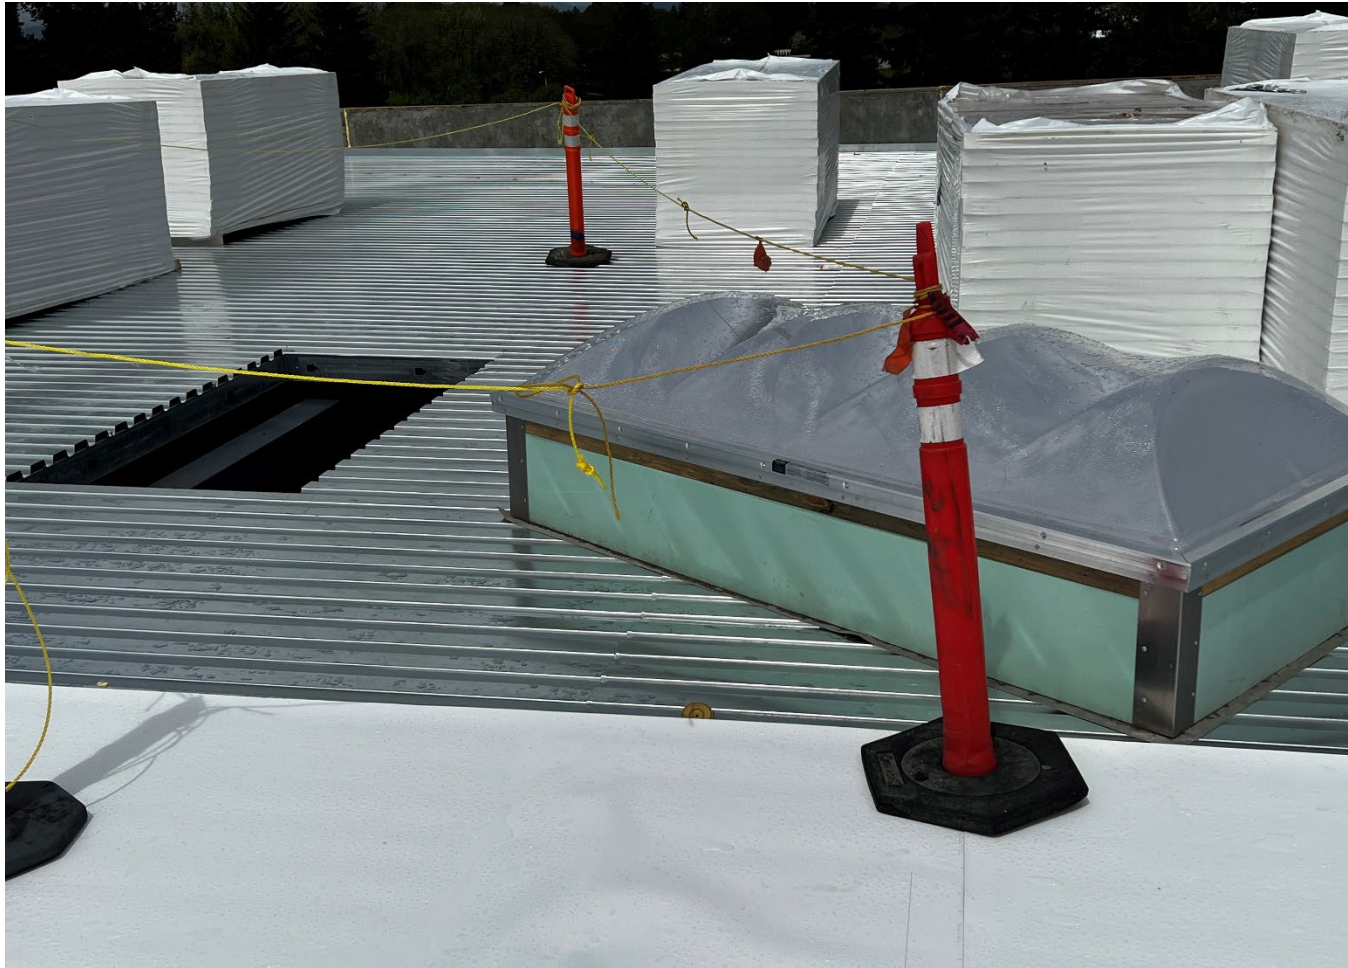
**Photo 2.** Alternate view of skylight hole and lid on roof.

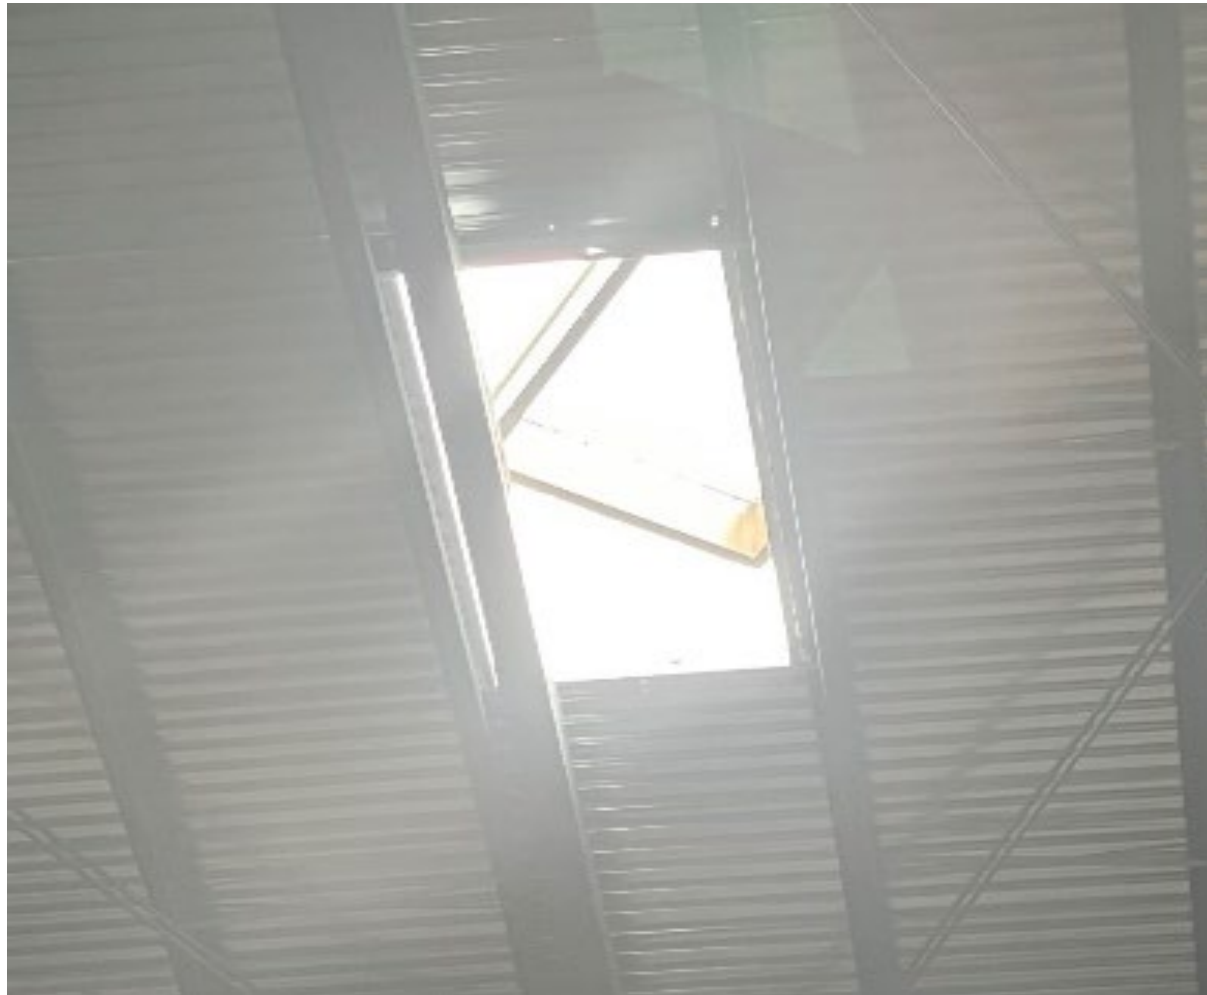
**Photo 3.** Interior view of skylight hole.

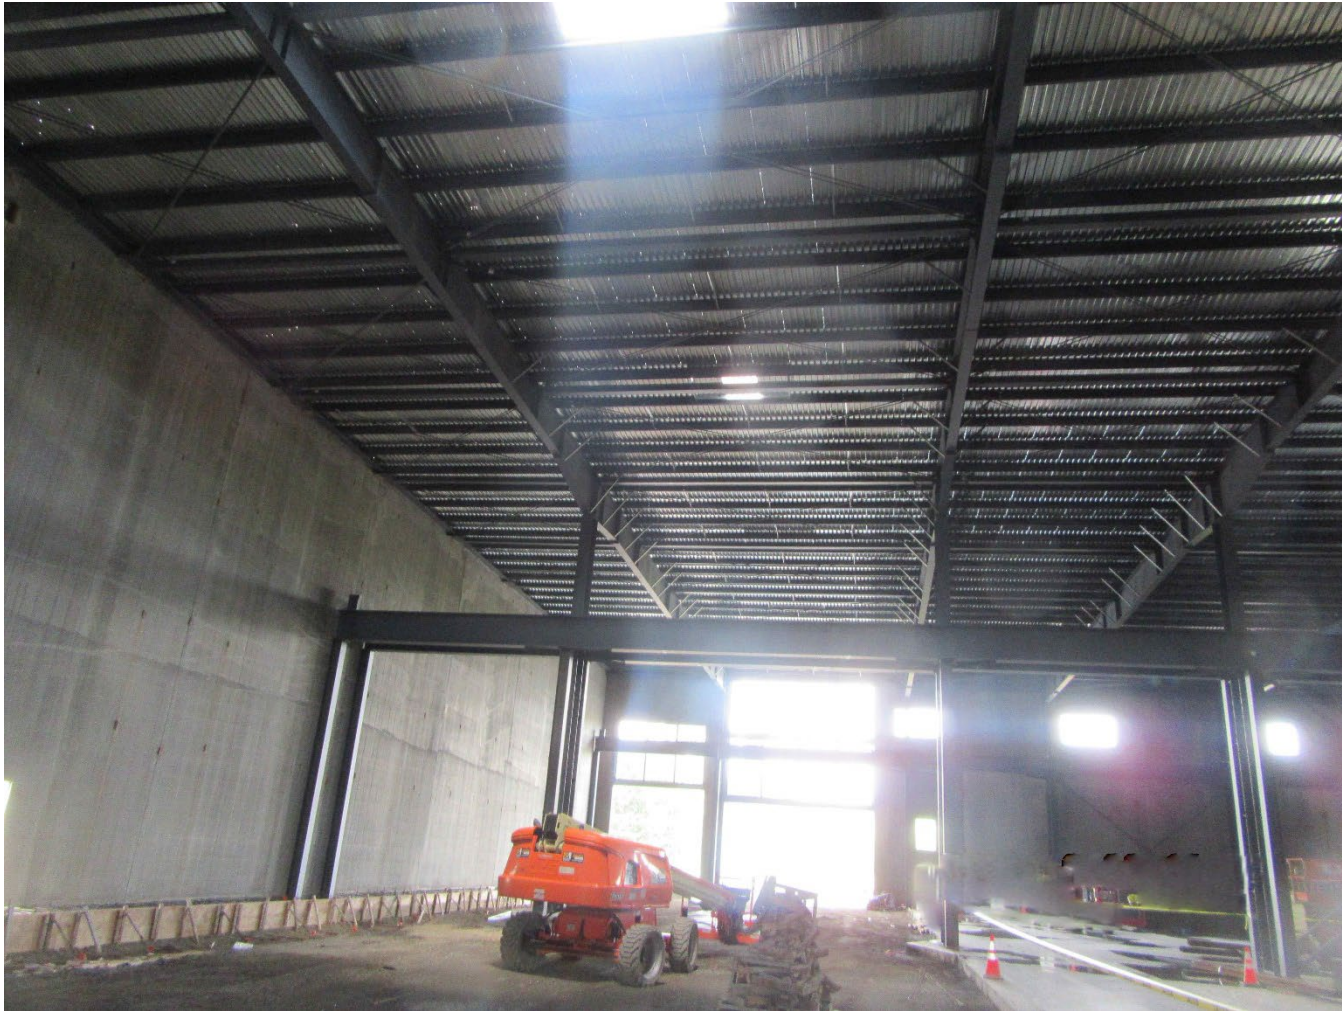
**Photo 4.** Interior of building with skylights.

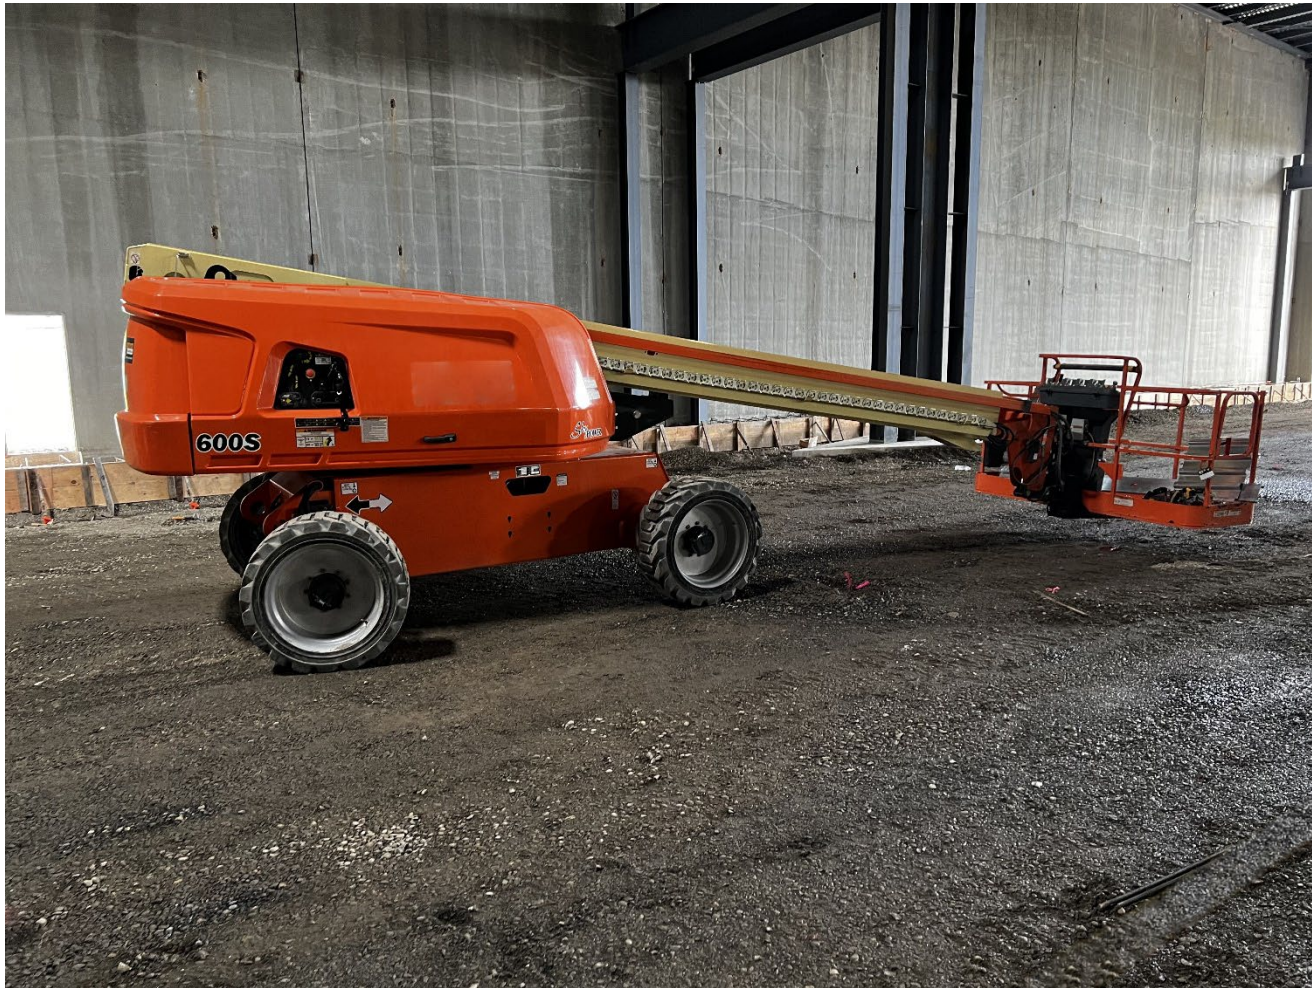
- The roofers were not experienced nor trained in skylight installations. They were going back and forth between installing insulation and skylights, which may have confused them about which skylights were secured. Visibility on the roof was impacted by the bundles of insulation.
- Fall protection warning lines were in place at the roof edge and around a roof ladder access hatch but no fall protection was being used by roofers inside the lines where skylight holes were present. The boom lift basket, which had been moved from below the hole before the fall occurred, was being used as a fall catch platform. This practice was against the manufacturer's safety guidelines and state fall protection rules.

**Photo 5.** Boom lift with basket used a fall catch platform.
