**REPORT #:**  
71-277-2026

**SCENE:**  
Residential construction site

## CONSTRUCTION FATALITY NARRATIVE

### Laborer Falls through Guardrail

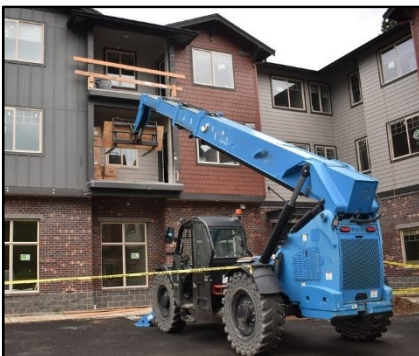
Scene where worker fell.

A 27-year-old construction laborer died when he fell 14 feet through a guardrail while unloading a telehandler from a second-floor balcony.

The open edge of the balcony had a temporary guardrail made of a pair of two-by-six-inch boards.

The boards were fastened with wood screws to supporting posts 10 feet apart at opposite ends of the balcony.

- The pair of two-by-six-inch wood guardrails did not have a mid-way post for their 10-foot span as required for a span of more than eight feet. The guardrails were fastened to the front of the supporting posts of the balcony using just one two-and-a-half-inch wood screw on each end. The actual thickness of the nominal two-by-six-inch board is one inch and three-quarters, which allowed only a half inch of the screw to thread into the post. One of the boards also had a screw that was not fully seated into it.
- The worker weighed over 300 pounds, but the guardrails were unable to withstand at least a 200-pound outward load applied to them, as required.
- The site supervisor did not check the guardrail installation, nor did he know who had installed them.

- **Perform a pre-job review of guardrail requirements with workers.** Have supervisors review and ensure that workers understand specific guardrail requirements at the job site before they begin work.
- **Inspect guardrail systems before and during work.** Arrive on-site each day before work begins or appoint a supervisor to check that guardrails are installed according to requirements. Do not begin work until requirements are met. Spot check guardrails throughout the day to ensure they are in good condition.
- **Make fall prevention a company priority.** Emphasize fall protection in one-on-one worker check-in meetings, daily crew meetings, monthly safety meetings, annual stand-downs, and company media.
