Two Propane Gas Supplier Workers Electrocuted when Boom Truck Crane's Boom Contacts 7,200 Volt Overhead Power Line

Investigation: # 10WA031
Release Date: April 21, 2015
SHARP Report: # 52-32-2015

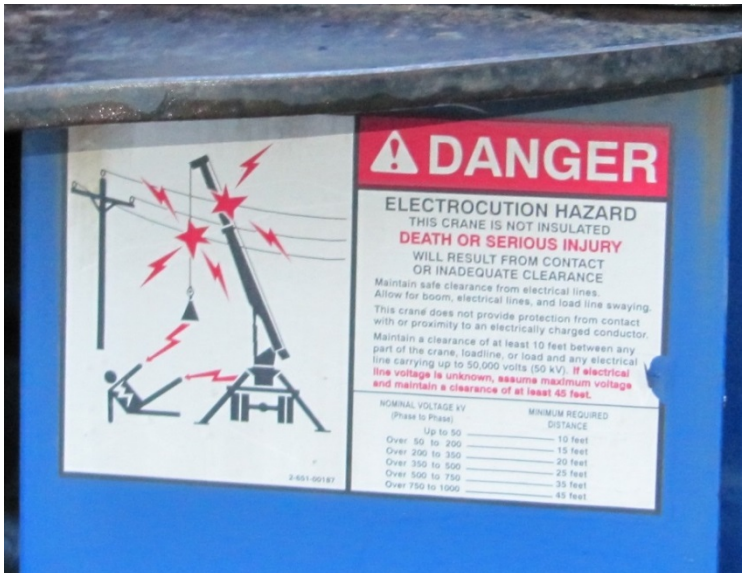
Photo 3. Safety sticker warning of electrocution hazard placed on the right side of the crane operator's station on the boom truck. There were seven such warning signs located on various parts of the boom truck.

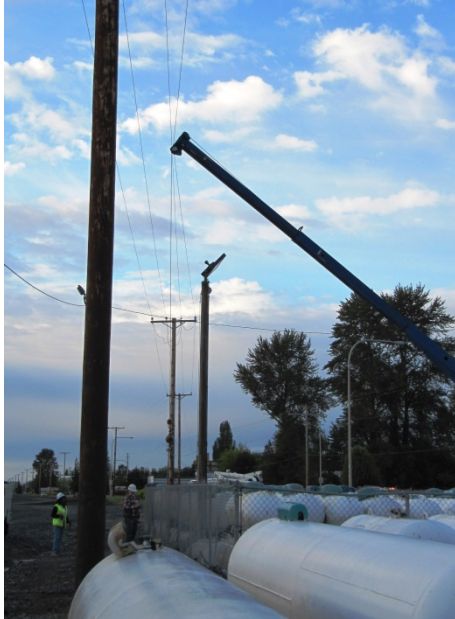
Photo 9. Incident scene with crane boom contacting power line.

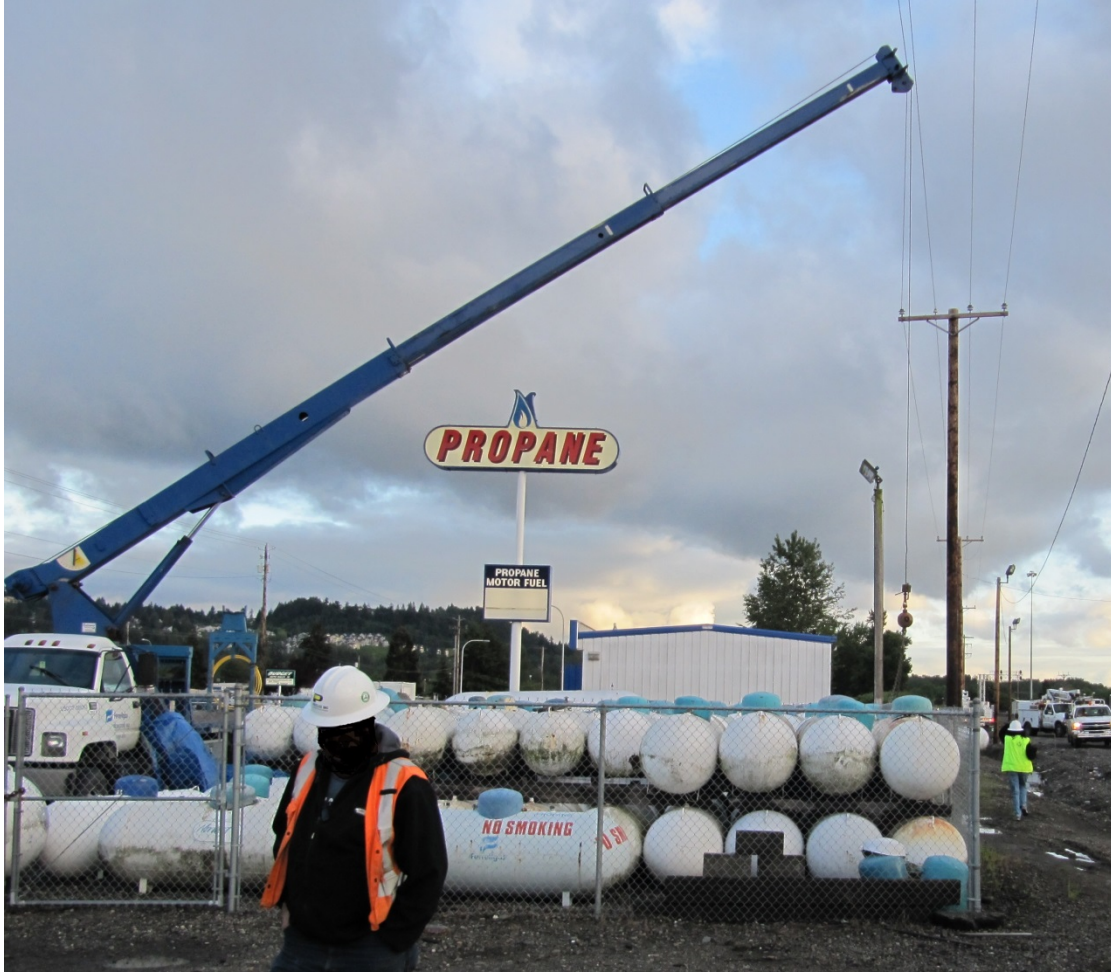
Photo 10. Crane boom tip contacting eastern phase wire of a three-phase 7,200 volt power line. The power lines were located to the west of the yard, and for a short distance inside the yard, and ran north and south. The sequence of the three-phase 7,200 volt power line wires in relationship to the crane boom is eastern phase, neutral, middle phase, and western phase.

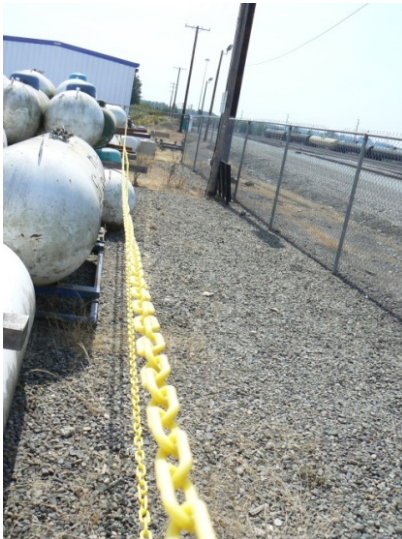
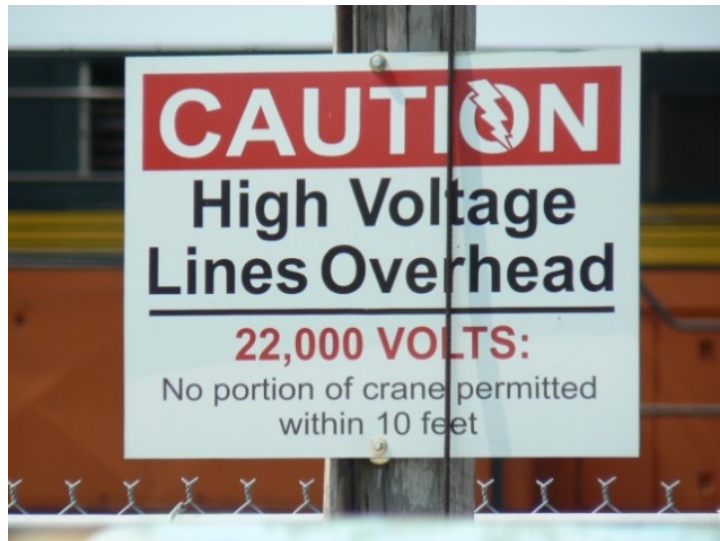
Photos 11 and 12. Employer tank storage yard post-incident. The employer installed a chain barricade ten feet from the overhead power lines and signage to remind crane operators to stay back 10 feet. (The voltage on the sign refers to the cumulative voltage of the 3-phase wires.)

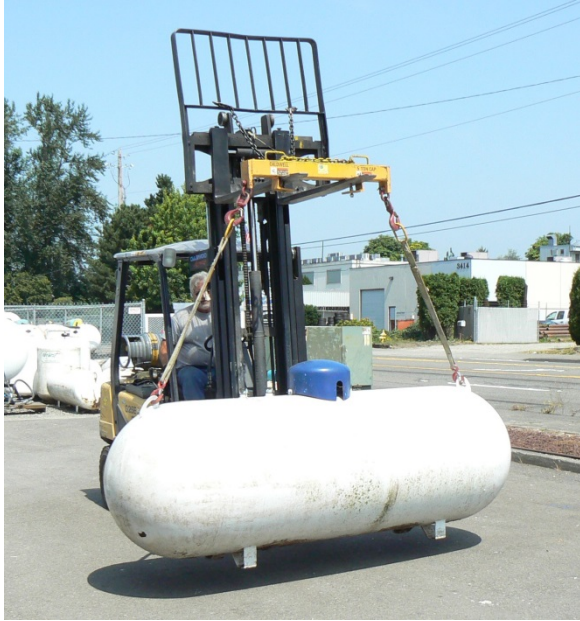
Photo 13: An alternative method of lifting and moving tanks. Propane storage tank being moved by a forklift using a spreader bar and nylon straps attached to the tank's lifting lugs at the employer's yard. According to the employer safety and technical support manual, this method of using rigging attached to lifting lugs to lift and move tanks is used on tanks that are empty or contain no more than 5% of product. For tanks with defective lugs or containing more than 5% of product the straps or chains are positioned under the belly of the tank and to the outside of the tank legs.

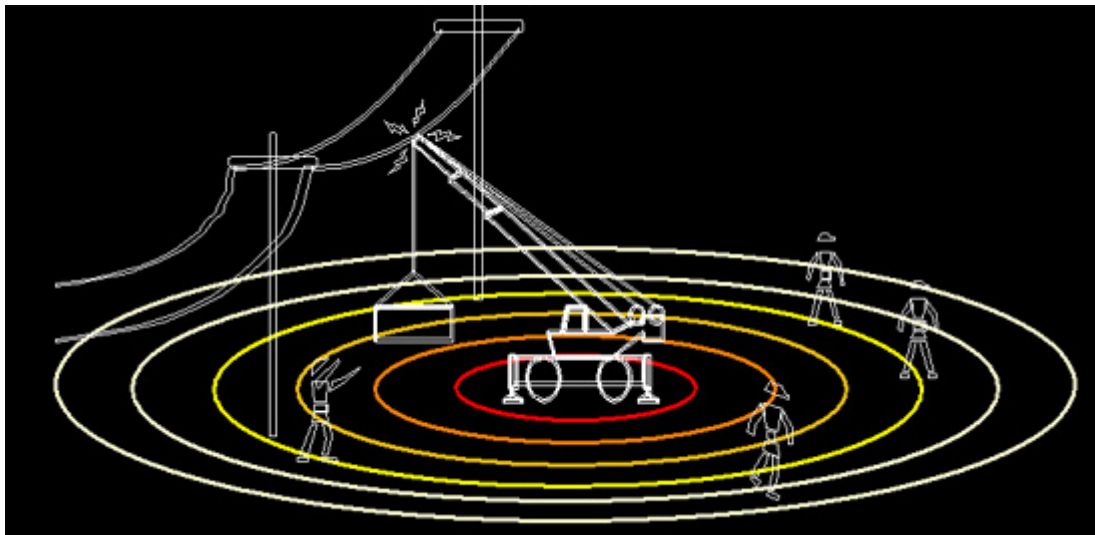
Figure 1: Illustration of how electric current can flow outward through the ground in a ripple pattern from equipment in contact with the power line.
