Laborer Struck by Temporary Steel Shoring Tower Parts

INCIDENT FACTS

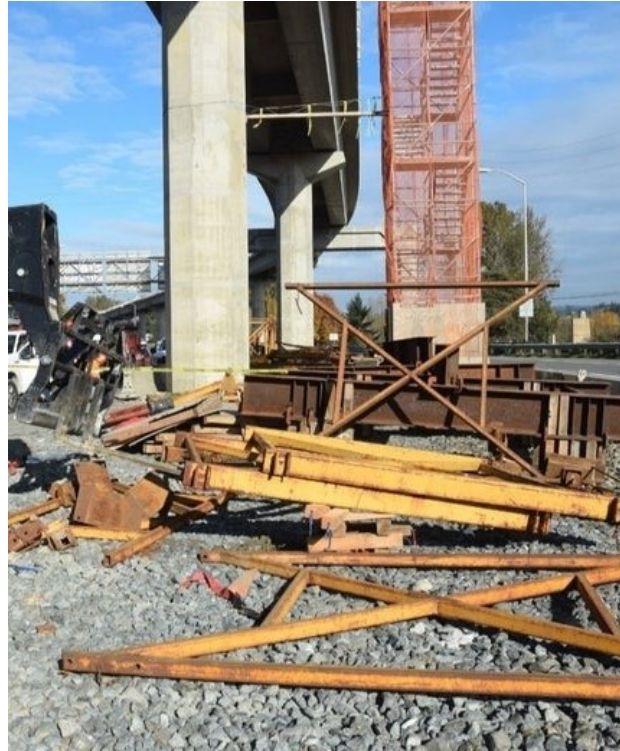
Photo 1. Incident scene beneath an elevated section of a light rail line under construction.

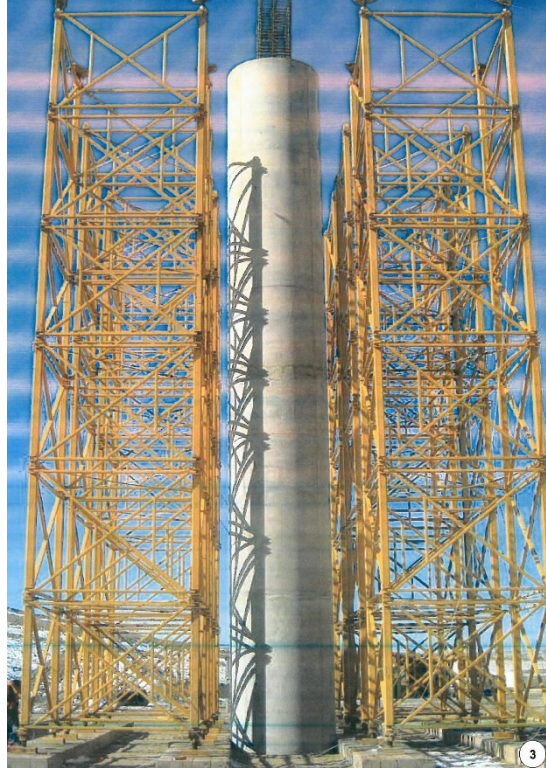
Photo 4. Example of shore towers provided by the manufacturer.
