Operator Electrocuted while Performing Maintenance on Center Pivot Irrigation System

INCIDENT FACTS

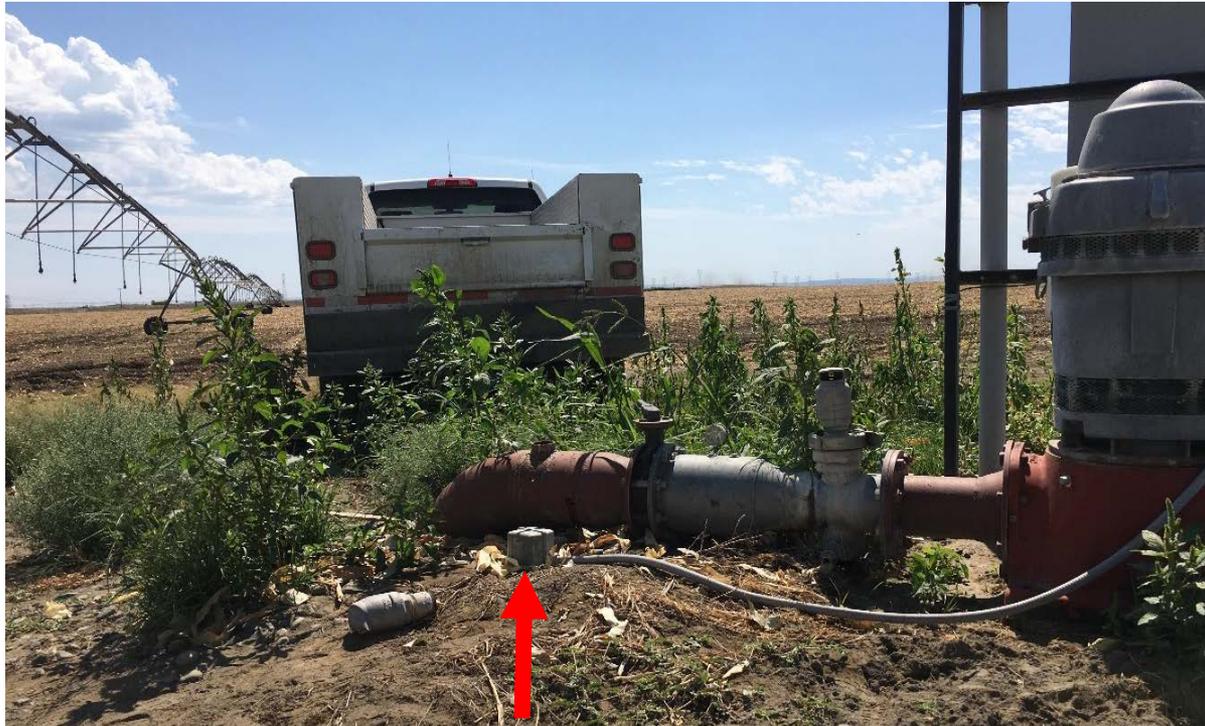
Photo 1. Incident scene showing the operator's truck that he backed into the center pivot irrigation system's water main, breaking off its flow regulator and pressure switch. This caused water to be released. The operator was electrocuted when he picked up the electrified switch (indicated by arrow).

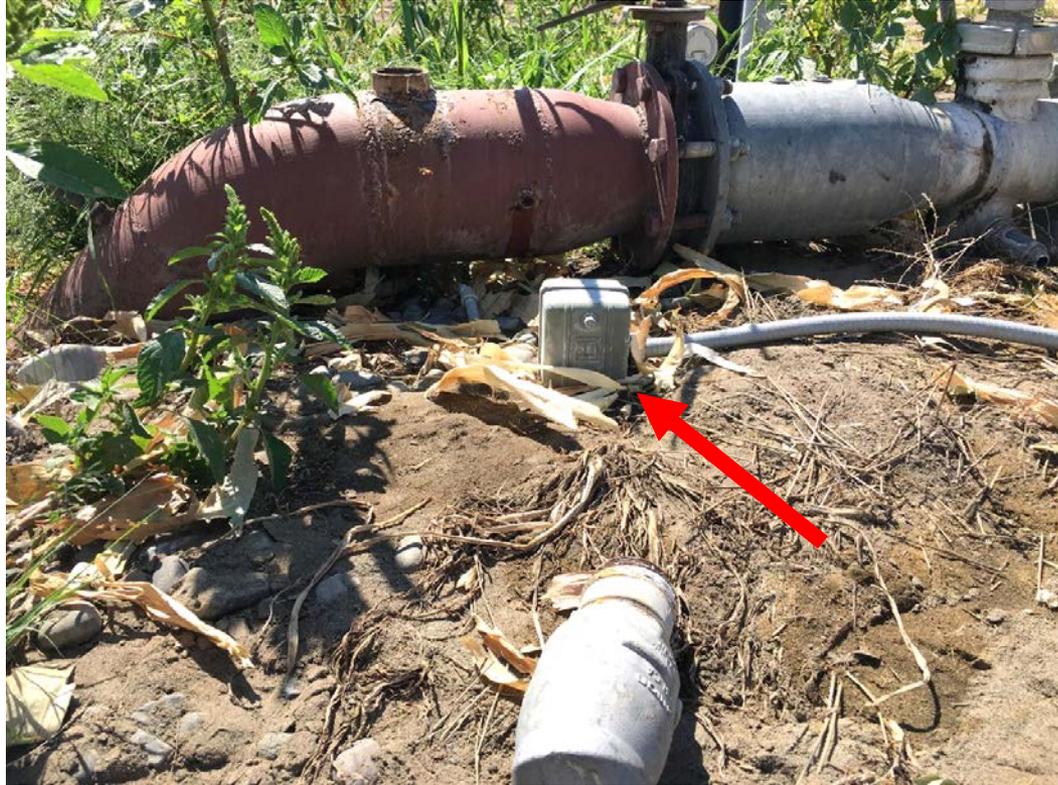
Photo 2. Pivot water main with broken water flow regulator and pressure switch (indicated by arrow).

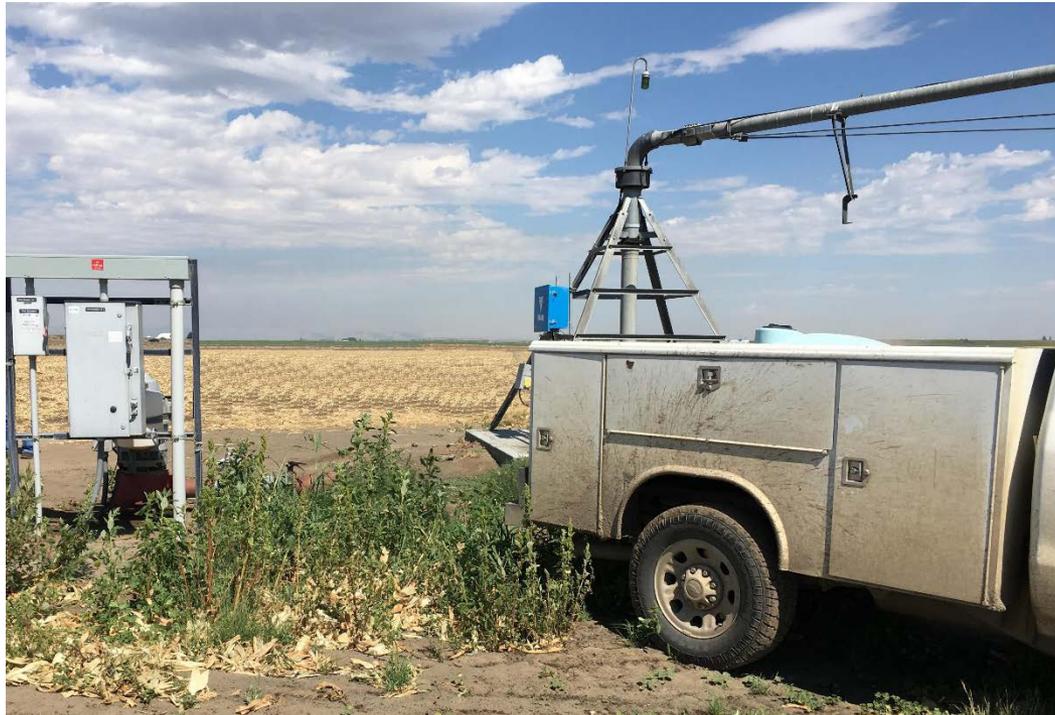
Photo 3. Vegetation blocking operator's view of water main.
