INCIDENT HIGHLIGHTS

May 6, 2021

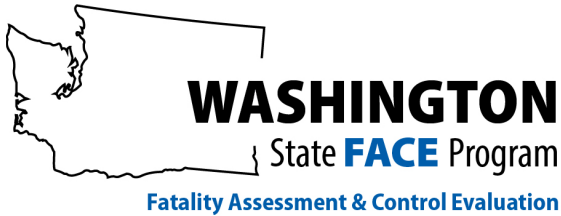
Washington FACE • PO Box 44330 • Olympia, WA 98504-4330
1-888-66-SHARP (toll-free) or 360-902-5667

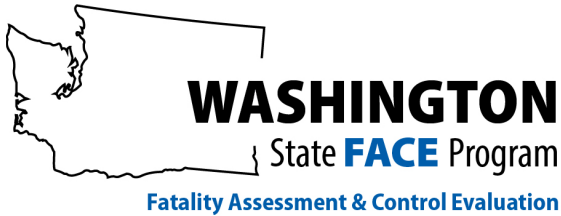
Washington FACE • PO Box 44330 • Olympia, WA 98504-4330
1-888-66-SHARP (toll-free) or 360-902-5667

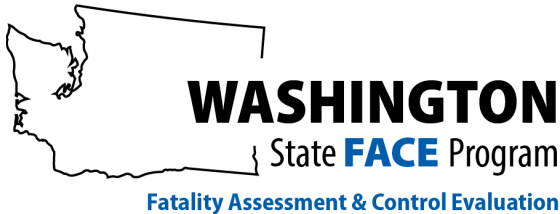
Washington FACE • PO Box 44330 • Olympia, WA 98504-4330
1-888-66-SHARP (toll-free) or 360-902-5667

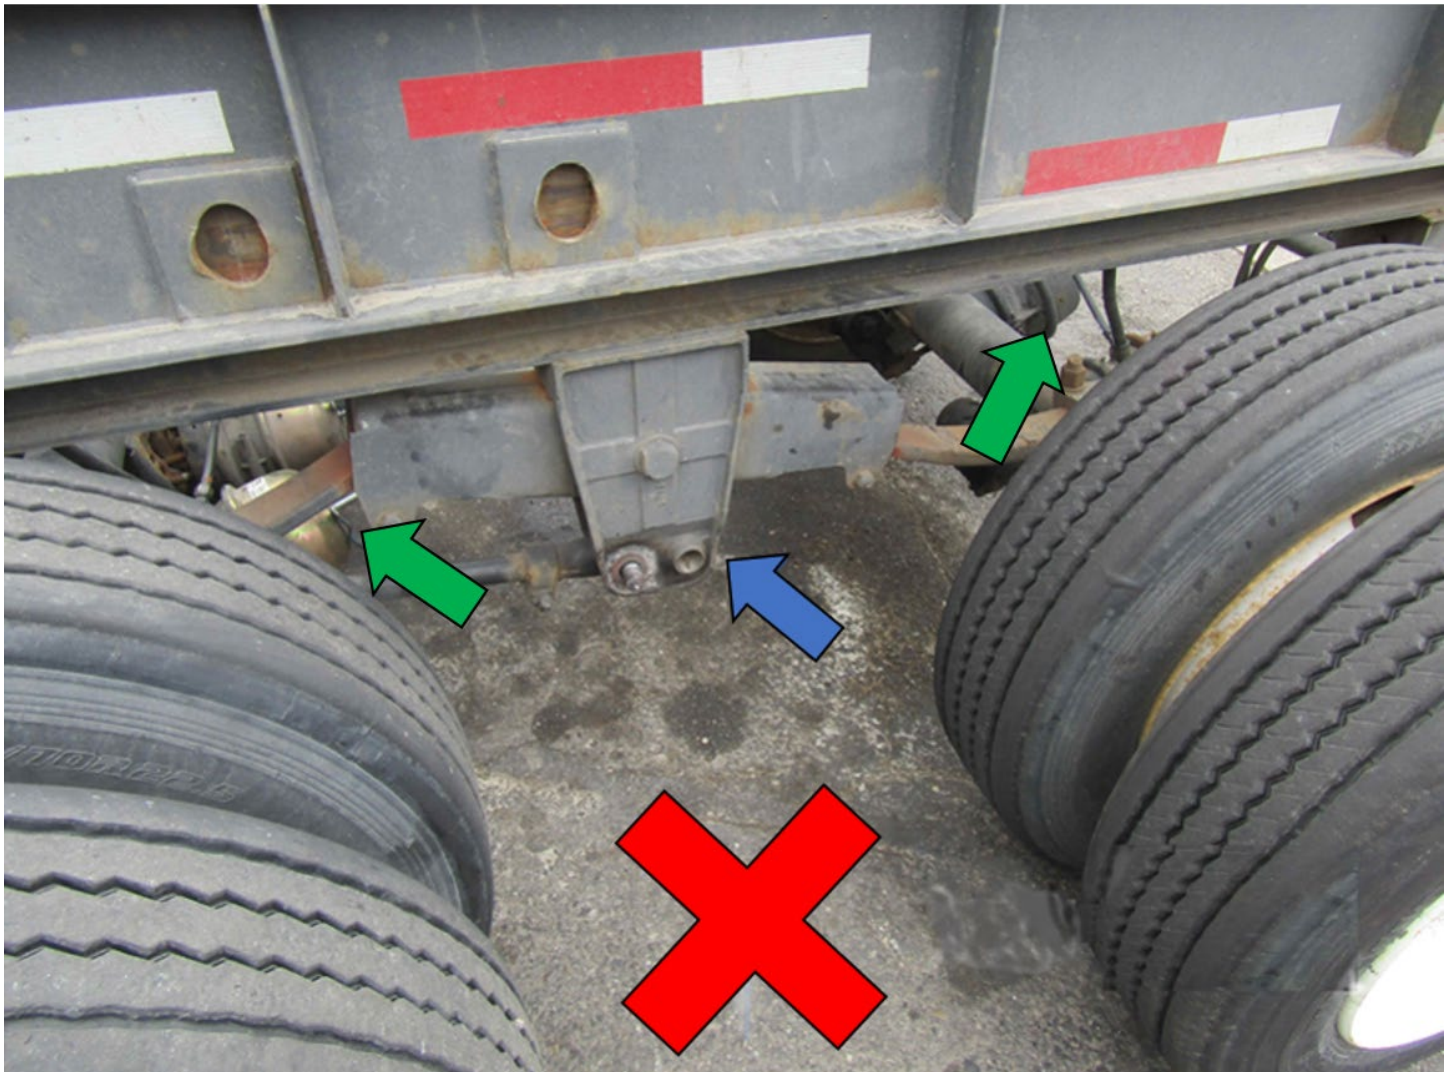
Photo 8: X shows where mechanic was trapped and crushed by the rollaway chassis' wheels. Green arrows show airbrake chambers and air supply lines. Blue arrow shows leaf spring/torque arm hanger where repair was being made.
