Carpenter Falls through Floor of Two-Story Garage

INCIDENT FACTS

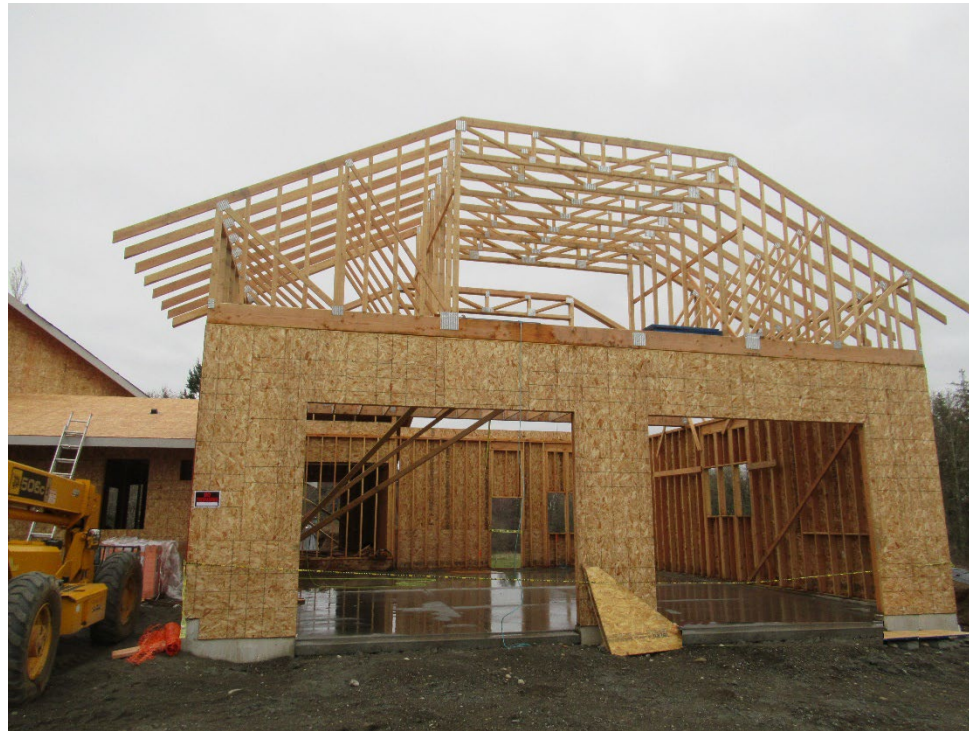
Photo 1. View of front of two-story garage the carpenter and his brothers were building.
