Rofer Falls Constructing Leading Edge of Metal Roof

INCIDENT FACTS

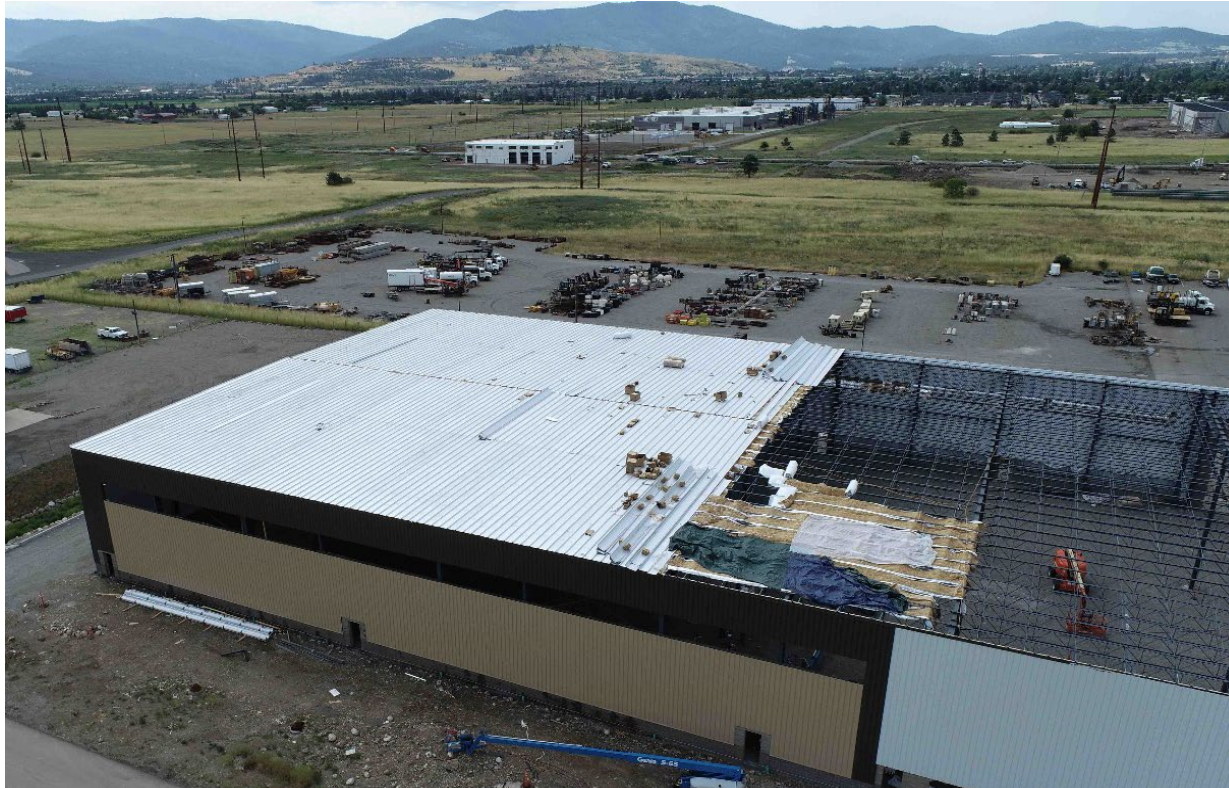
Photo 1. View of the incident scene where the roofers were installing the low-pitch metal roof. The mobile elevating work platform used to access the roof is in the bottom center of the photo.
